To:	Amy Driessen Alberta Transportation	From:	Leslie Cho and Carrie Murray Stantec Consulting Ltd.
File:	123315222	Date:	June 12, 2022

Reference: North Central Region, Edson, Site NC018 - Highway 764:02 Pembina River Bridge (N. of Cherhill), Spring 2022 Instrumentation Monitoring Report

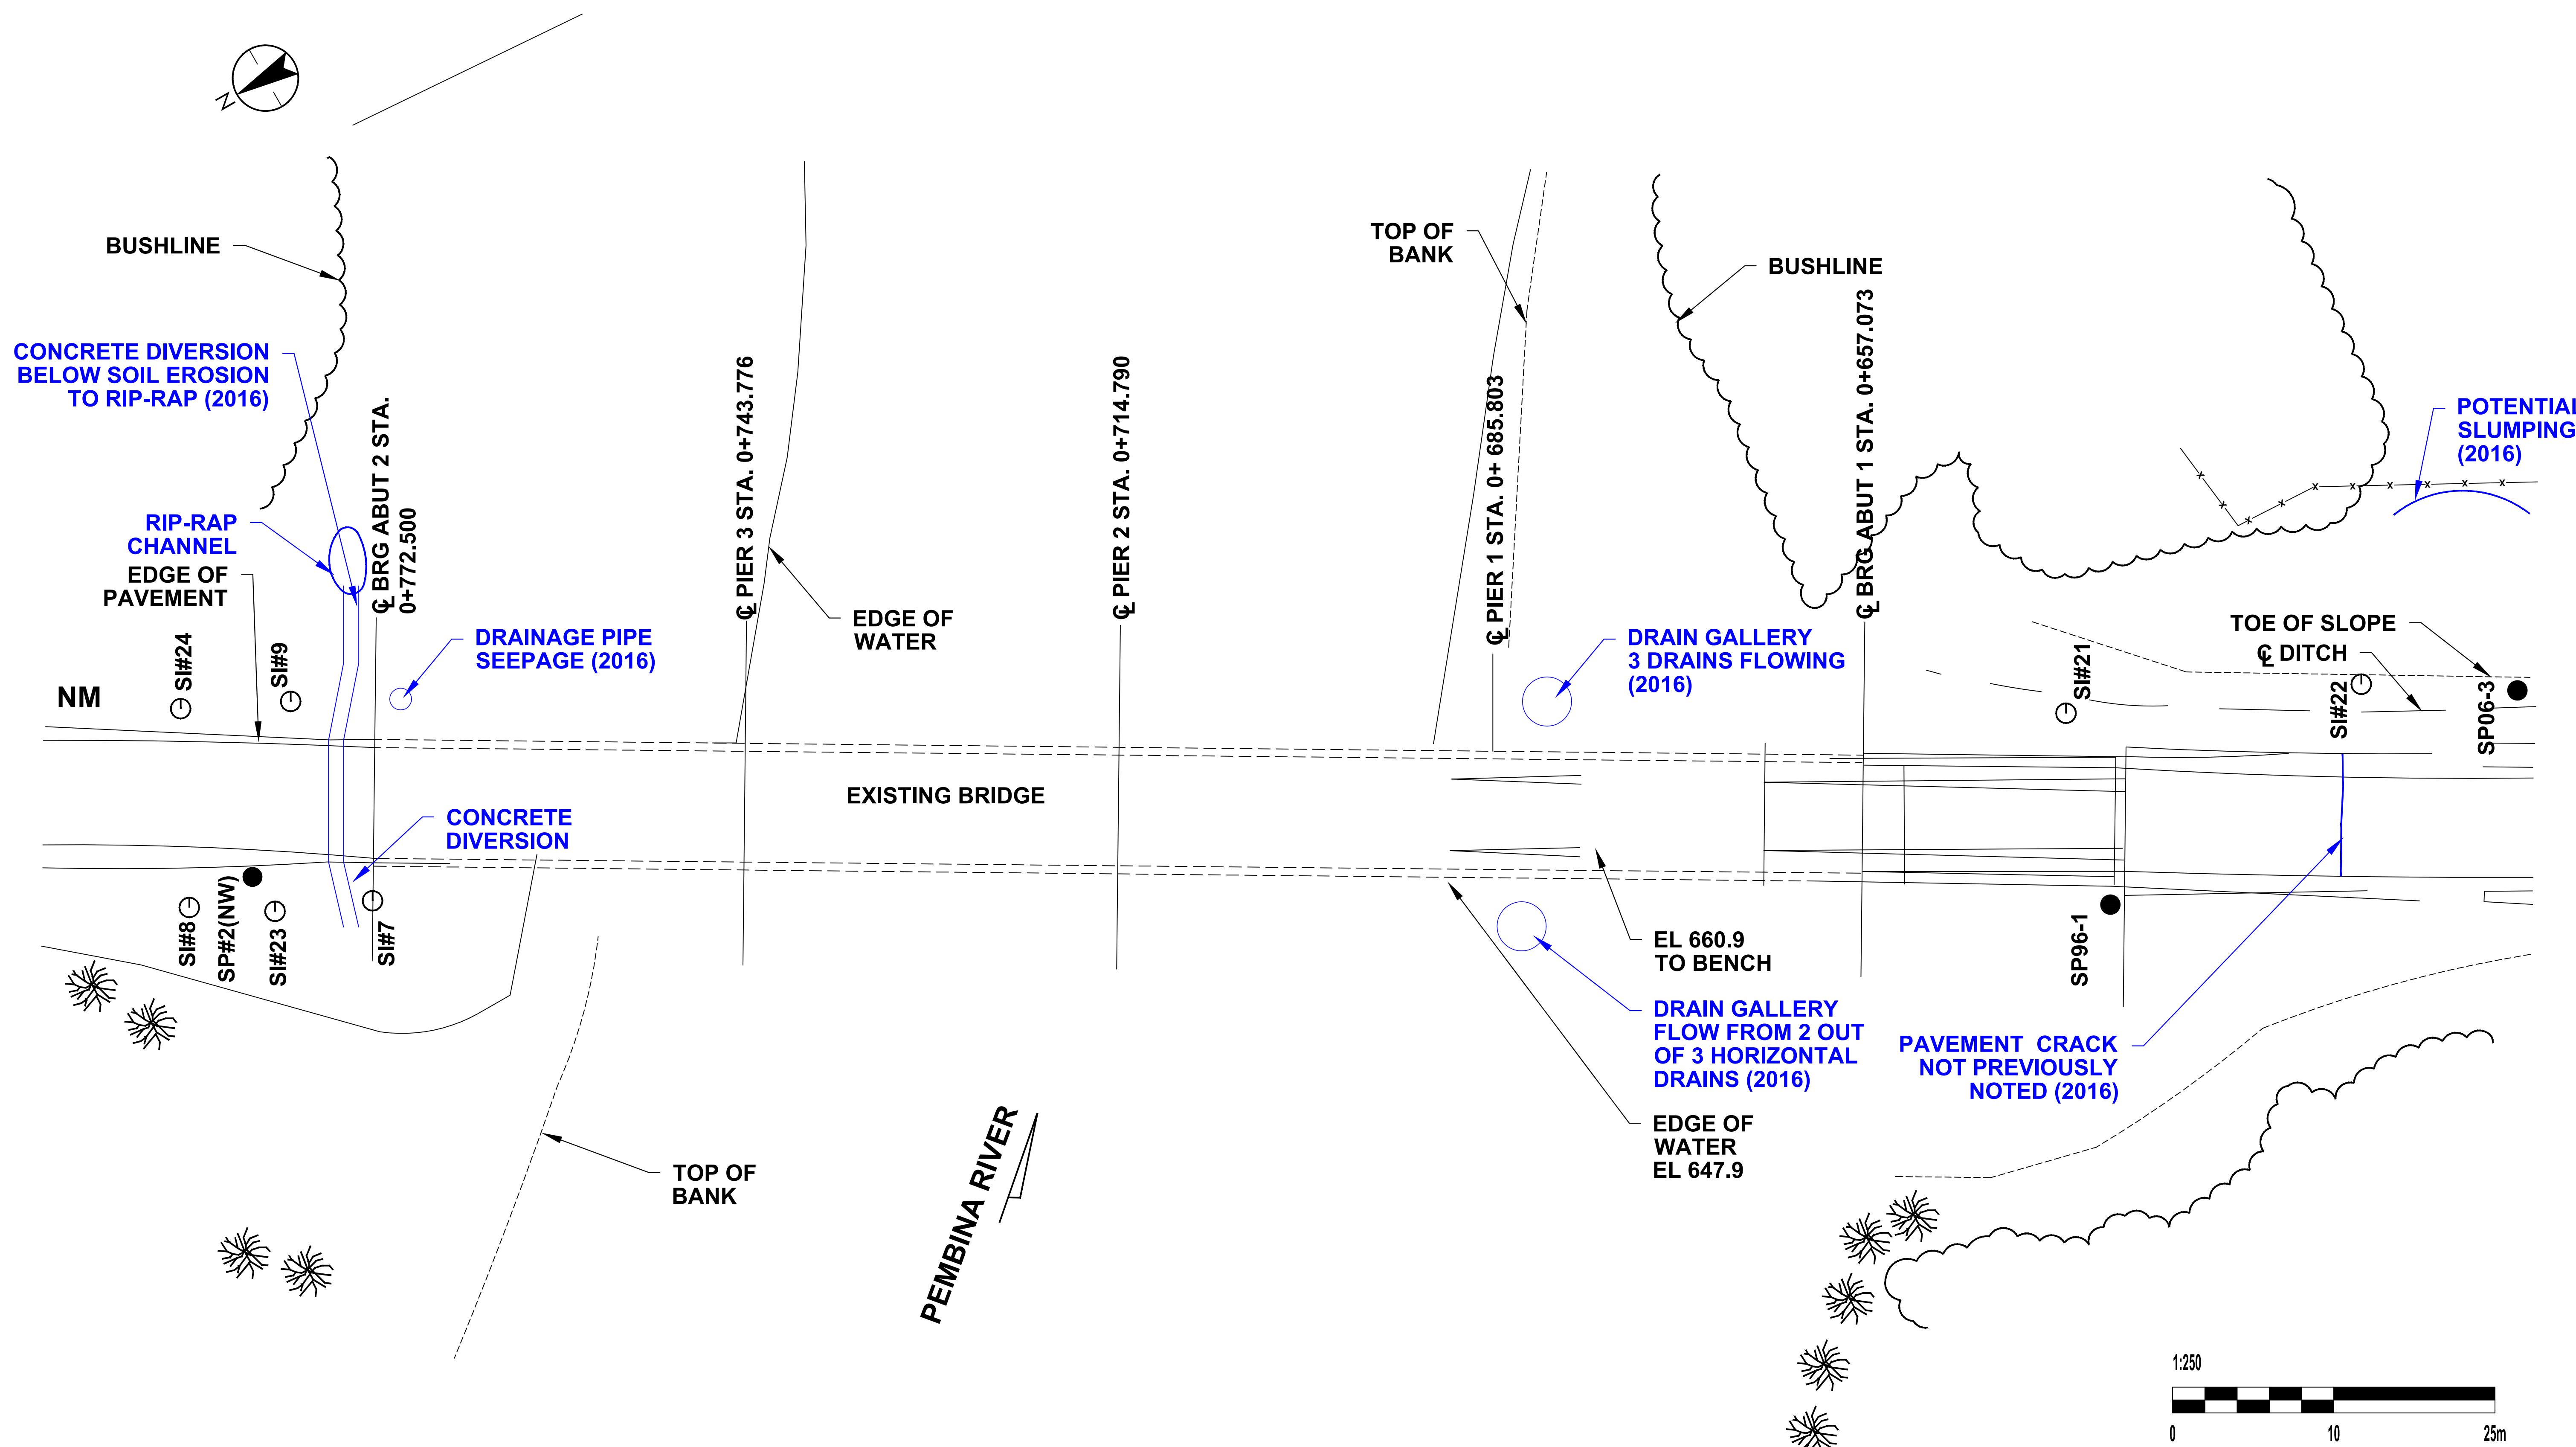
Stantec		STANTEC CONSULTING 10160-112 STREET EDMONTON ALBERTA CANADA			
		ALBERTA TRANSPORTATION GEOHAZARD MONITORING PROGRAM NC18 - HWY 764 - PEMBINA RIVER BRIDGE SITE PLAN			
DRAWN	WW	CHECK	LC	APPROVE	CDM
DATE	04 AUG. 2016	SCALE	AS SHOWN	PROJECT #	123315222
FIGURE - 1					-

The Spring 2022 reading cycle consisted of instrument readings of five slope inclinometers (SI7, SI8, SI9, SI22, and SI24) and three standpipes (SP2, SP96-1 and SP06-3). **Figure 1** attached provides a schematic of the site. The instruments were read by Mahendran Senthooan, M.Eng., EIT and Akintola Fakinlede, M.Sc., Engineering Technologist on May 4, 2022.
