SITE NUMBER AND NAME: NC018 – Pembina River Bridge (North of Cherhill)	LOCATION: On Highway 764, 12 km north of Cherhill	HIGHWAY: 764:02	KM: 12.052
LEGAL DESCRIPTION: NW-15-57-5-W5	NAD83 COORDINATES: UTM11U 5978069 N, 652940 E		
AVERAGE ANNUAL DAILY TRAFFIC (AADT): 410 (2022)		CONTRACTOR MAINTENANCE AREA (CMA): 509

PRIMARY SITE ISSUE: Washed out head slope at north abutment of BF9333
APPROXIMATE DIMENSIONS: 35 m wide by 13 m long
SITE BACKGROUND AND HISTORY: <u>Thurber Engineering Ltd. (Thurber, 1996) Bridge File #9333 Geotechnical Review of Proposed Rehabilitation Work:</u> <ul style="list-style-type: none"> • Field observations indicate distress at south abutment concrete face (H-piles forced out of abutment concrete). Soil under the west side of the south abutment had settled by about 300 mm. Distress to the north abutment was also observed but to a lesser extent than the south abutment. No indication of distress to the north head slope was observed although some cracking along the lower slope was noted. Settlement was observed within the north abutment fill prior to the 1996 review by Thurber. • TEC's files indicate bolts on piers have undergone shear related deformation in th

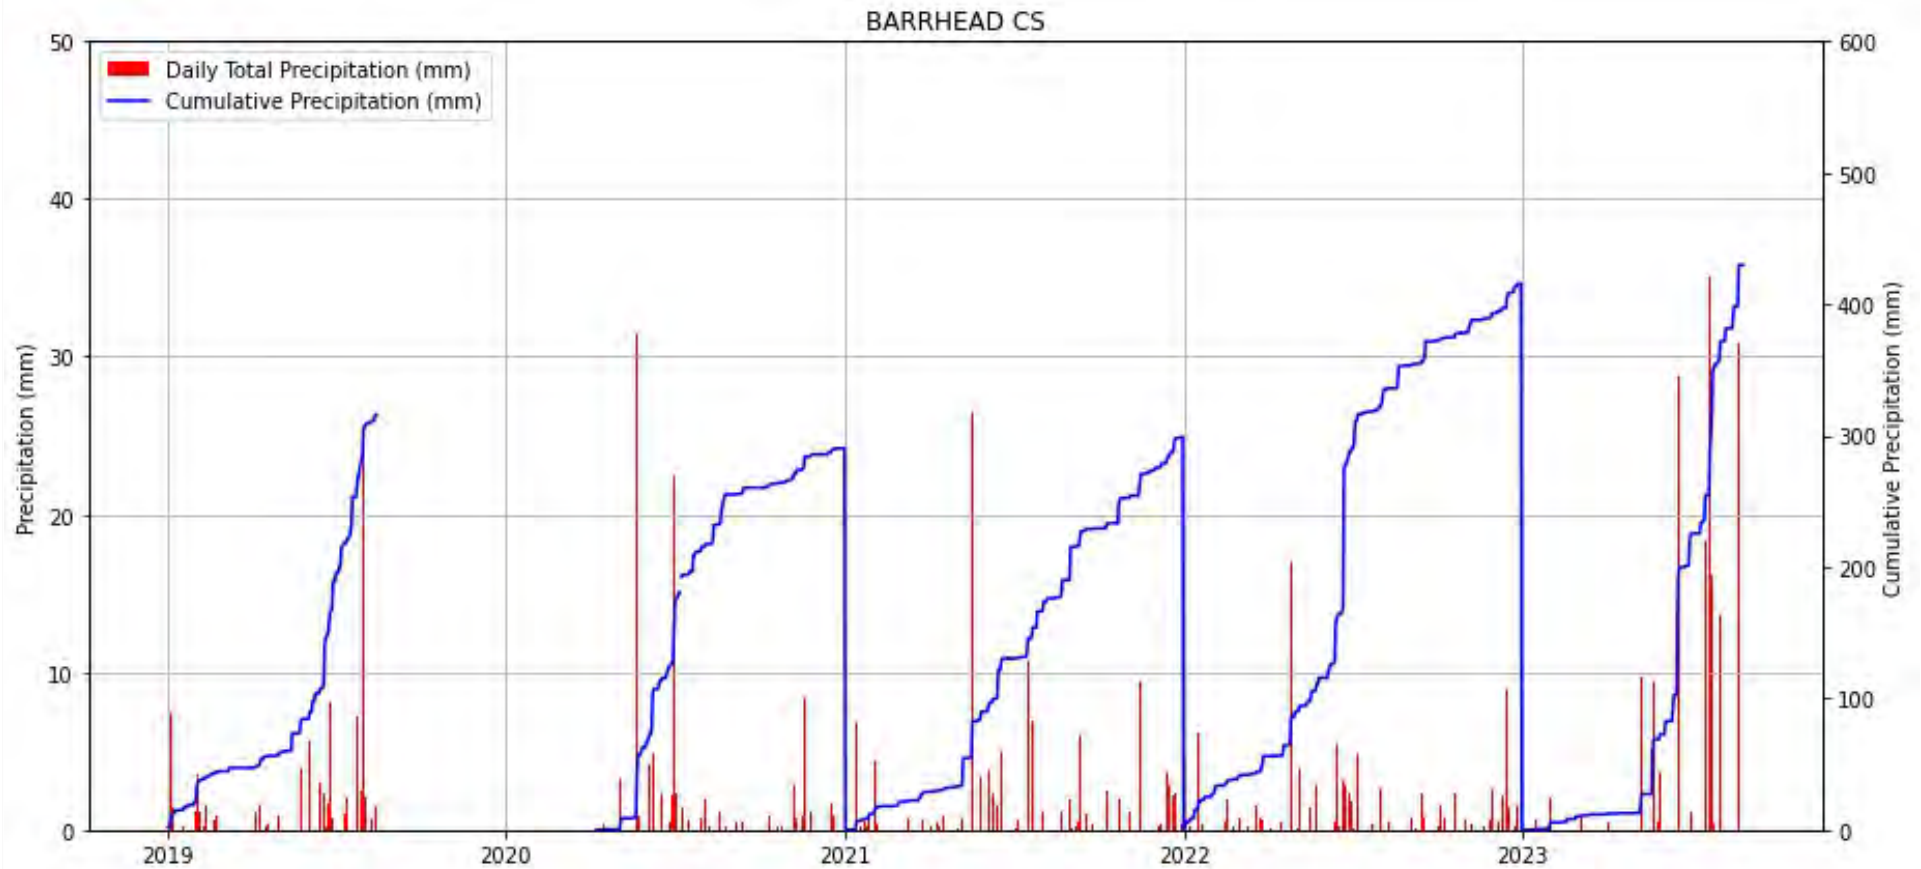
Figure No.
3

- Weather station data from the Barrhead CS weather station located 24 km northeast of the site indicates two significant rainfall periods in mid-June and late July (Figure 2). During this period, approximately 100 mm of rainfall was received within a few days. The cumulative precipitation for 2022 is comparable to 2023, as shown on Figure 3, however, higher intensity rainfall was experienced in 2023. Due to the rainfall received in mid-June 2023 the Pembina River water level increased by more than 3 m (Figure 4) as recorded at the Entwistle Hydrometric Station approximately 40 km southwest (upstream) from NC018. Despite comparable cumulative precipitation in 2022, river levels only risen about 1 m given the lower intensity.
