**STONY PLAIN REGION
GEOHAZARD RISK ASSESSMENT
SITE INSPECTION FORM**

SITE NUMBER AND NAME: NC 2 - Pavement Cracking	HIGHWAY AND KM: Hwy 22:30, km 3.64	PREVIOUS INSPECTION DATE: May 20, 2010	INSPECTION DATE: June 14, 2011
LEGAL DESCRIPTION: SE 11-49-7-W5M	NAD 83 COORDINATES: -60737 E, 5897694 N	RISK ASSESSMENT: PF: 10 CF: 4 TOTAL: 40

LAST READING DATE: May 17, 2011
PRIMARY SITE ISSUE: Landslide dating back to 1960's.
APPROXIMATE DIMENSIONS: 200 m long
DATE OF REMEDIAL ACTION: Pavement overlay in 2004.

North Central (Stony Plain)
Geohazard Risk Management Plan
NC-2 Wiley West Park

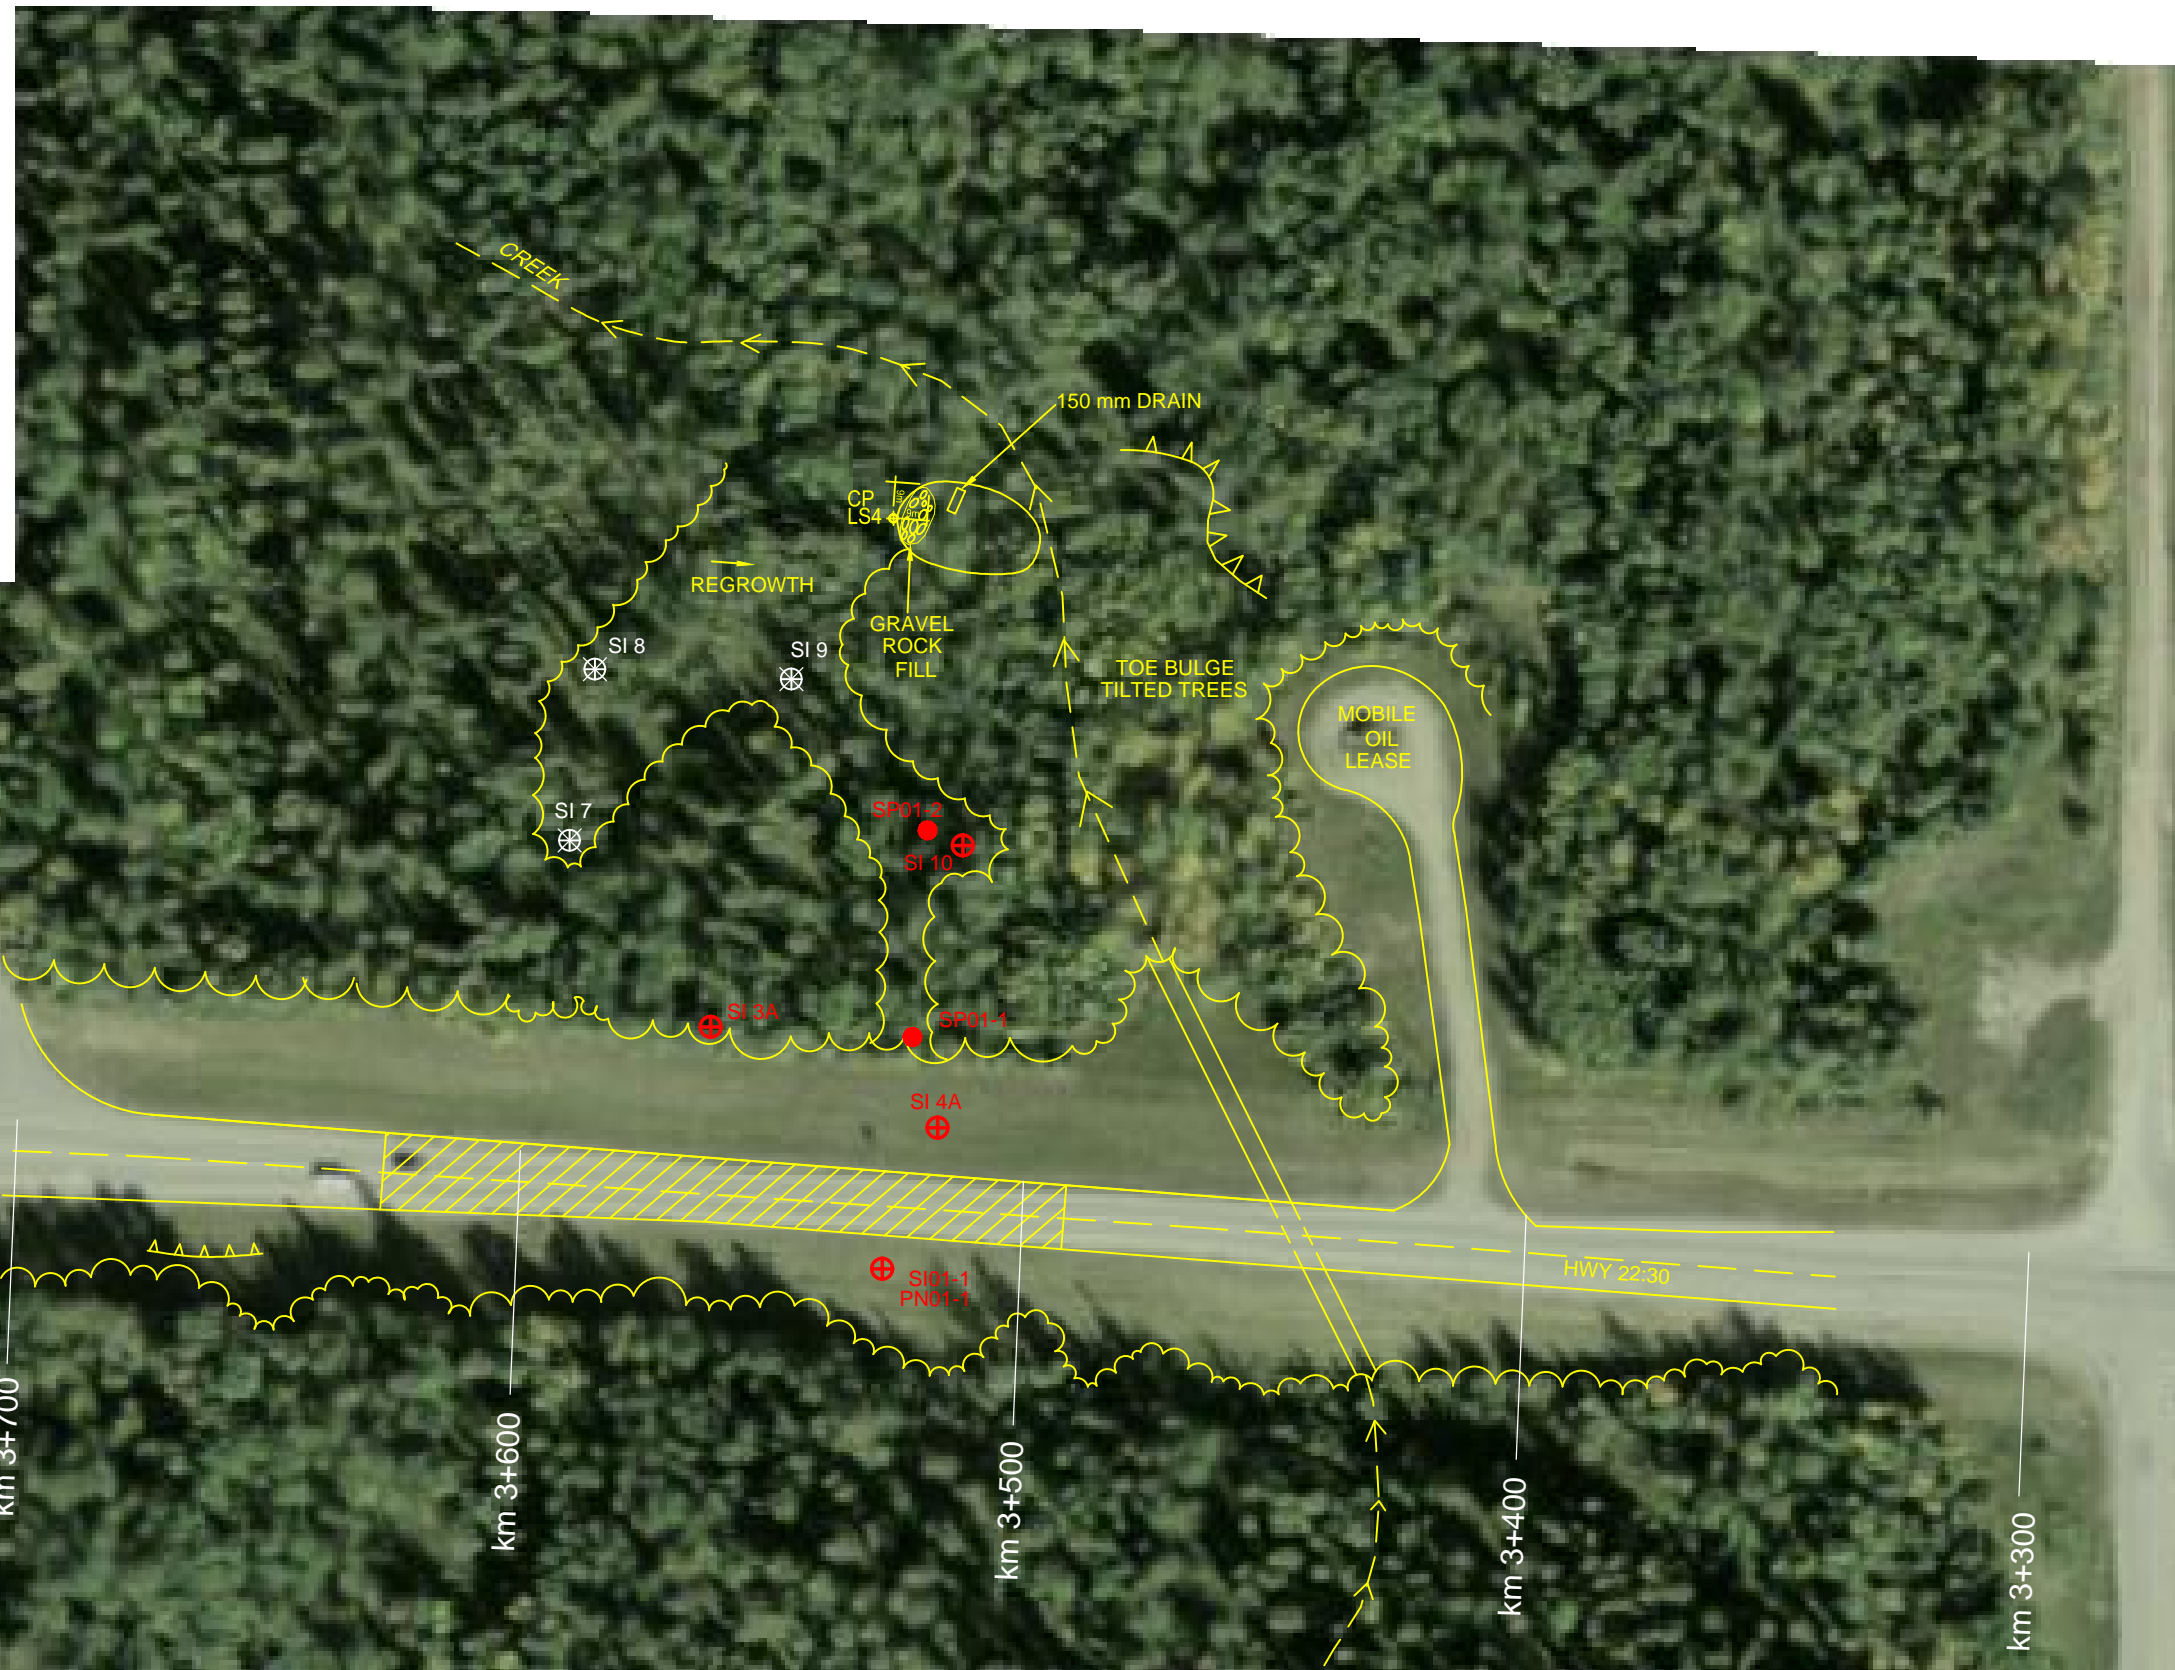
Figure NC2-1

COMMENTS: Location and site plan shown on Figure NC2-1. Site conditions shown in Photo 1. Risk level unchanged from 2010. Site recently cleared in preparation of twinning. Condition of highway unchanged from 2010 inspection.
--
