THURBER ENGINEERING LTD.

August 1, 2006

**NORTH CENTRAL REGION – STONY PLAIN AREA
GEOHAZARD ASSESSMENT CALL-OUT, (CE 142-06)
NC 56: WEST DITCH EROSION ALONG HWY 60:02**

FIGURE NC56-1 SITE PLAN
NC56: HWY 60:02 WEST DITCH EROSION
NORTH CENTRAL REGION - STONY PLAIN AREA GEOHAZARD ASSESSMENT
DATE: JULY 2006
THURBER PROJECT #15-85-49

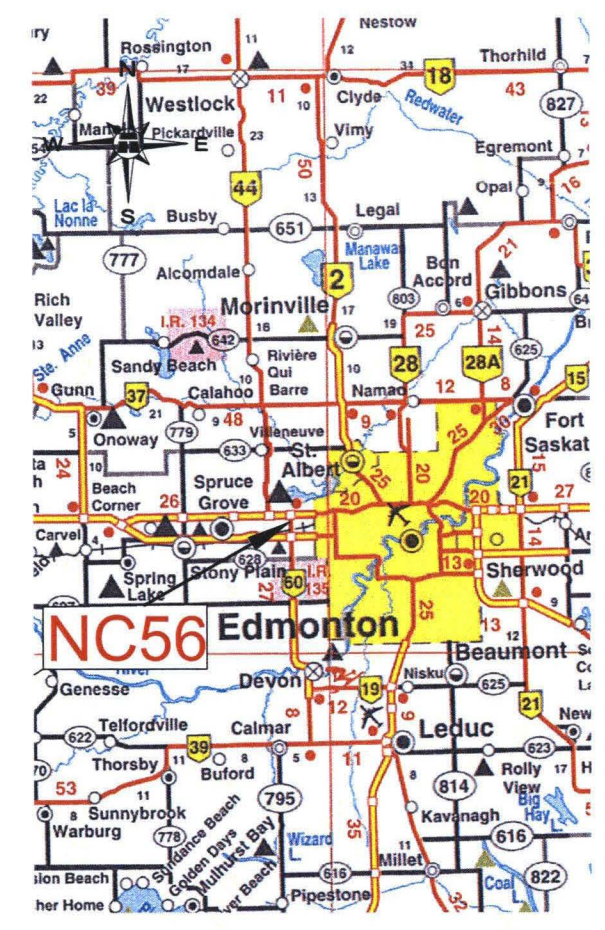
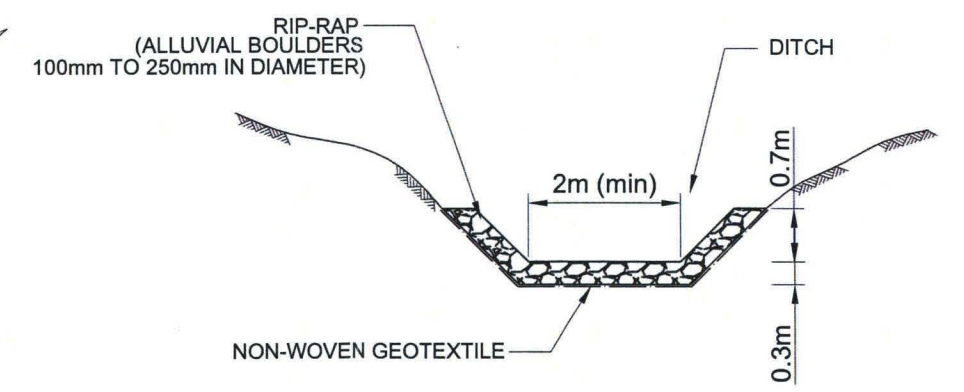
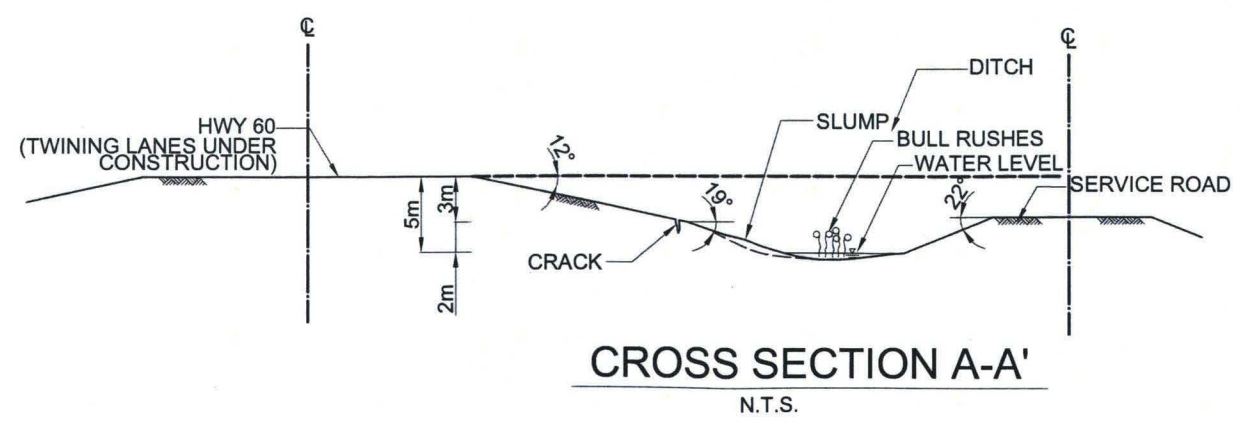
taking place). The longitudinal alignment of the ditch is about 6 m west of the highway shoulder. However, the ditch turns northwest for a length of about 12 m, descending to about 5 m below the highway elevation and continues there towards the north. In that transition turn, a thin layer of riprap was previously placed to protect the bottom of the ditch against erosion. It was at that location where an erosion gully 9 m long x 2.7 m wide x 1.2 m deep was noticed, exposing a Telus telephone cable as its soil cover has been eroded. No geotextile was noted under the riprap. The erosion direction in the gully is retrogressive, advancing through the transition turn of the ditch towards the southeast.

The soil at the erosion gully location is mainly composed of silty sand. Some riprap boulders mentioned above were observed at the bottom of the gully as the soil around them has been eroded.

The west sideslope of Hwy 60 is well covered with grass and no erosion features were noted on the sideslope. However, a slump was noted on the east slope of the ditch, about 10 m north of the culvert. The slump was about 2 m high and 20 m wide. The toe of the ditch slope seems to have been eroded by the water running in the ditch. A surficial crack extends 30 m from the slump towards the north, parallel to the ditch suggesting that the slump is on the verge of growing in size.

A small slump was also observed on the west slope of the ditch, located opposite to the above-mentioned slump. The height of that slope is 2.8 m and the west ditch slope has a 22 degree inclination.

Erosion along the toe of the ditch slopes due to runoff in the ditch and from flow exiting from the CSP culvert may have triggered the ditch slope failures. The slump in the east slope of the lower level ditch could eventually retrogress toward the highway and endanger the stability of the highway embankment.

In the short term, the ground surface at the erosion gully location should be stripped and all loose or disturbed material removed. The disturbed riprap should also be removed and salvaged if possible. The gully should be backfilled with packed clay. A new ditch with a smoother alignment should be excavated through the new fill to smoothly transfer the flow from the upper level highway ditch to the lower level highway ditch. The ditch should be cut with a flat bottom and sloped sides and lined with Class 1 riprap placed over non-woven geotextile. A suggested ditch cross-section is shown on Figure NC56-1. Care will need to be taken to avoid damaging the Telus cable that crosses the eroded ditch section.

In the long term, the slump on the east ditch slope should be repaired. Extending the rip-rap as mentioned earlier may help preventing further erosion at the toe of the slope. The slide material should be excavated and removed, and the rip-rap ditch (over non-woven geotextile) should be extended 50 m north beyond the existing CSP culvert. The slope should be reconstructed using compacted pit run gravel (AIT 6-80) as backfill material. The gravel backfill will also provide some

slope drainage in case seepage has been a contributing factor to the slope failure. Finally, the repaired slope should be covered with topsoil and double seeded to prevent surface erosion.
