August 1, 2006

File: 15-85-48

**NORTH CENTRAL REGION – STONY PLAIN AREA
GEOHAZARD ASSESSMENT CALL-OUT (CE 142-06)
NC 55: NORTHEAST RAMP EROSION
AT HWY 779 AND HWY 16 INTERCHANGE**

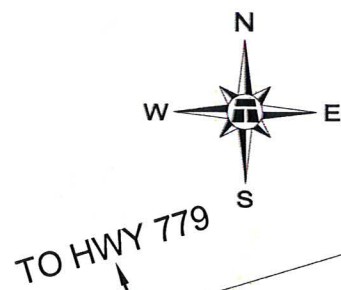
A hole 2.5 m long x 1.7 m wide x 0.6 m deep was noted beside the highway shoulder, penetrating about 0.4 m into the pavement. About 6 m downslope there was another hole 1.6 m long x 0.6 m wide and 0.8 m deep. These holes were connected underneath the surface through a piping tunnel, the former being the entrance hole and the latter being the exit hole. Erosion gullies were noticed outside the exit hole, running downslope.

Several shallow erosion holes caused by running water were noticed along the highway north shoulder, where large amount of gravel and scarce vegetation cover were present. The holes were about 0.6 m x 0.3 m wide and 0.20 m deep. They are shown on Figure No. NC55-1.

PIPING TUNNEL	SIZE OF HOLES (LENGTH X WIDTH X DEPTH) (mXmXm)	
	ENTRANCE	EXIT
#1	0.3 X 0.3 X 0.3	0.6 X 0.2 X 0.3
#2	1.7 X 1.2 X 0.6	0.6 X 0.6 X 0.3
#3	2.5 X 1.7 X 0.6	1.6 X 0.6 X 0.8
