# ALBERTA TRANSPORTATION INSTRUMENTATION MONITORING RESULTS FALL 2011

### NORTH CENTRAL (STONY PLAIN) REGION

#### SITE NC47: AR 172 (EAST OF HWY 21:26) NEW SAREPTA

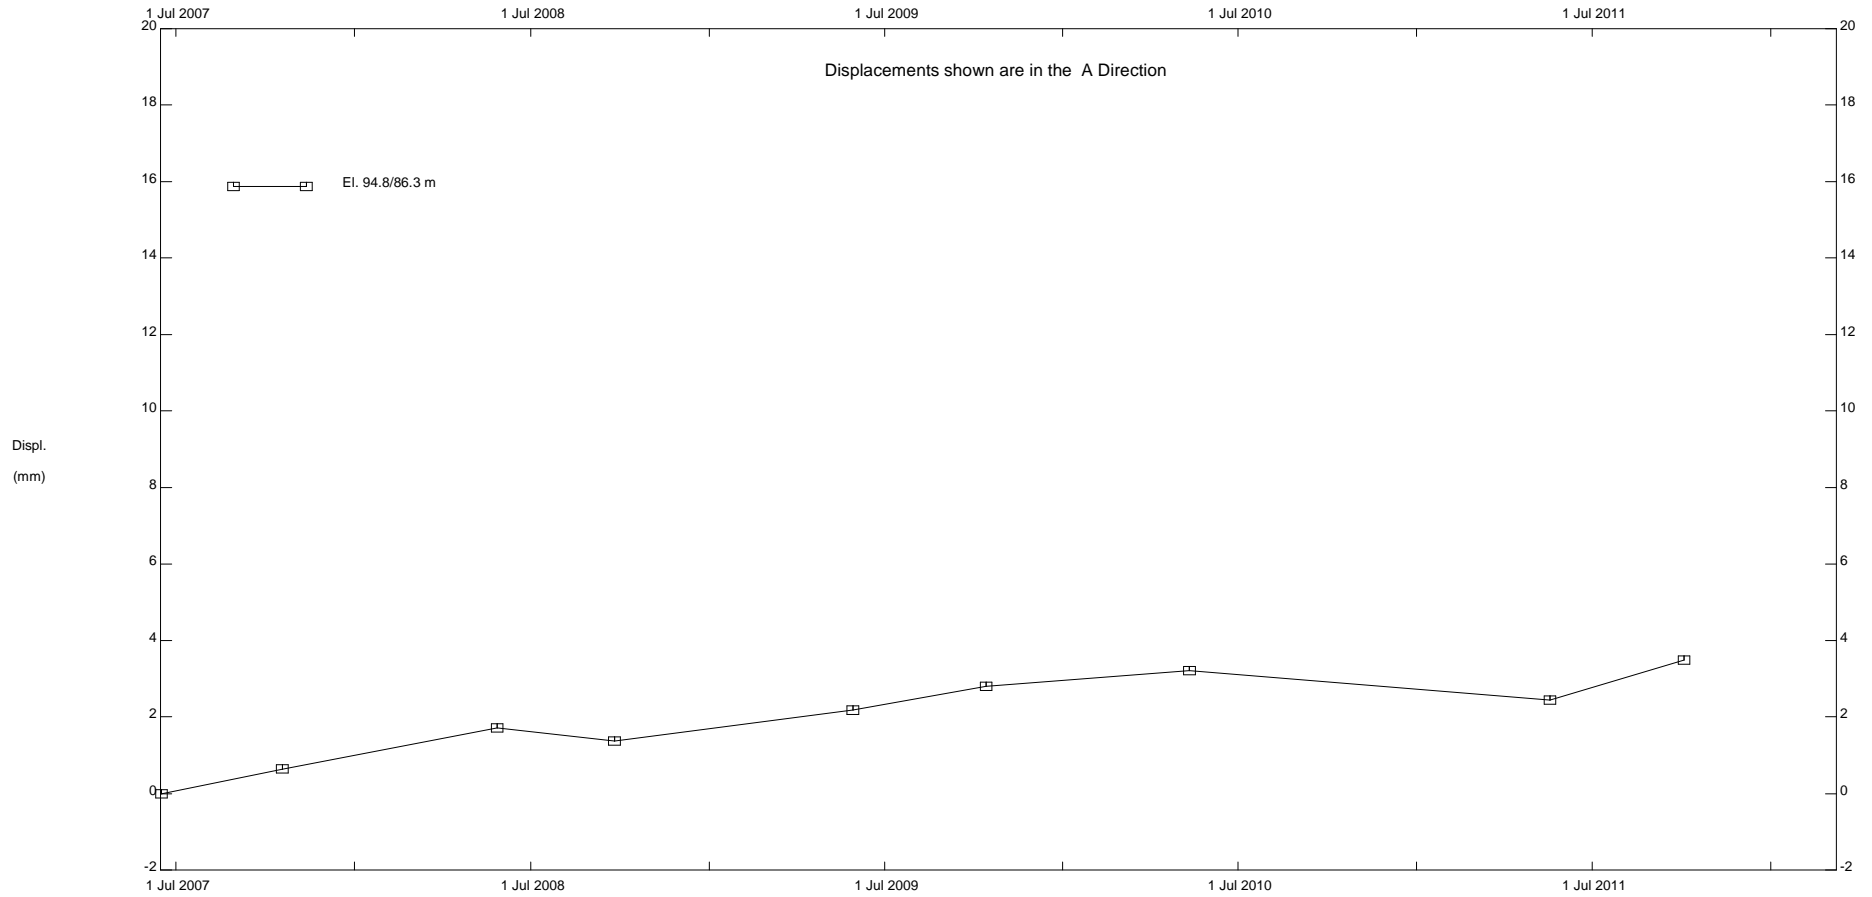
NC47, Inclinator SI-1

Air launched soil nails had been installed on either side of the SI in October 2008. As such, EBA has concluded that installation of the soil nails has not damaged the SI. There is no discernible movement recorded by the SI in the upper embankment near the repaired slope failure. There appears to be some minor movement at the base of the embankment near 6 m depth. This is likely due to lateral spreading along soft clay or organic materials left in place in the highway embankment foundation. The rate of movement is calculated at 2.8 mm/year however there has been less than 1 mm of incremental movement at the shear zone since spring 2011 monitoring.
