SITE NUMBER AND NAME: NC095 – Cloverbar Road at Highway 16 EB	HIGHWAY AND KM: 16:18, km 7.48	PREVIOUS INSPECTION: N/A	CURRENT INSPECTION: June 1, 2023
LEGAL DESCRIPTION: NE 12-53-23-W4M	NAD83 COORDINATES: UTM12U 59638031N, 350446E		RISK ASSESSMENT: PF: 9 CF: 3 Total: 27
AVERAGE ANNUAL DAILY TRAFFIC (AADT): 35,130 (2022)		CONTRACTOR MAINTENANCE AREA (CMA): 510

2023 Site Inspection Photos at NC095

Client/Project Transportation and Economic Corridors 123315222
 Geohazard Monitoring Program
 NC95 - Cloverbar Road at Hwy 16 EB

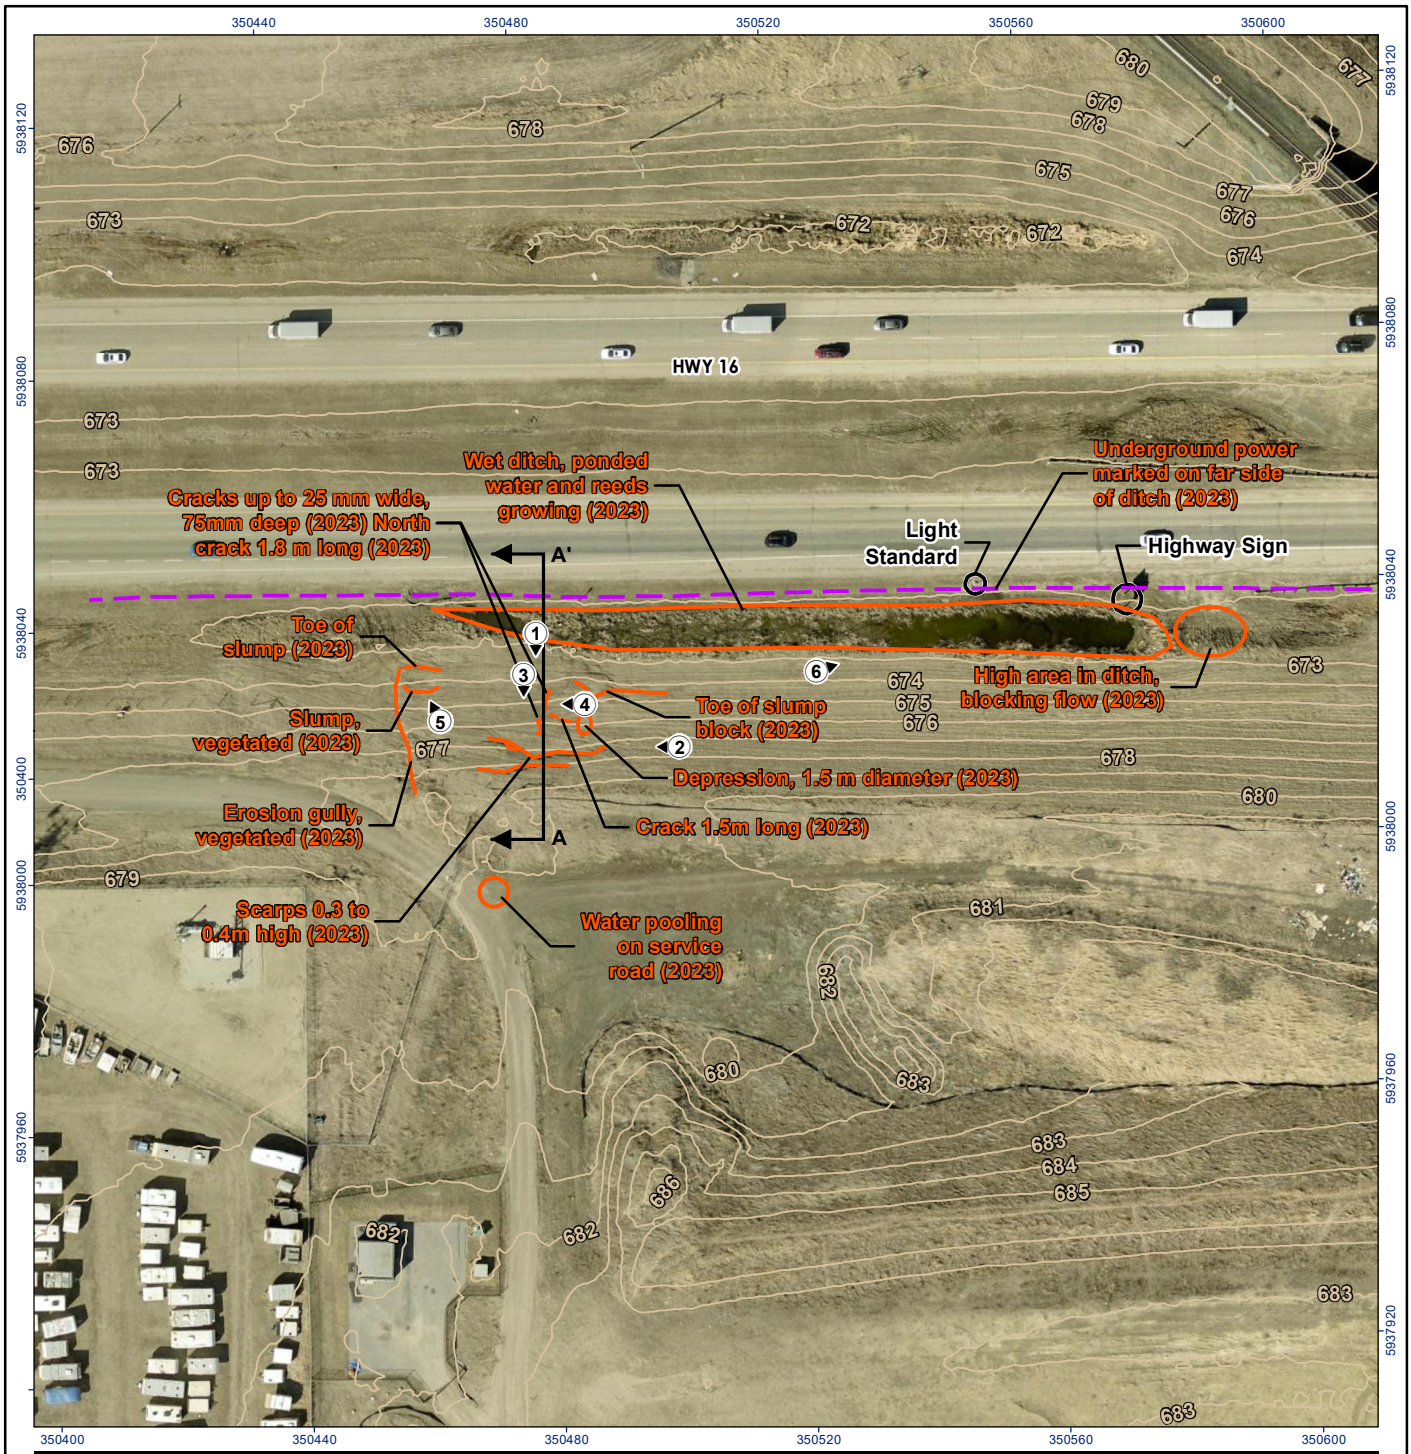
Figure No.
 1
Title
 Site Plan

ITEM	CONDITIONS EXIST		DESCRIPTION AND LOCATION	NOTICEABLE CHANGE FROM LAST INSPECTION	
	YES	NO		YES	NO
Pavement Distress		X			N/A (no previous inspection)
Slope Movement	X		Two scarps approximately 20 m long observed on the upper slope. Another slump observed further downslope. Tension cracks up to 75 mm deep and 25 mm wide.		
Erosion	X		Erosion gully on the west side of the mid-slope slump.		
Seepage		X			
Bridge/Culvert Distress		X

COMMENTS
<ul style="list-style-type: none"> The pavement on Highway 16 does not appear to show any distress related to the slope movement. Two scarps, 0.3 to 0.4 m high and approximately 20 m long, were observed approximately 5 m downslope from the crest (Photos 1 and 2). The toe of the slump block was observed further downslope, above the wet ditch. A depression in the ground, approximately 1.5 m in diameter, was observed on the east side below the lower scarp. Multiple tension cracks were observed on the slope below the two scarps. Cracks were up to 1.8 m long, 25 mm wide, and 75 mm deep. A well-vegetated slump was observed to the west of the two scarps, beginning mid-slope with the toe located just above the wet ditch. Landslide activity can be observed as early as 2012 from Google Earth imagery. The main scarp does not appear to have retrogressed since 2012, although periodic widening of the landslide and localized failures downslope of the main scarp can be seen.

- In the short-term, the slope should be regraded and revegetated to seal the ground cracks and protect the ground from water infiltration and erosion.
- Long-term remediation may include the following:
 - Improve drainage: Install a centerline culvert to redirect surface water to the median ditch. The high-level cost for the culvert installation is \$300,000 to \$450,000, excluding engineering costs.
 - Improve drainage: Regrade the south ditch to drain water further east (minimum 100 m) beyond the slope failures. The high-level cost for regrading is \$5,000 to \$10,000, excluding engineering costs.
 - Remove and replace: The slide mass could be excavated, and the embankment slope rebuilt with granular fill. The high-level cost for removal and replacement is \$250,000 to \$350,000, excluding engineering costs.
- Site inspections should continue to be completed once per contract cycle.
