SITE NUMBER AND NAME: NC086 – Poplar Creek Slide	HIGHWAY AND KM: 39:06, km 4.915	PREVIOUS INSPECTION: May 22, 2020	CURRENT INSPECTION: June 29, 2021
LEGAL DESCRIPTION: SW 11-49-06-W5	NAD83 COORDINATES: UTM11U 5897673N, 648158E		RISK ASSESSMENT: PF: 3 CF: 3 Total: 9
AVERAGE ANNUAL DAILY TRAFFIC (AADT): 3,280 (2020)		CONTRACTOR MAINTENANCE AREA (CMA): 509

NORTH CENTRAL REGION GRMP
EDSON / STONY PLAIN
SITE INSPECTION FORM

2021 Site Inspection Photos at NC086

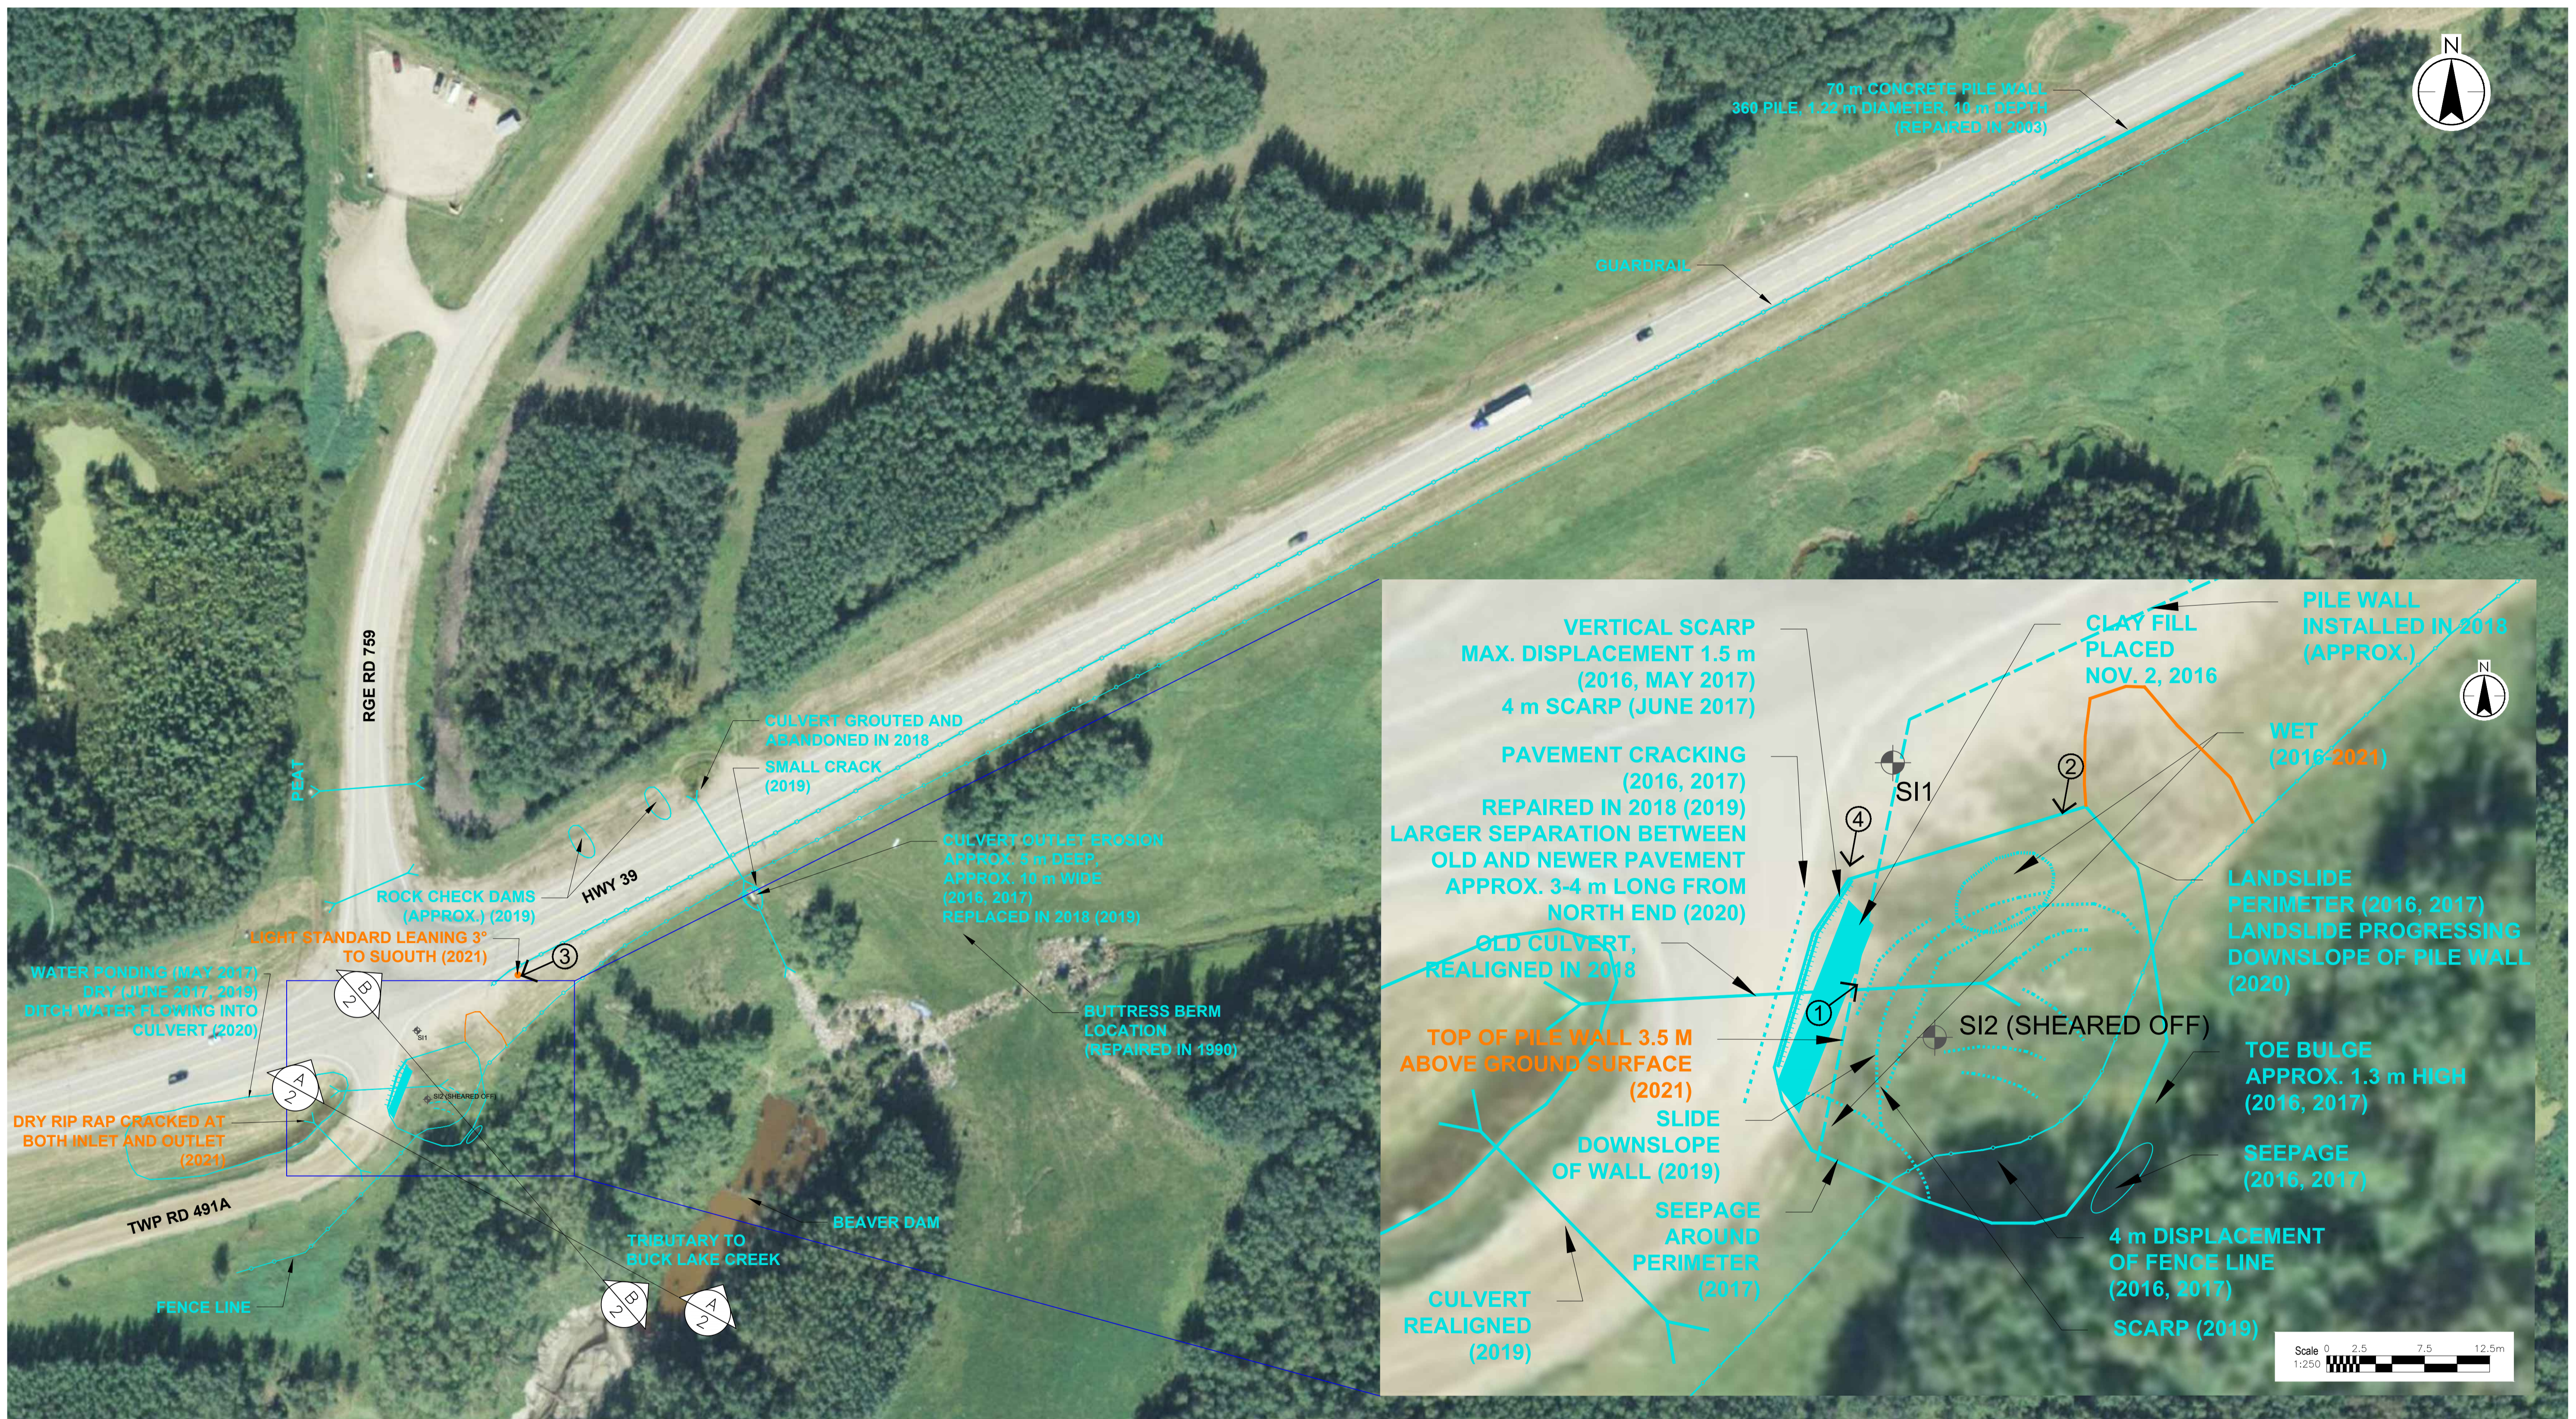
FIGURE -1

ALBERTA TRANSPORTATION
GEOHAZARD MONITORING PROGRAM
NC86 HWY 39 AND TWP RD 491A - NEAR DRAYTON VALLEY
SITE PLAN
