SITE NUMBER AND NAME: NC067 – Anthony Henday Bridge	HIGHWAY AND KM: 216:06, km 10.528	PREVIOUS INSPECTION: May 21, 2020	CURRENT INSPECTION: June 28, 2021
LEGAL DESCRIPTION: SE 4-52-25-W4	NAD83 COORDINATES: UTM12U 5926734N 326219E		RISK ASSESSMENT: PF: 4 CF: 10 Total: 40
AVERAGE ANNUAL DAILY TRAFFIC (AADT): 70,690 (2020)		CONTRACTOR MAINTENANCE AREA (CMA): AHD

2021 Site Inspection Photos at NC067

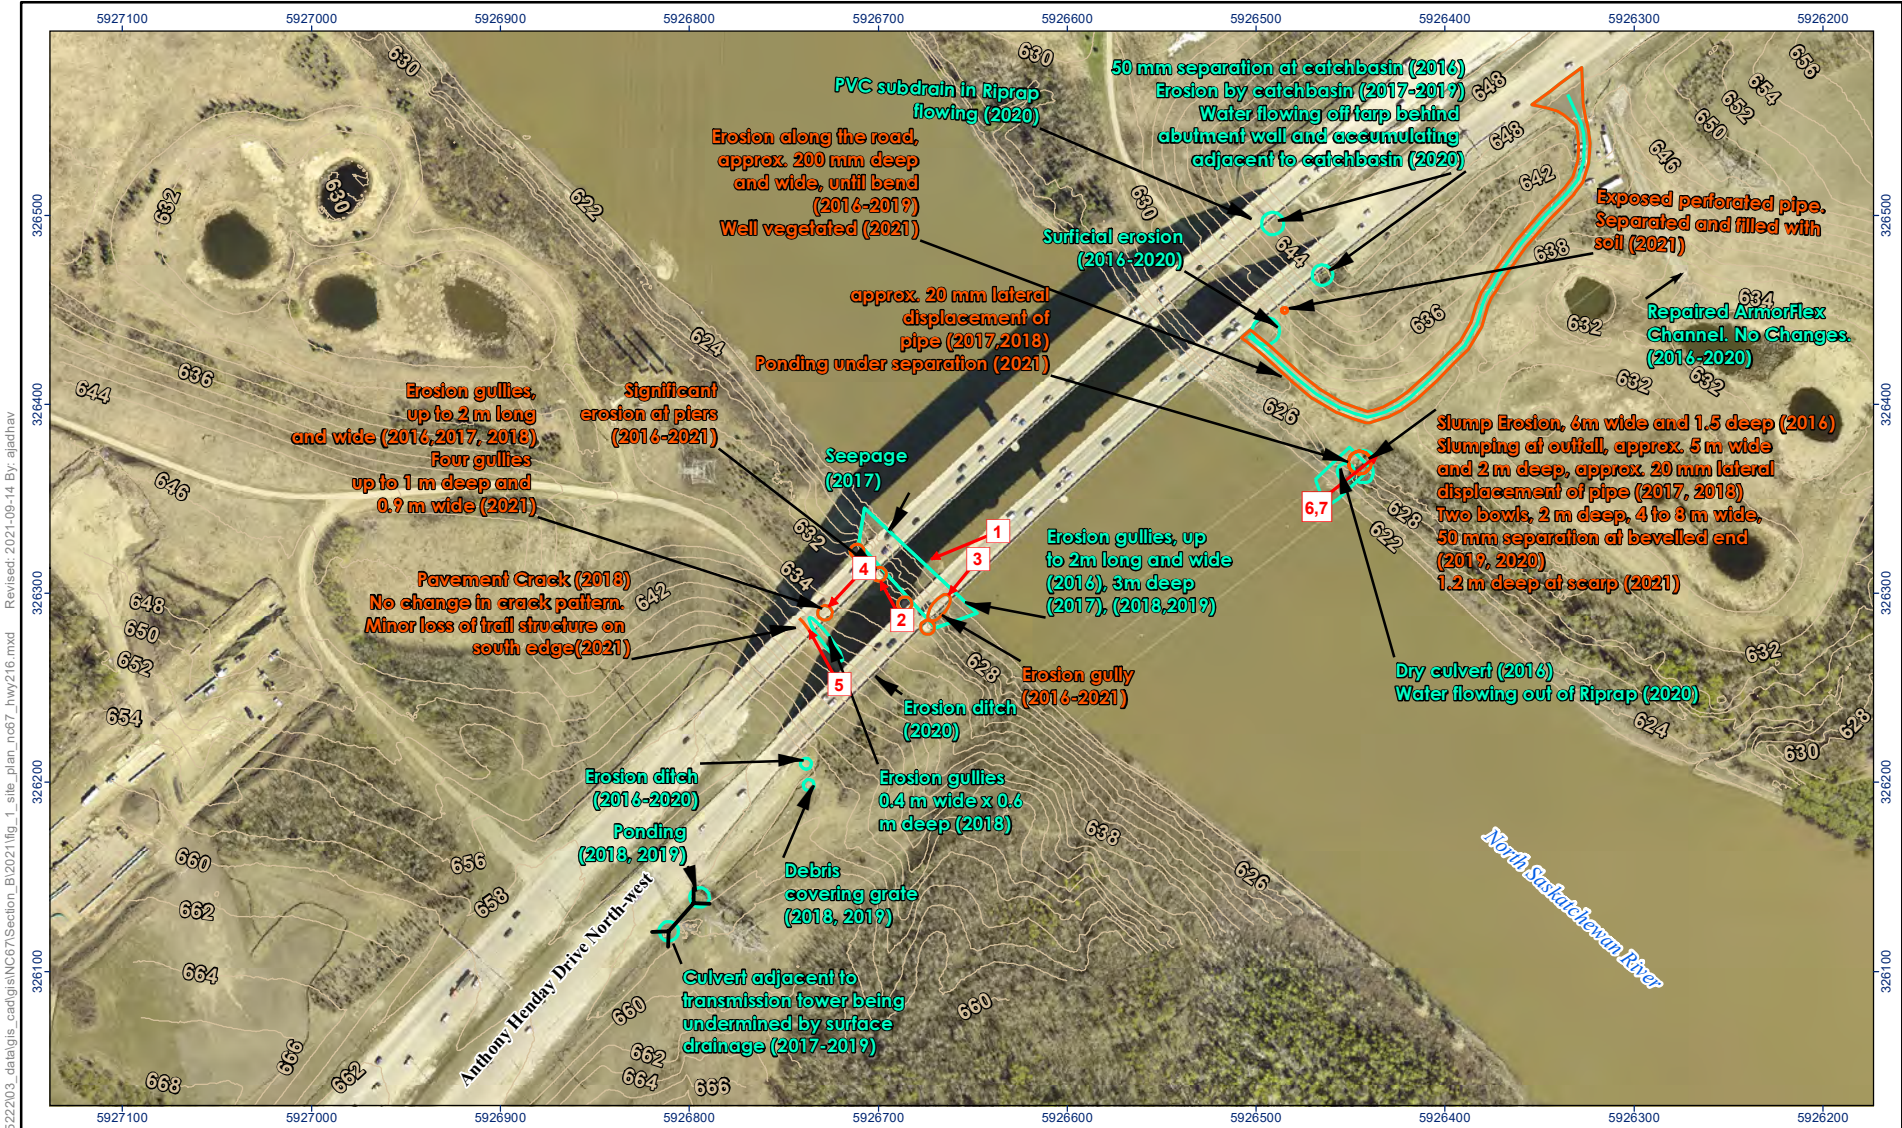
Photo 7: Water ponding below the separated pipe at the outfall. Looking down.

- Outfall remediation as part of NC79 work: Replace separated sections of pipe with 750 mm reinforced concrete pipe. Reline storm sewer with cured-in-place pipe installed at 5% slope. The estimated cost for construction is approximately \$800,000, excluding engineering costs. Construction is scheduled for 2024.
