To:	Amy Driessen Alberta Transportation	From:	Leslie Cho and Carrie Murray Stantec Consulting Ltd.
File:	123315222	Date:	June 12, 2022

Reference: North Central Region, Stony Plain, Site NC067 - Highway 216:06 Anthony Henday Bridge, Spring 2022 Instrumentation Monitoring Report

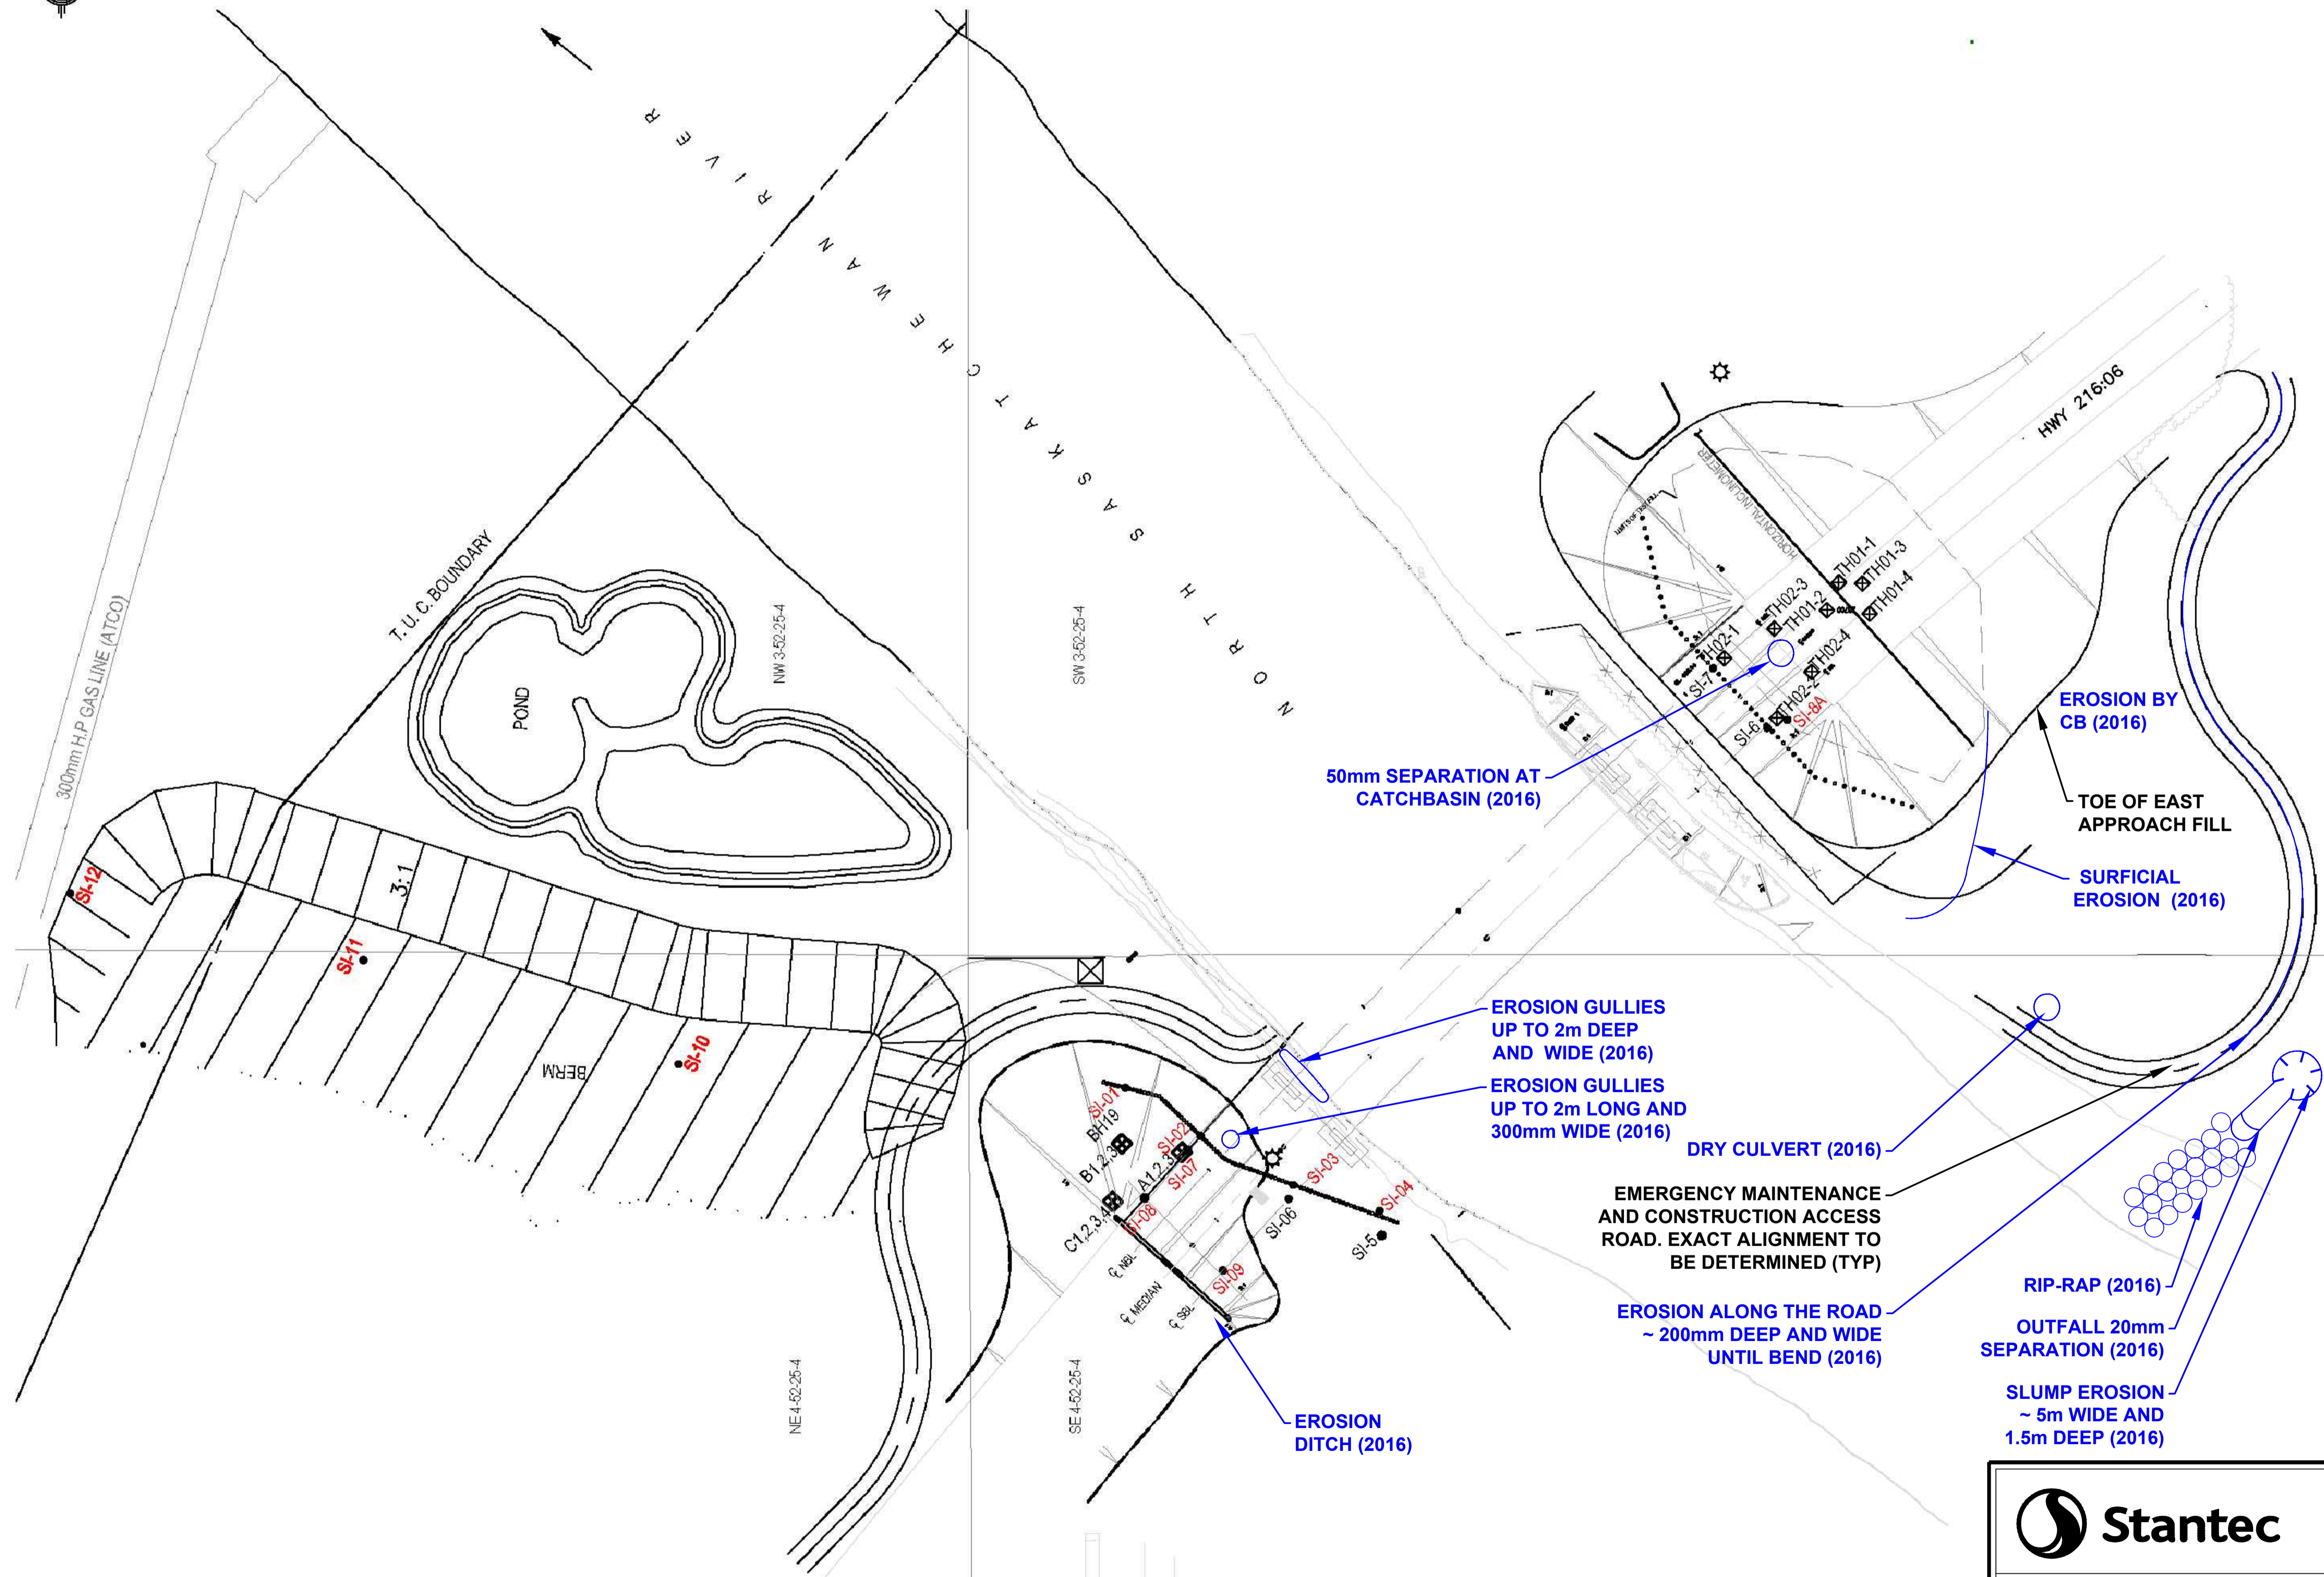
FIGURE - 1

The Spring 2022 monitoring cycle consisted of reading ten slope inclinometers (SI), twenty-two pneumatic piezometers (PN), and twenty-six vibrating wire piezometers (VW). **Figure 1** attached provides a schematic of the site. The instruments were read by Mahendran Senthooan, M.Eng., EIT and Akintola Fakinlede, M.Sc., Engineering Technologist on May 7, 2022.

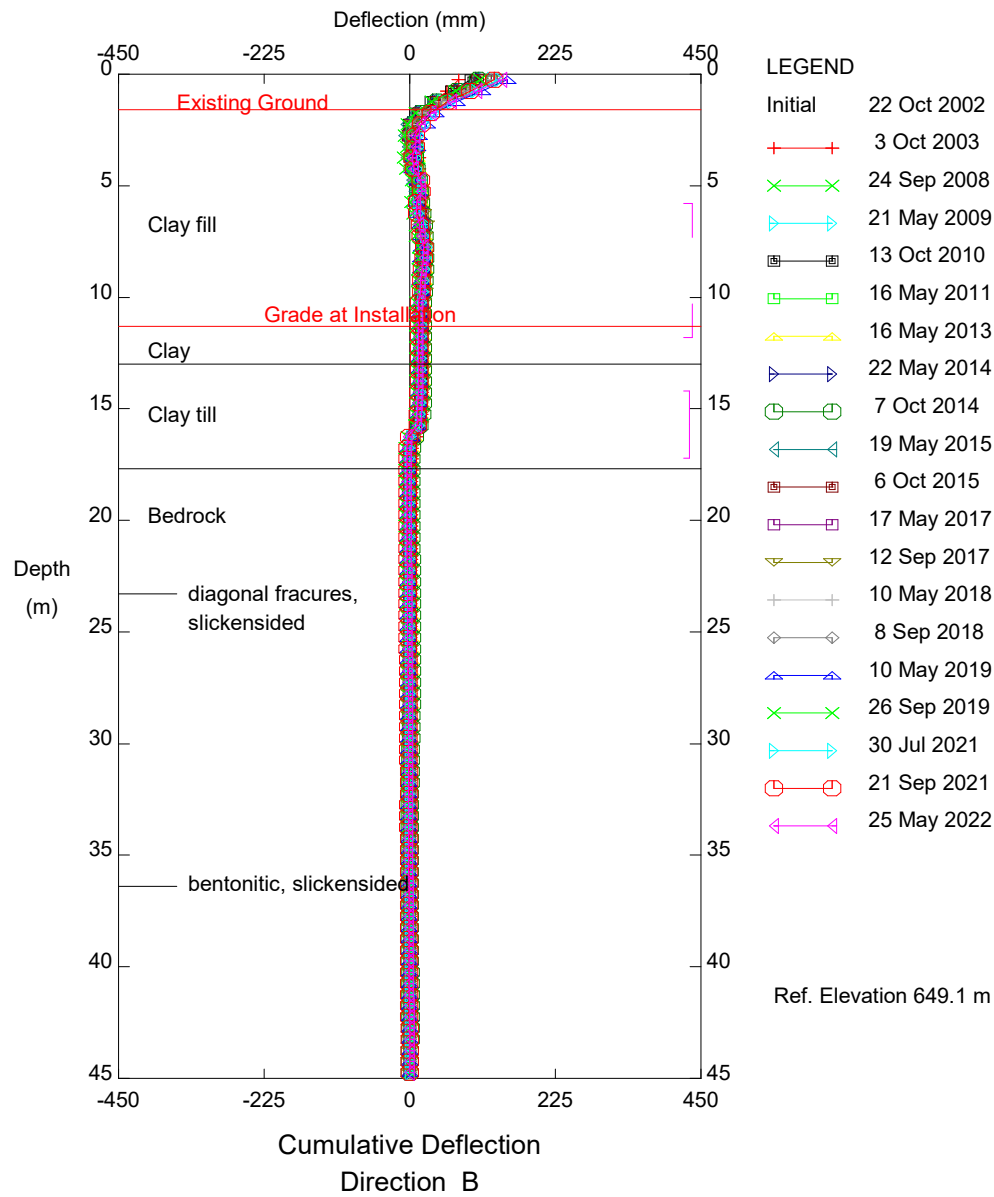
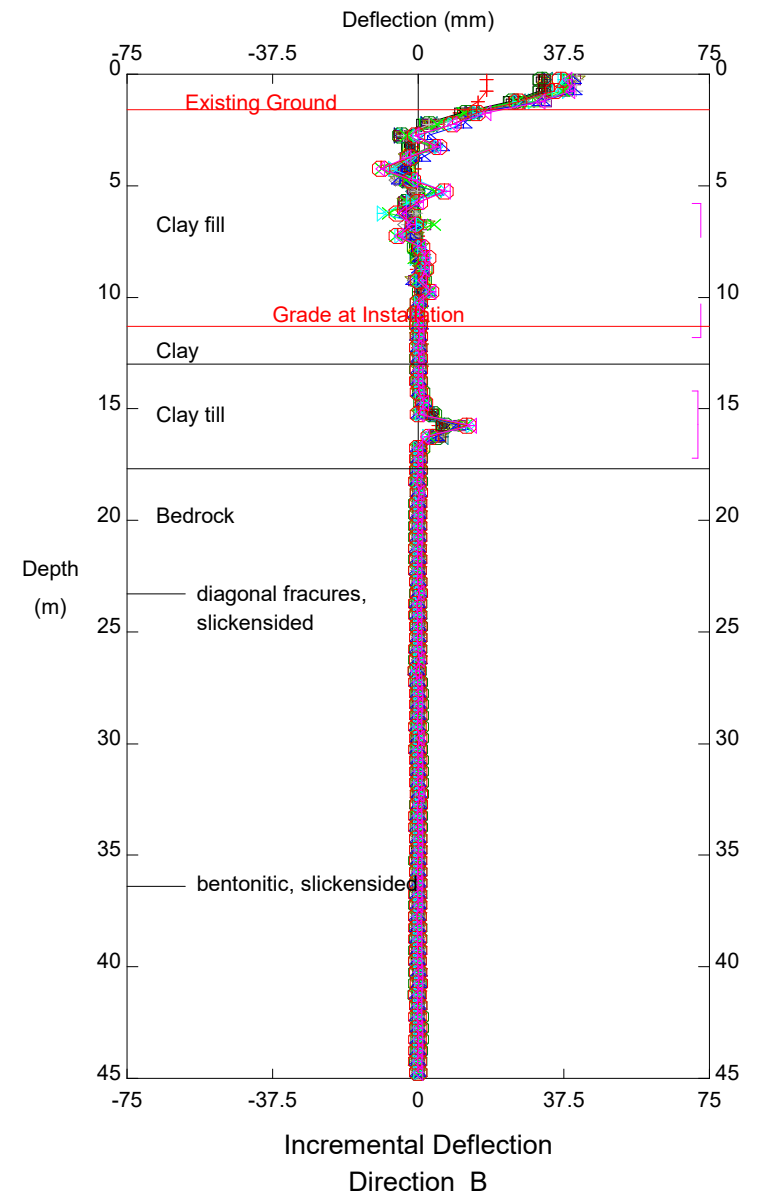
NC067, Inclinator SI-08
Alberta Transportation

SI-08 has two zones of movement observed at around 8 m and 16 m depth. The average rate of movement in the upper zone was about 3 mm/yr since 2003. The current rate of movement is 5 mm/yr with a total cumulative movement of about 56 mm. The lower movement zone appears to be creeping at a rate of less than 1 mm/yr since 2003.
