**NORTH CENTRAL REGION GRMP  
EDSON / STONY PLAIN  
SITE INSPECTION FORM**

<b>SITE NUMBER AND NAME:</b> NC067 – Anthony Henday Bridge	<b>HIGHWAY AND KM:</b> 216:06, km 10.528	<b>PREVIOUS INSPECTION:</b> June 15, 2022	<b>CURRENT INSPECTION:</b> June 1, 2023
<b>LEGAL DESCRIPTION:</b> SE 4-52-25-W4	<b>NAD83 COORDINATES:</b> UTM12U 5926734N 326219E		<b>RISK ASSESSMENT:</b> PF: 5 CF: 10 Total: 50
<b>AVERAGE ANNUAL DAILY TRAFFIC (AADT):</b> 73,140 (2022)		<b>CONTRACTOR MAINTENANCE AREA (CMA):</b> AHD

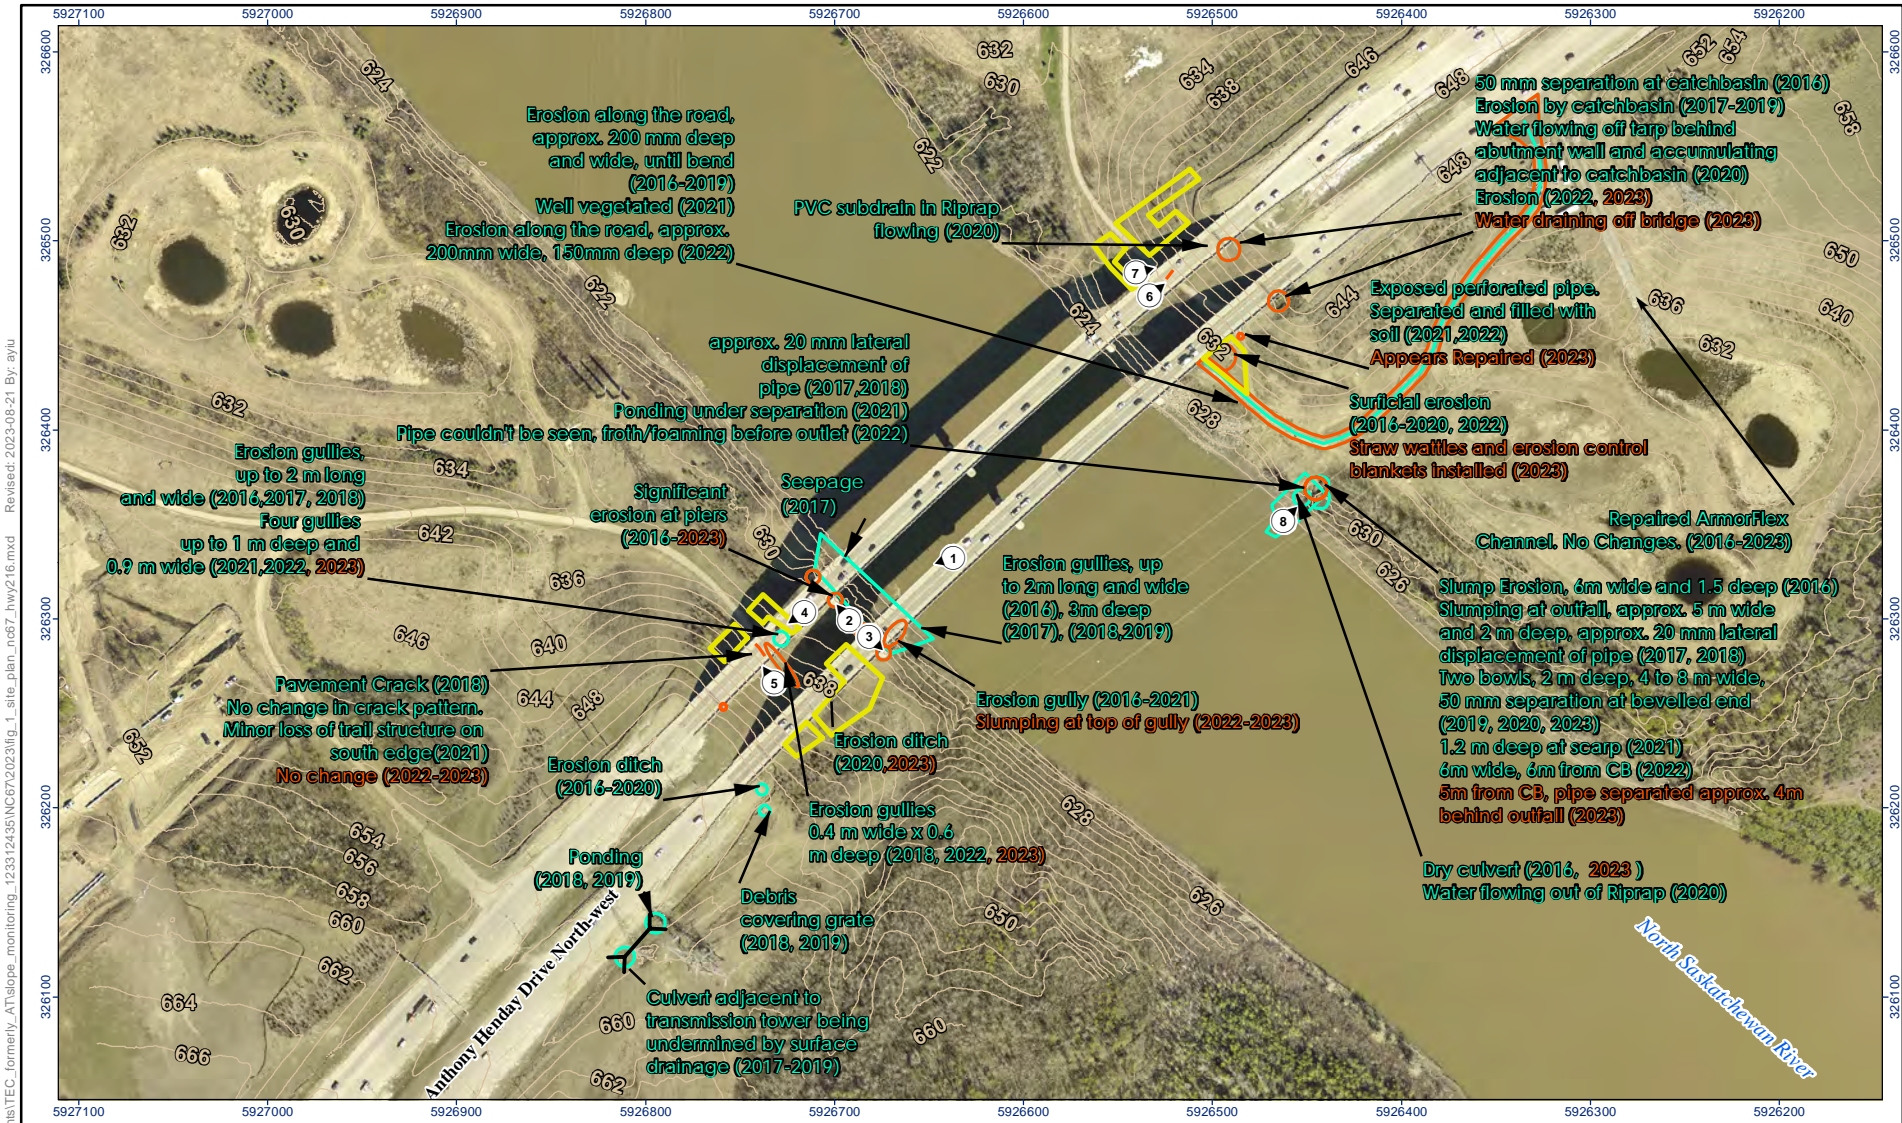
- A crack across the paved trail was observed on the south slope below the NBL (Photo 7).
- The erosion/slumping adjacent to the outfall at the south abutment appeared to have progressed since the 2022 site inspection. The scarp is still 6 m wide but has retrogressed 1 m southeast and is currently 5 m from the catch basin (Photo 8).

**Photo 8:** Two slumps adjacent and behind the outfall on the south bank of the river. Looking southeast.

- Outfall remediation as part of NC79 work: Replace separated sections of pipe with 750 mm reinforced concrete pipe. Reline storm sewer with cured-in-place pipe installed at 5% slope. The estimated cost for
