<b>SITE NUMBER AND NAME:</b> NC079 – Wedgewood Ravine Slides	<b>HIGHWAY AND KM:</b> 216:06, km 12.849	<b>PREVIOUS INSPECTION:</b> May 21, 2020	<b>CURRENT INSPECTION:</b> June 28, 2021
<b>LEGAL DESCRIPTION:</b> SE 28-52-25-W4	<b>NAD83 COORDINATES:</b> UTM12U 5927932N, 324250E		<b>RISK ASSESSMENT:</b> PF: 11 CF: 8 Total: 88
<b>AVERAGE ANNUAL DAILY TRAFFIC (AADT):</b> 66,510 (2020)		<b>CONTRACTOR MAINTENANCE AREA (CMA):</b> Anthony Henday Drive (AHD)

<b>SUMMARY OF INSTRUMENTATION:</b> No instrumentation installed at this site. <b>LAST READING DATE:</b> N/A	<b>INSPECTED BY:</b> Stantec: Leslie Cho and Owen Zhang AT: Bernard Ching and Rishi Adhikari
<b>PRIMARY SITE ISSUE:</b> Two slope failures south of the northwest approach of Anthony Henday Drive (AHD). Erosion above both outfalls north of AHD crossing over Wedgewood Creek	
<b>APPROXIMATE DIMENSIONS:</b> North slide: Approximately 12 m wide by 6 m high South Slide: Approximately 9.5 m wide by 4 m high with several successive scarps up to 3 m high.	
<b>DATE OF ANY REMEDIAL ACTION:</b> Riprap extended south under southbound lane (SBL) in Fall 2020 / Spring 2021.

2021 Site Inspection Photos at NC079

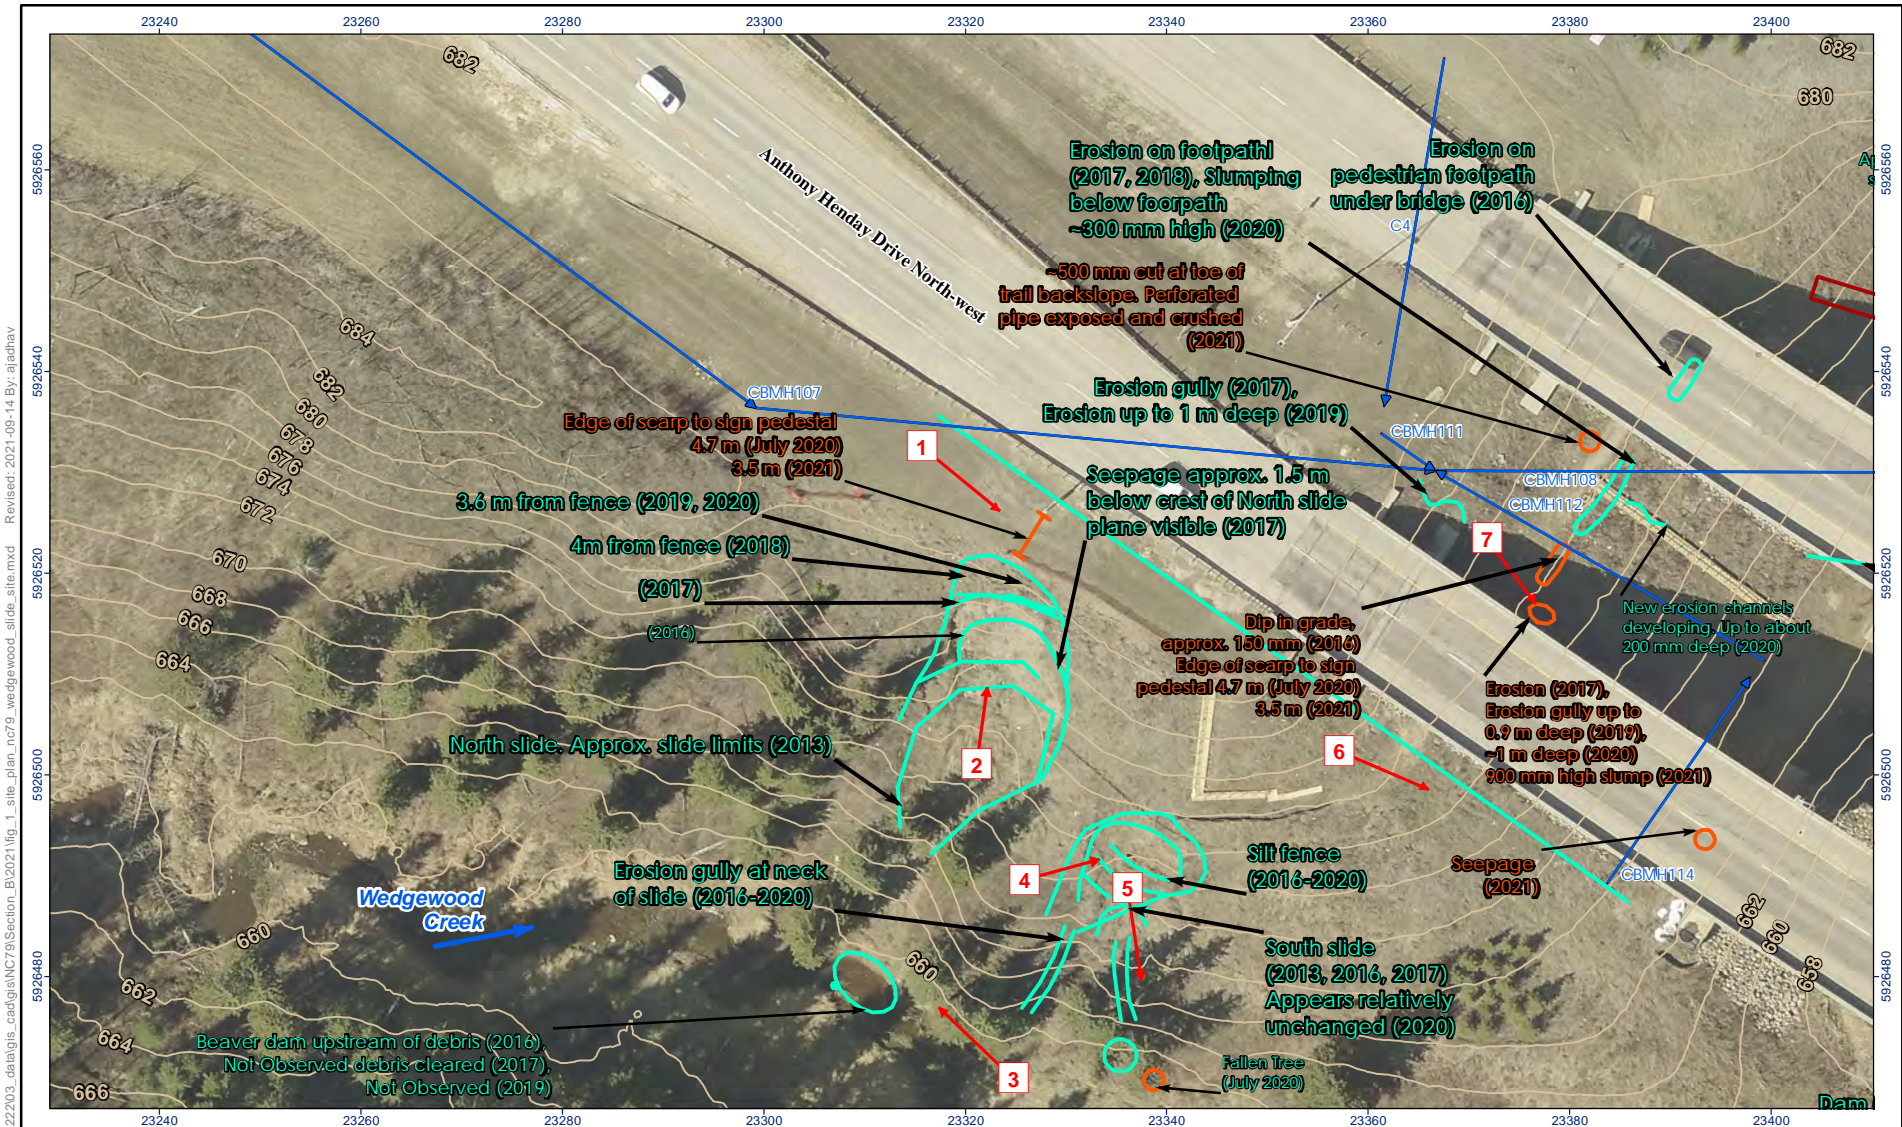
- Erosion/slumping of the footpath at the north corner of the riprap below the SBL developing a scarp (Photo 7). Scarp is about 900 mm high and is starting to retrogress into footpath. Surface water appears to be flowing between the highway towards this slump.
- Erosion observed behind both outfalls located on the west and east sides of Wedgewood Creek north of AHD (Photo 8). Erosion above west outfall appears to be retrogressing further upslope with a new scarp developed (Photo 9). East outfall condition looked similar to the previous inspection (Photos 10 and 11).
- The gap (fill settlement) at the northeast corner of the northernmost pedestal increased by 30 mm to 200 mm.
- The two slumps on the west slope between the concrete piers appear unchanged (Photo 12).

**Photo 12:** Two slumps between the two concrete pedestals for bridge piers. Looking northwest.
