SITE NUMBER AND NAME: NC079 – Wedgewood Ravine Slides	HIGHWAY AND KM: 216:06, km 12.849	PREVIOUS INSPECTION: June 28, 2021	CURRENT INSPECTION: June 15, 2022
LEGAL DESCRIPTION: SE 28-52-25-W4	NAD83 COORDINATES: UTM12U 5927932N, 324250E		RISK ASSESSMENT: PF: 11 CF: 8 Total: 88
AVERAGE ANNUAL DAILY TRAFFIC (AADT): 64,930 (2021)		CONTRACTOR MAINTENANCE AREA (CMA): Anthony Henday Drive (AHD)

2022 Site Inspection Photos at NC079

Alberta Transportation
 Geotechnical Monitoring Program
 NC79 Wedgewood Ravine Slides

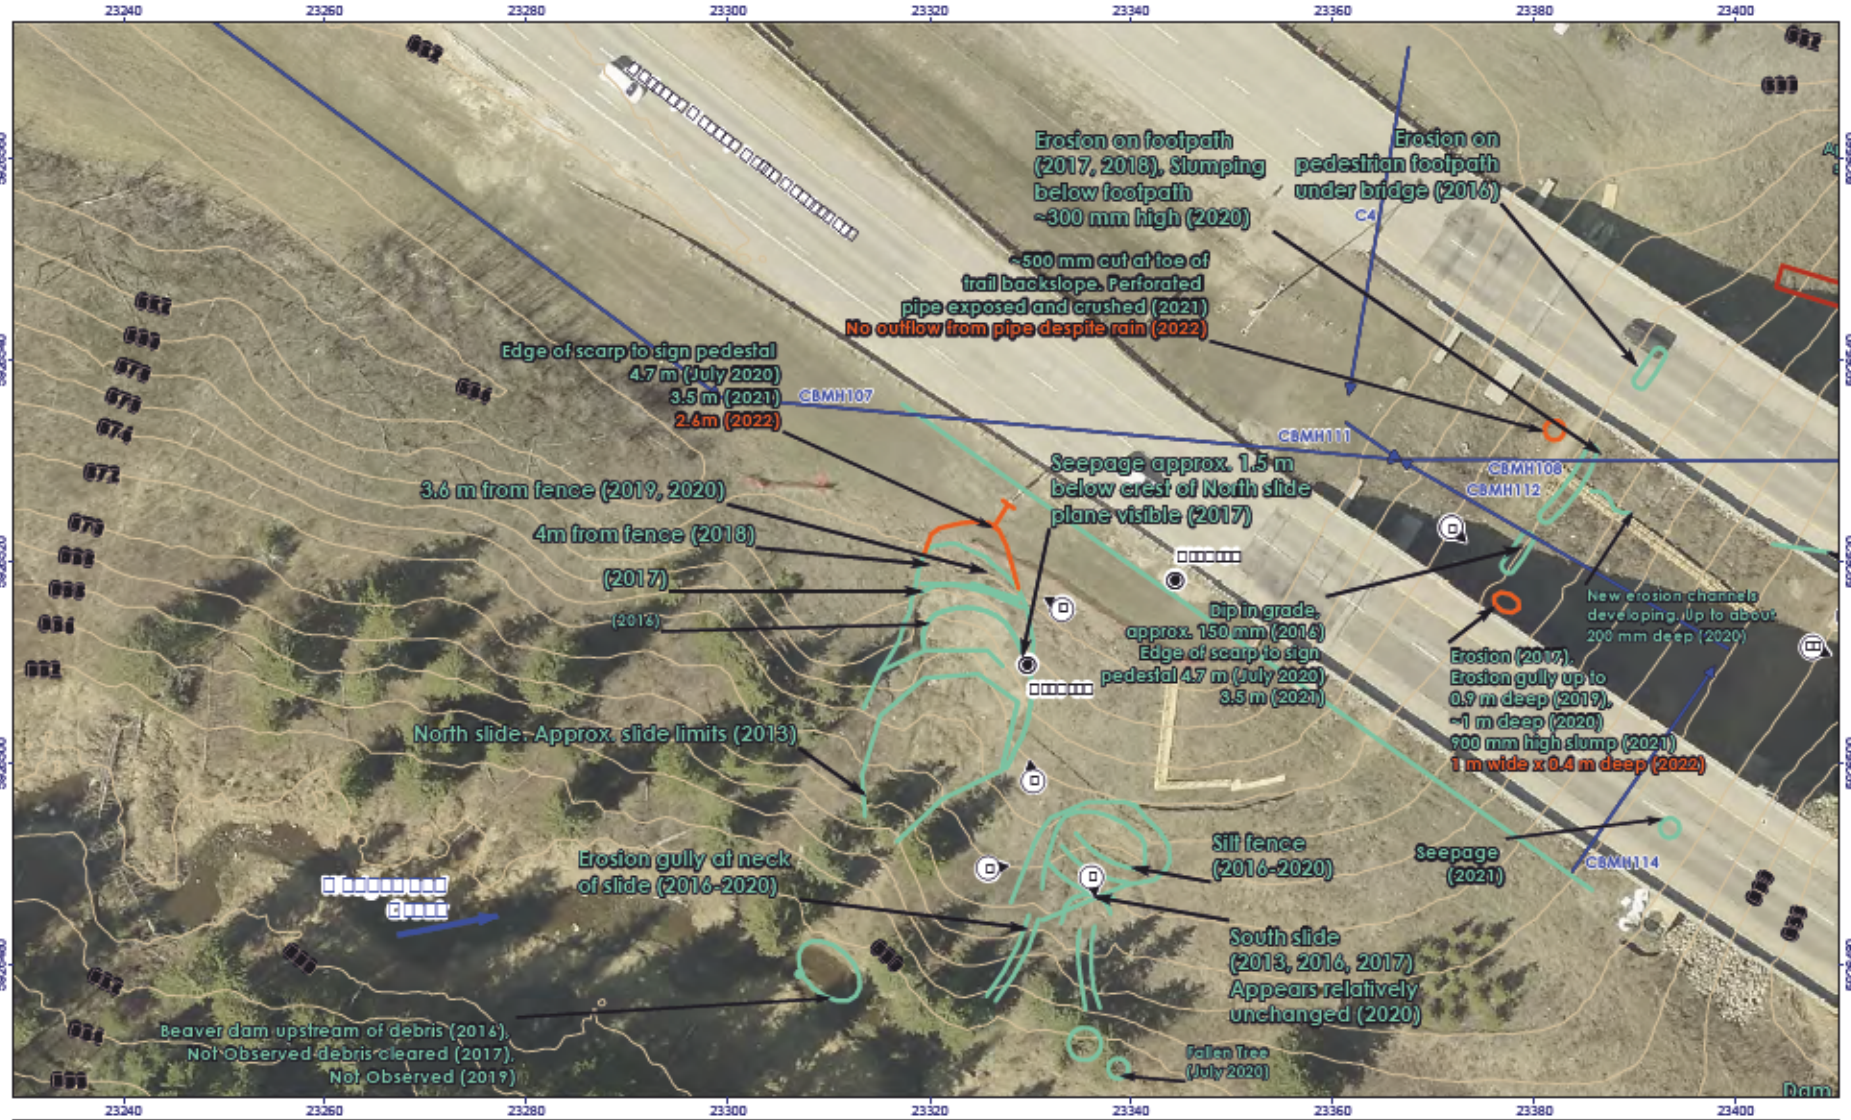
- The slope below the northernmost pedestal on the east bank has failed, with debris piled at the edge of the creek (Photo 10). The slope below the southernmost pedestal on the east bank appears to be experiencing erosion and most of the vegetation appears dead.

Photo 10: Slope failure on east bank below AHD NB pedestal, erosion below AHD SB pedestal. Looking southeast.

- Stantec submitted a proposal for remediation of the new slump on the east bank. Remediation of the slump is expected to consist of removal and replace. The estimated cost of construction for removal and replace is in the order of \$500,000 to \$650,000 including engineering.
