<b>SITE NUMBER AND NAME:</b> NC094 – 100 Ave at NB AHD	<b>HIGHWAY AND KM:</b> 216:06, km 20.550	<b>PREVIOUS INSPECTION:</b> June 30, 2022	<b>CURRENT INSPECTION:</b> June 1, 2023
<b>LEGAL DESCRIPTION:</b> NW-32-52-25-W4	<b>NAD83 COORDINATES:</b> UTM12U 5935400N, 323784E		<b>RISK ASSESSMENT:</b> PF: 13 CF: 4 Total: 52
<b>AVERAGE ANNUAL DAILY TRAFFIC (AADT):</b> 3,610 (2022, Traffic from west turning left)		<b>CONTRACTOR MAINTENANCE AREA (CMA):</b> AHD

NORTH CENTRAL REGION GRMP  
EDSON / STONY PLAIN  
SITE INSPECTION FORM

2023 Site Inspection Photos at NC094

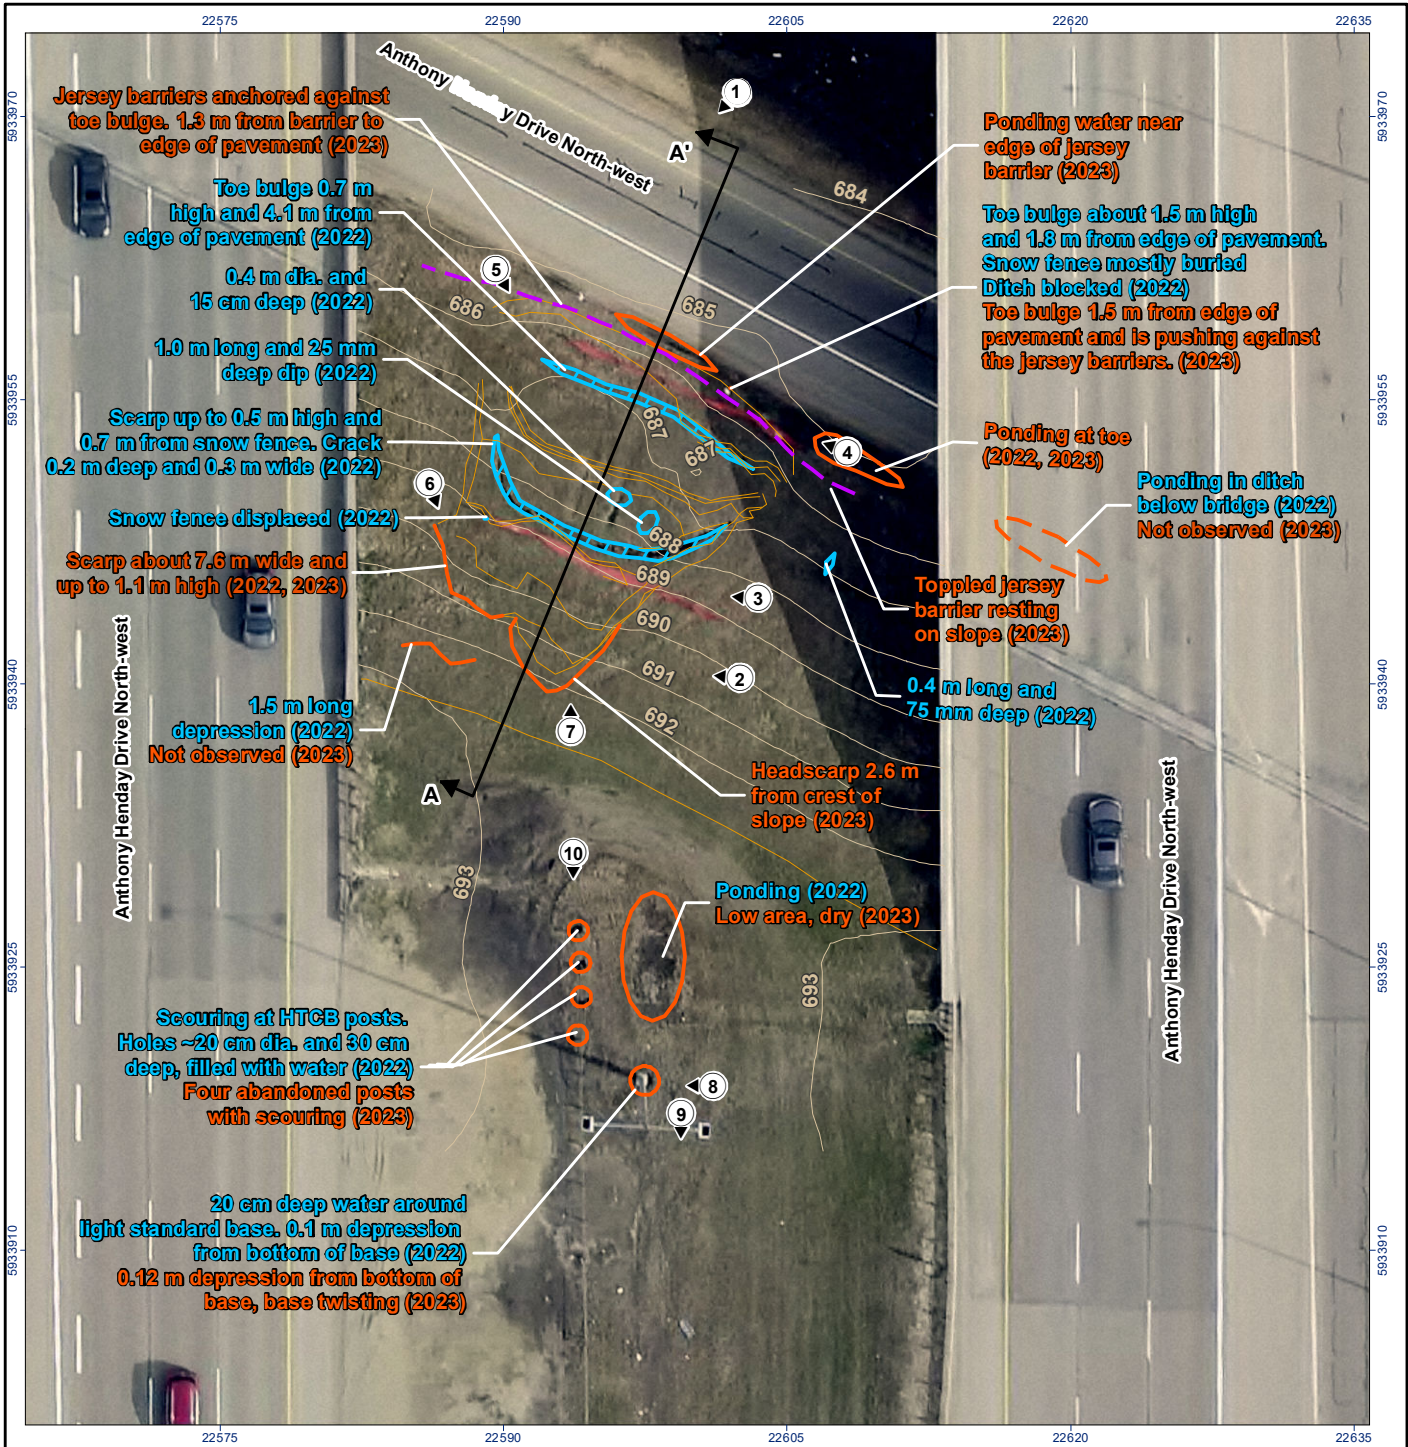
Figure No. 1  
 Title: **Site Plan**

<b>COMMENTS</b>
<ul style="list-style-type: none"> <li>The overall embankment is about 33 m wide and 8 m high. The slump exists between the two bridge abutments south of the 100 Avenue on-ramp to AHD northbound (Photo 1).</li> <li>The landslide is slightly west of center of the embankment. The scarp appears to have retrogressed, lengthening the slide area by 1.4 m since the previous inspection in late June 2022. The scarp was observed at the upper portion of the embankment and is up to 1.1 m high. The current scarp is 2.6 m from the crest of the embankment, compared to 4.0 m at the time of the last investigation (Photos 1 to 7).</li> <li>The east and west flanks of the landslide are approximately 12.5 m and 4.6 m from the east and west bridge abutment walls, respectively. These measurements have not changed since the previous investigation.</li> <li>The toe bulge has progressed further downslope towards 100 Avenue and has reduced the distance to the edge of pavement from 1.8 m to 1.5 m. The toe bulge is approximately 1.5 m high (Photos 4 and 5).</li> </ul>

- Jersey barriers have been placed around the toe of the landslide and anchored into the ground. The edge of the jersey barrier is 1.3 m from the edge of the pavement and the toe of the slump is pushed against the back of the jersey barriers (Photos 4 and 5).

- One jersey barrier at the far east side of the slump was observed to be toppled and resting against the slope.
- The 1.5 m long dip in the ground above the 2022 scarp was not observed during this inspection.

- The highway surface currently does not appear to be affected by the embankment failure.
- Snow fence previously placed above the slump has shifted down the embankment, and most of the snow fence placed below the slump is now buried beneath the toe bulge.

- The MCI and/or HMC should monitor the slump for progression towards 100 Avenue and the jersey barriers should be adjusted or maintained, as necessary.
- Stantec has completed the landslide remediation design for removal and replace. The design includes excavating the landslide mass in benches with an overall slope of 2H:1V followed by rebuilding the embankment with granular fill. The estimated cost of construction for landslide remediation ranges from \$180,000 to \$210,000 including part-time contract administration fees.
- It is understood that long term remediation is scheduled to take place in 2024. If the remediation work is pushed to another year later, TEC could consider annual surveys to monitor the movement of the slide.
- Site inspection frequency should continue annually.
