SITE NUMBER AND NAME: NC057 – Highway 624 Embankment Failure	HIGHWAY AND KM: 624:02, km 2.571	PREVIOUS INSPECTION: June 2, 2023	CURRENT INSPECTION: June 14, 2023
LEGAL DESCRIPTION: NE & NW 34-50-07-W5	NAD83 COORDINATES: UTM11U 5915066N, 637131E		RISK ASSESSMENT: PF: 10 CF: 6 Total: 60
AVERAGE ANNUAL DAILY TRAFFIC (AADT): 1,540 (2023)		CONTRACTOR MAINTENANCE AREA (CMA): 509

Client/Project: Transportation and Economic Corridors
 Geohazard Monitoring Program
 NC57 Hwy 624 Embankment Failure

2024 Site Inspection Photos at NC057

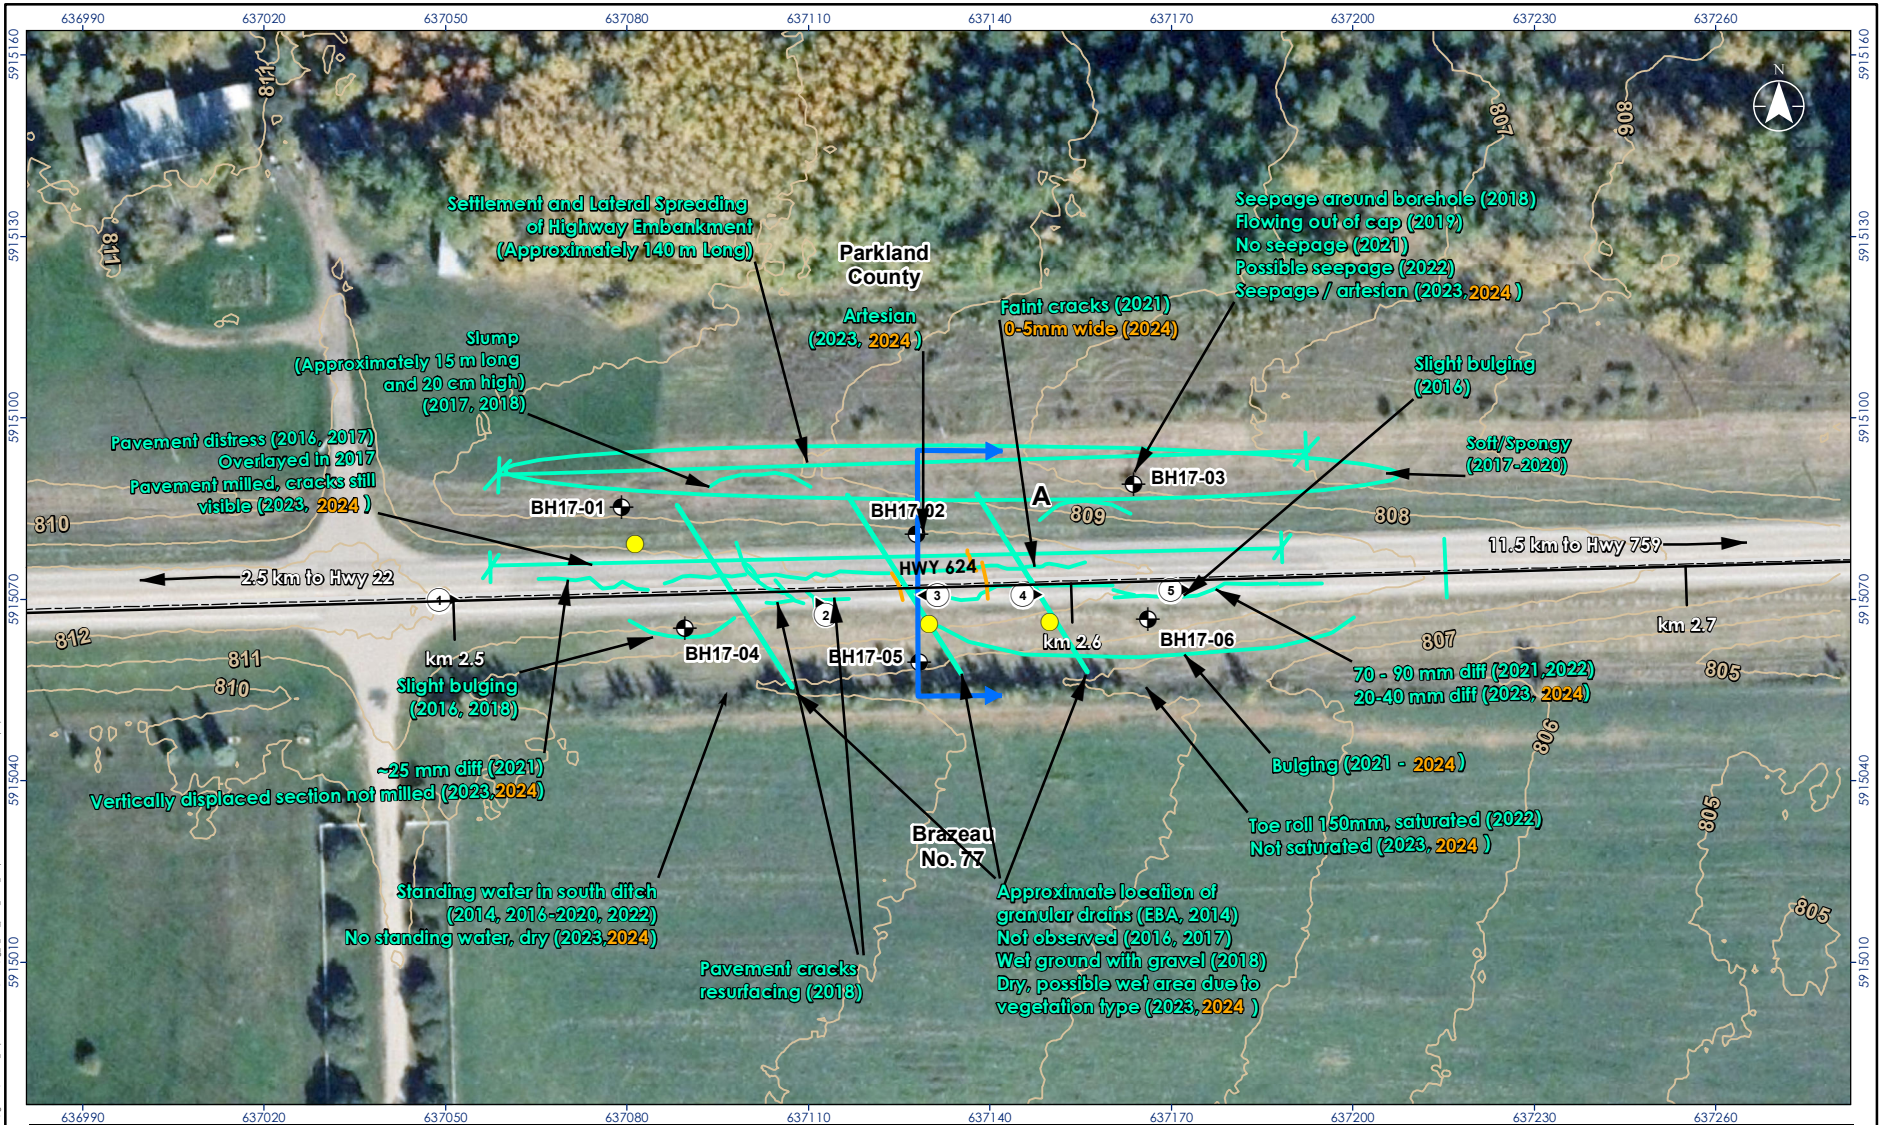
Figure No.: 1
 Title: Site Plan

COMMENTS
In general, little change was observed since the 2023 inspection. The following summarizes Stantec's observations: <ul style="list-style-type: none"> Pavement cracks are visible within the milled asphalt surface (Photos 1 to 5). The cracks were observed to be up to 5 mm wide. Additional faint, diagonal cracks were observed during this inspection. On the WBL, cracking has progressed to about 25 m east of BH17-02, similar to the observation in 2023. Vertical displacement was observed at the west extents of the pavement cracks on the WBL due to transition from milled to non-milled pavement (Photo 1). The EBL pavement cracks near BH17-06 show about 20 to 40 mm vertical displacement after milling. A portion of pavement near BH17-06, at the location of the greatest vertical displacement south of the crack, was not milled (Photos 4 and 5).

- A potential bulge was observed south of BH17-06 approximately halfway down the embankment slope.
- The piezometer levels remain high at this site with the piezometers showing artesian conditions as high as 0.4 m above ground surface. High piezometric levels are likely contributing to the embankment instability. Little to no change was observed between Spring 2024 and Fall 2023 readings, however the artesian conditions have risen by approximately 0.1 m since the Spring 2023 reading.
- Range Roads 71 and 72 could be used for detours and would require less than 20 minutes of additional travel time. However, travel over gravel roads would be required and may not be suitable for transport trucks. Transport trucks may see additional travel times in the order of 30 minutes on paved roadways.

- Pavement cracks should be sealed to reduce surface water infiltration into the embankment. Additional pavement patches are not recommended since it is considered an additional driving force on the embankment. Mill and fill could be completed to address the vertical displacement until remediation is completed.
- Detailed design of this site is complete. The remediation option will include removal of the existing embankment and reconstructing it using tire derived aggregate to improve embankment drainage.
- Site inspections should continue annually.
- Instrumentation should continue to be read semi-annually.
- If remediation is delayed by more than two years, slope inclinometers should be considered to monitor the depth and rate of slope movement. This information will be useful for characterizing the failure and optimizing the design.
