**Reference: Call Out Site – Highway 825 at Sturgeon River Crossing
Task D – Call Out Report**

This letter documents the findings of a call out inspection of an erosion disturbance adjacent to Highway 825 at the Sturgeon River crossing approximately 200 m south of Township Road 555. The legal land description of the site is NW-28-55-22-W4M. The location of the site is shown on **Figure 1** in **Attachment B**.

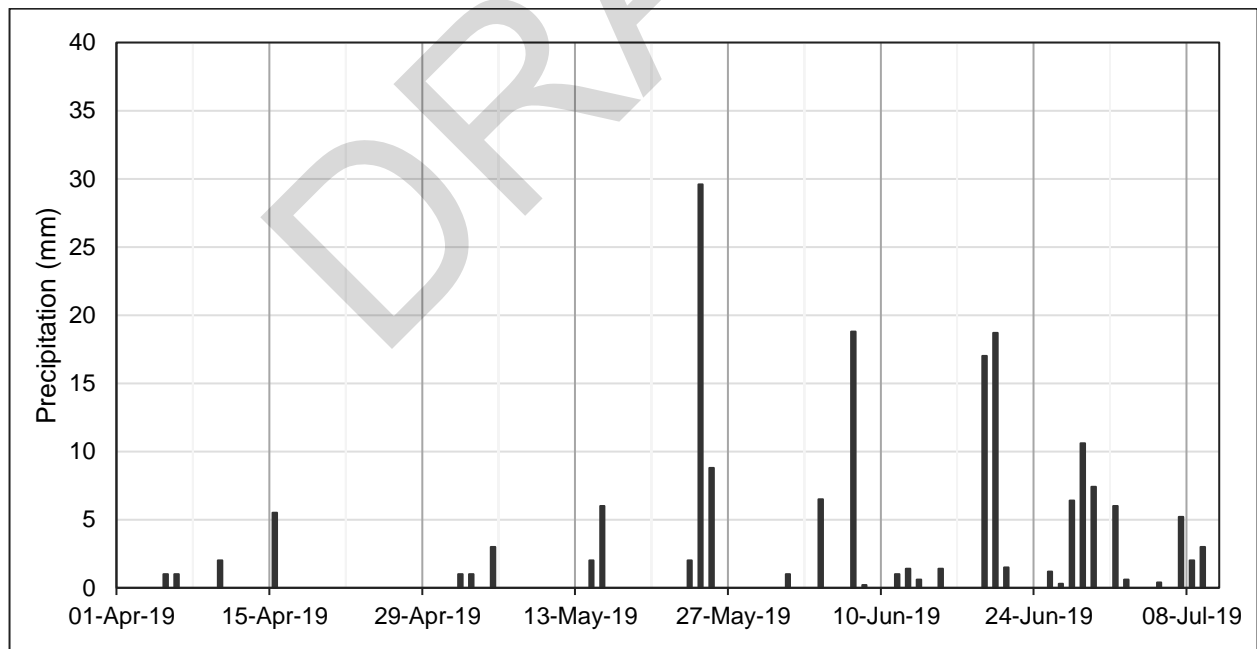
**Chart 1: Daily total precipitation prior to call-out inspection
(obtained from Government of Canada website for Fort Saskatchewan weather station)**

Precipitation data obtained from the Government of Canada for the Fort Saskatchewan weather station approximately 10 km south of the site is shown below in **Chart 1**. This plot shows a number of relatively significant rainfall events in the weeks leading up to the erosion event. Most notably, a nearly 30 mm rainfall event occurred on May 24, followed by several events in the range of 15 to 20 mm of precipitation in June, with 17 and 19 mm observed on June 19 and 20, respectively.
