## STONY PLAIN REGION GEOHAZARD RISK ASSESSMENT SITE INSPECTION FORM

| <b>SITE NUMBER AND NAME:</b><br>NC 23 – Landslide near Greenwood Lake Road | <b>HIGHWAY AND KM:</b><br>Hwy 39:06, km 13.08 | <b>PREVIOUS INSPECTION DATE:</b><br>June 10, 2014 | <b>INSPECTION DATE:</b><br>June 16, 2015 |

| <b>PRIMARY SITE ISSUE:</b> Highway situated on a large historic landslide which is failing primarily north toward Modeste Creek; the lower west flank portion continues to move which has previously caused pavement distress. | |

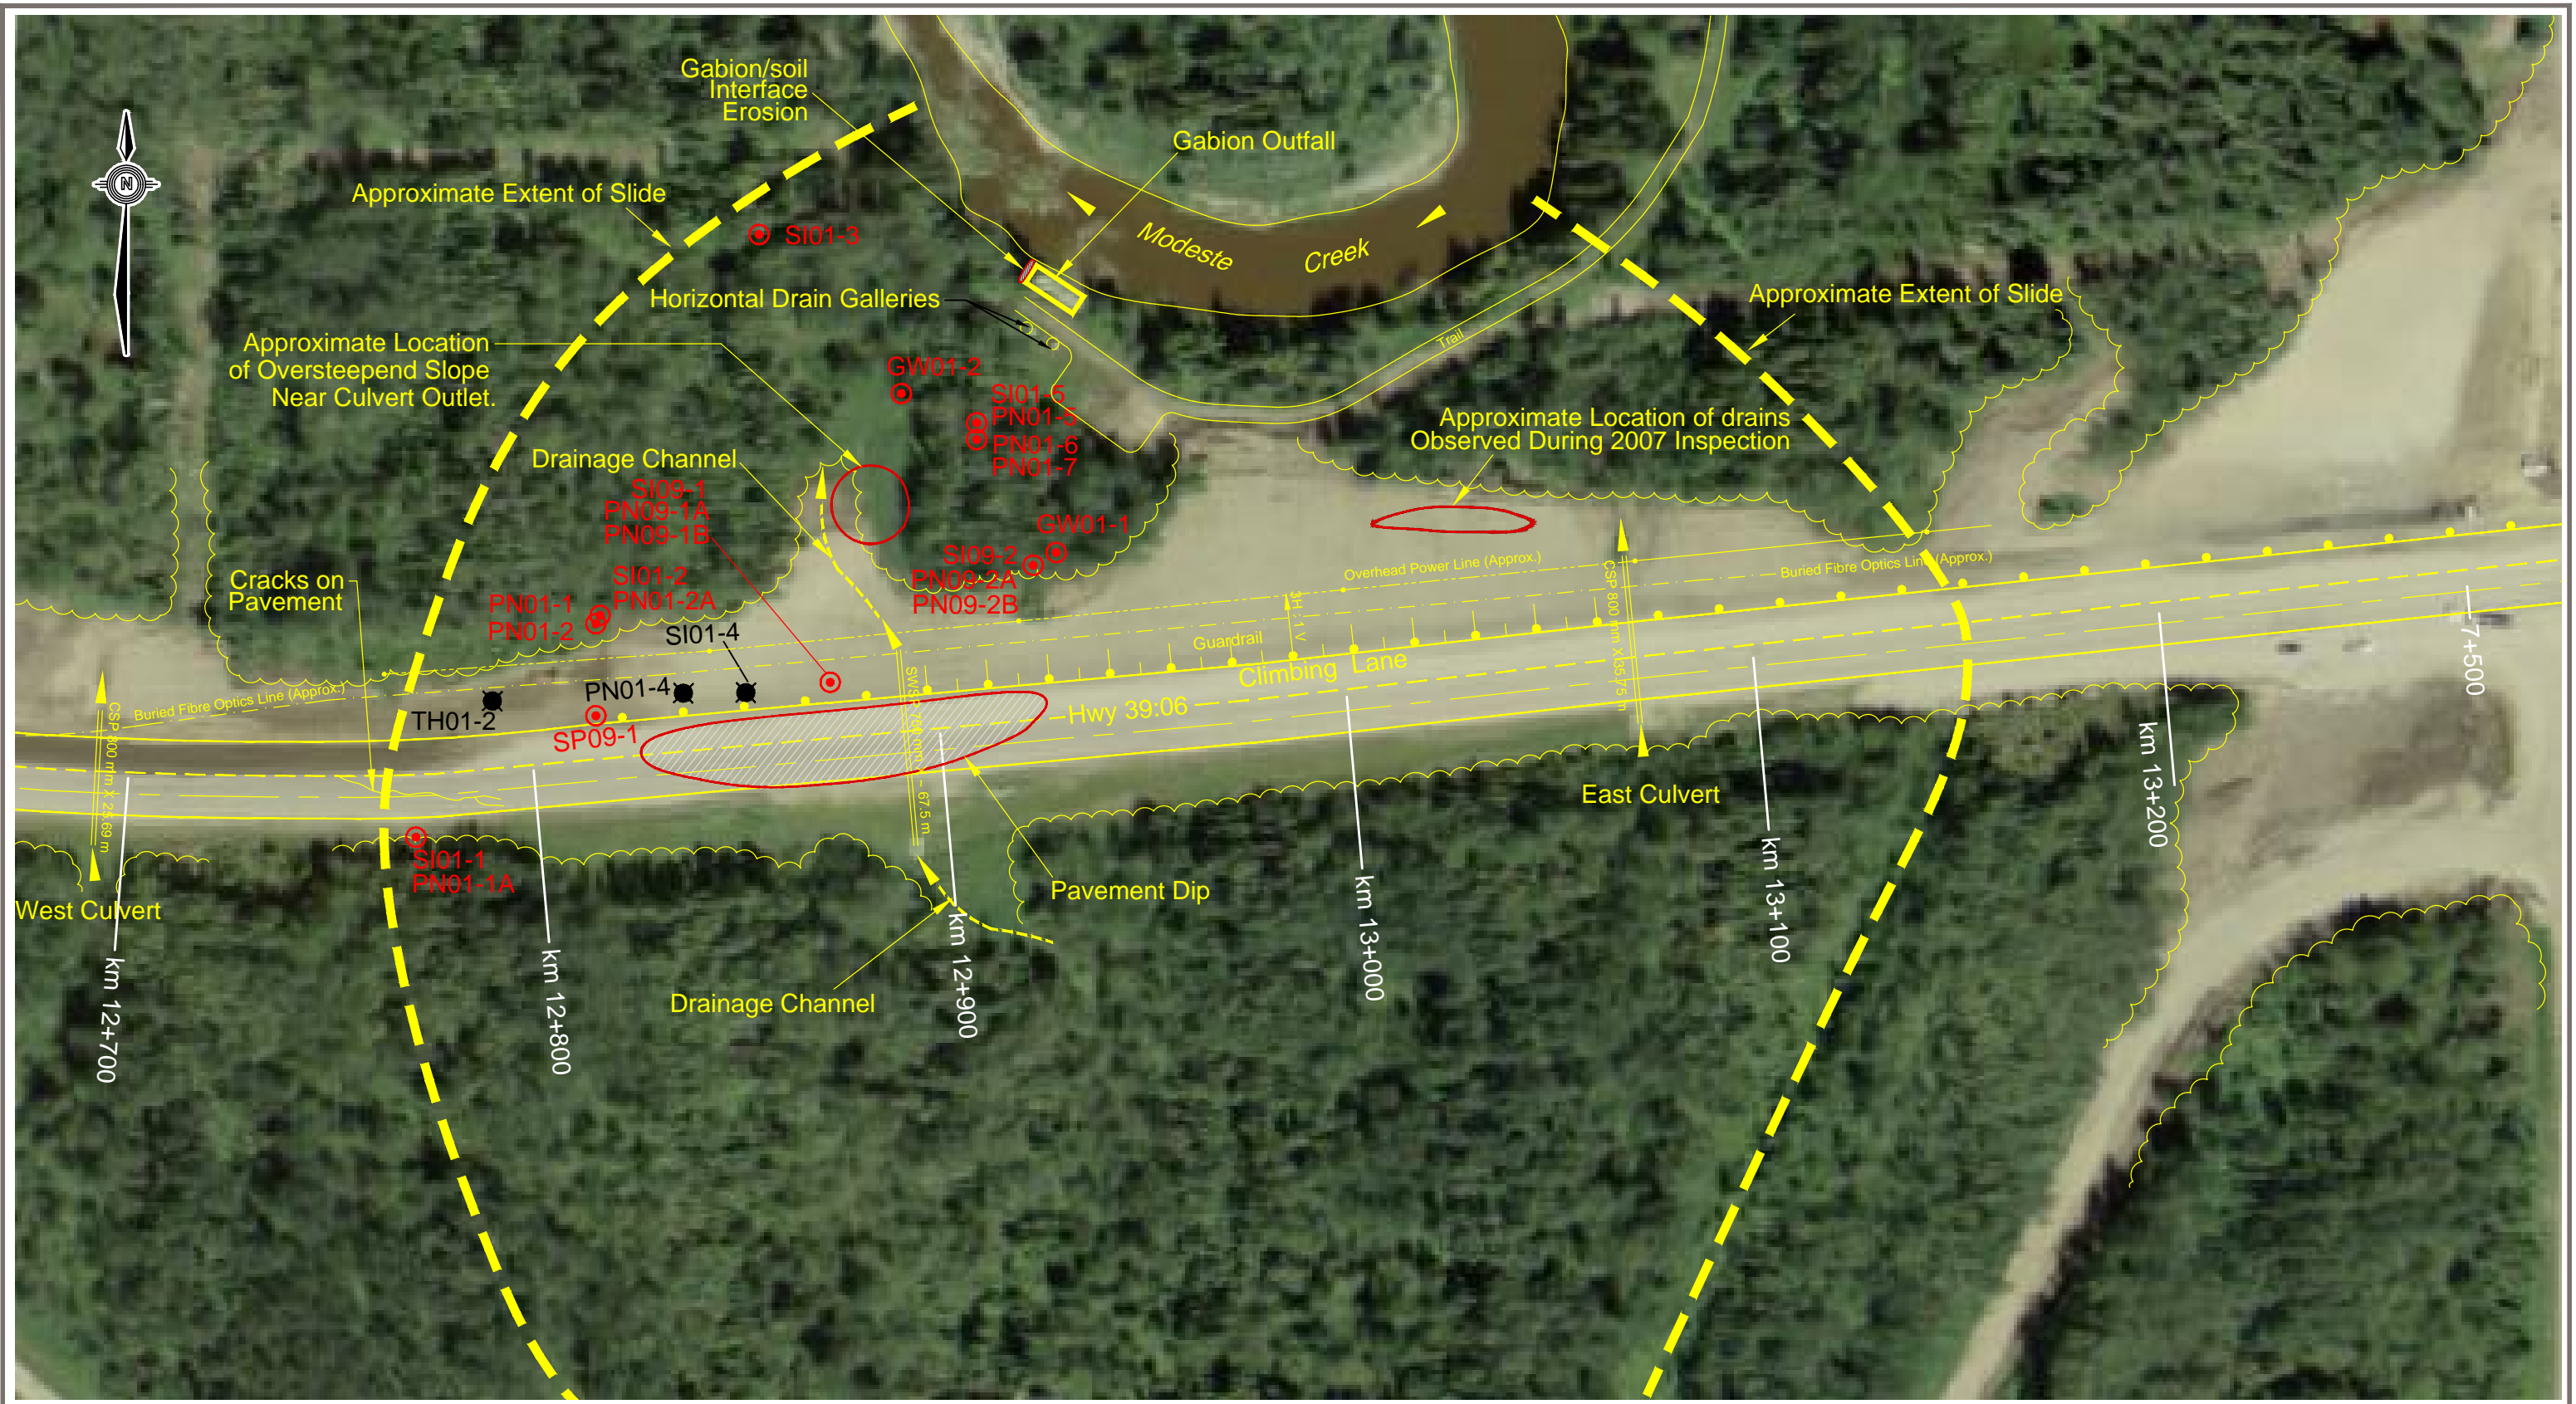
Q:\Edmonton\Drafting\PROJECTS\E12103001\02\Report\Components\Autocad\E12103001\_002\_FIG\_NC-23.dwg [FIGURE NC-23] August 09, 2012 - 3:36:42 pm (BY: KIROS, TIGIST)

Vegetation well established on north facing slope.  
East culvert inlet elevated above ditch causing ponding.  
Location and site plan shown on Figure NC-23.  
Site conditions shown in Photos 1 to 7.  
Risk level unchanged from 2014.
