**ALBERTA TRANSPORTATION  
GEOHAZARD ASSESSMENT PROGRAM  
PEACE REGION (GRANDE PRAIRIE DISTRICT-NORTH)  
2023 INSPECTION**

**THURBER ENGINEERING LTD.**

Site Number	Location	Name (Old Site 5)	Hwy	km
PH023	12 km W. Cleardale	Clear River East Hill-Twin Pipes	64:02	23.4-24.1
Legal Description		UTM Co-ordinates (NAD 83)		
NE28/NW27-84-11-W6		11 N 6244273	E 335460

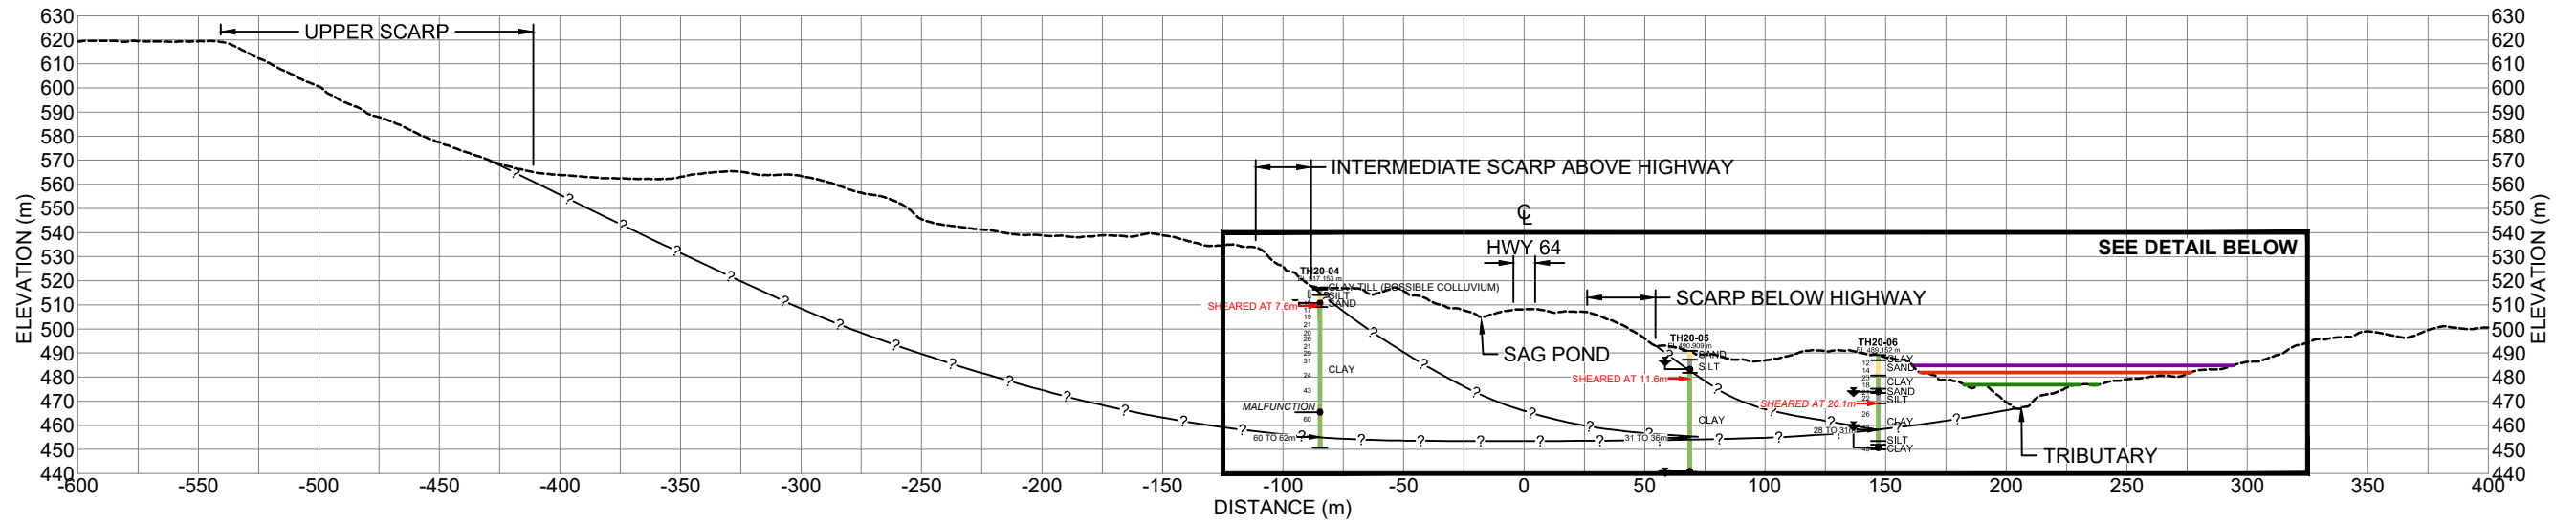
**CROSS-SECTION B-B'**  
SCALE 1:3000

**Instrumentation:** Last read June 23, 2023 - The inclinometer movement zones, and piezometer tip depth measurements are shown on the cross-sections attached (Drawings PH023-4 to -6).
