**ALBERTA TRANSPORTATION AND  
ECONOMIC CORRIDORS  
GEOHAZARD ASSESSMENT PROGRAM  
PEACE REGION (GRANDE PRAIRIE DISTRICT– NORTH)  
2024 INSPECTION**

Site Number	Location	Name	Hwy	km
PH067	West of Fairview	East Hill Ditch Erosion Section	682:02	13.8-14.1
Legal Description		UTM Co-ordinates (NAD 83)		
Centre 36-81-5-W6		11 N 6214450	E 398000

**PH067-1: HWY 682:02 - HINES CREEK  
2024 INSPECTION PLAN**

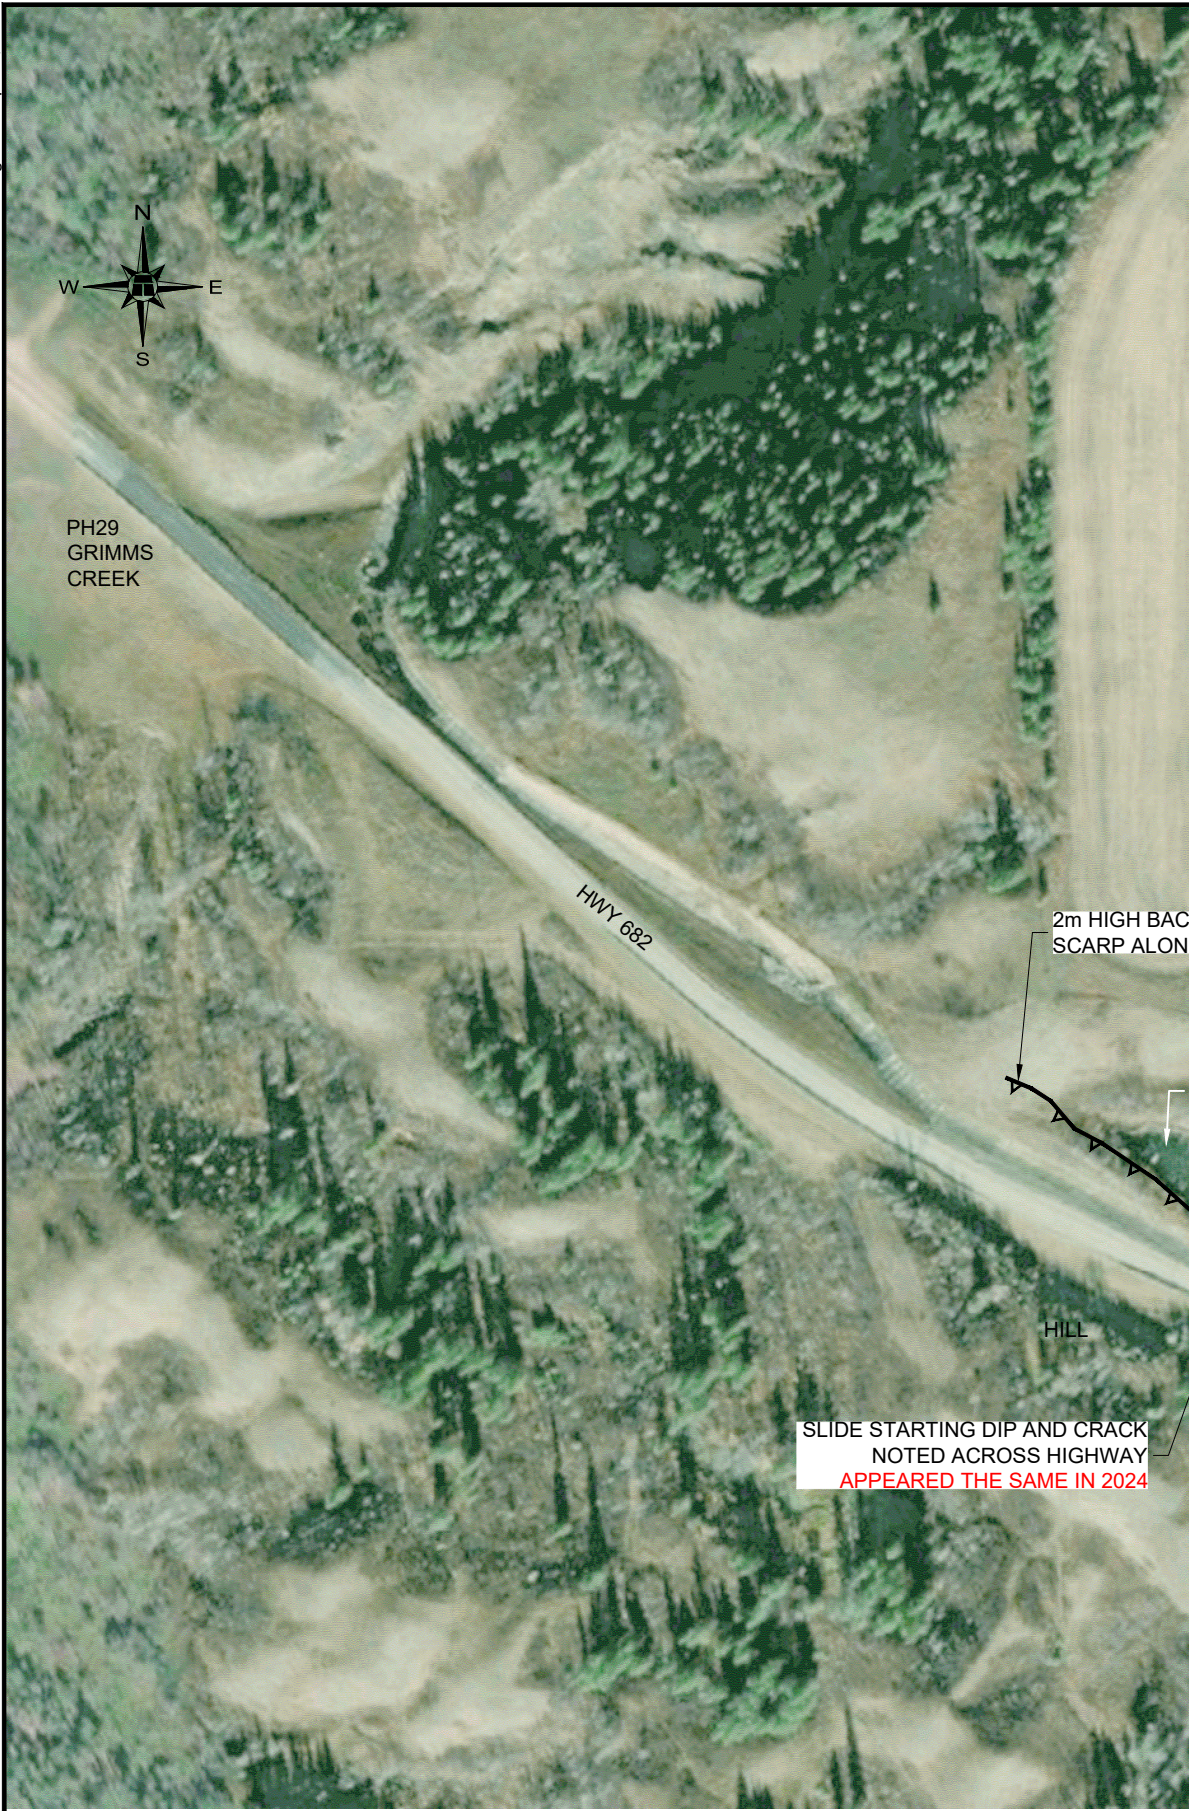
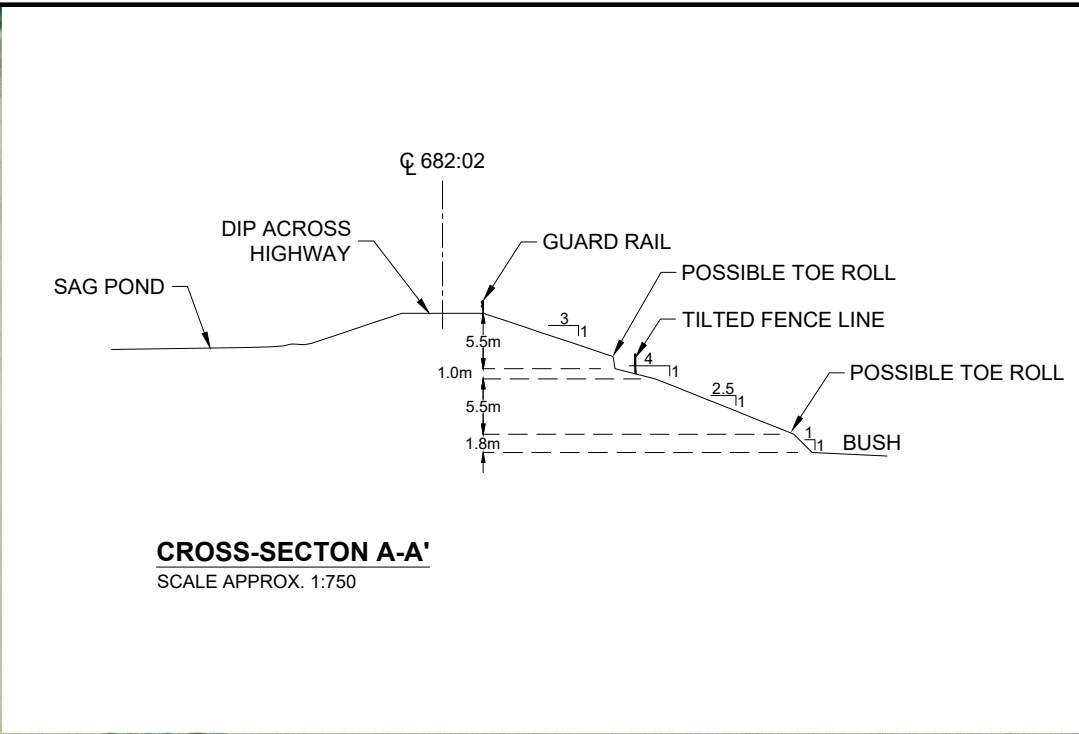
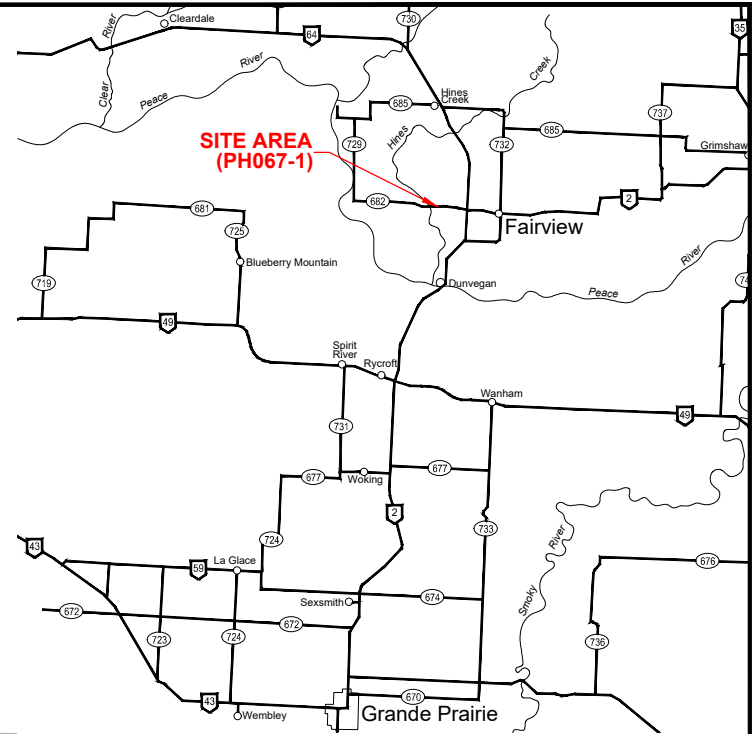
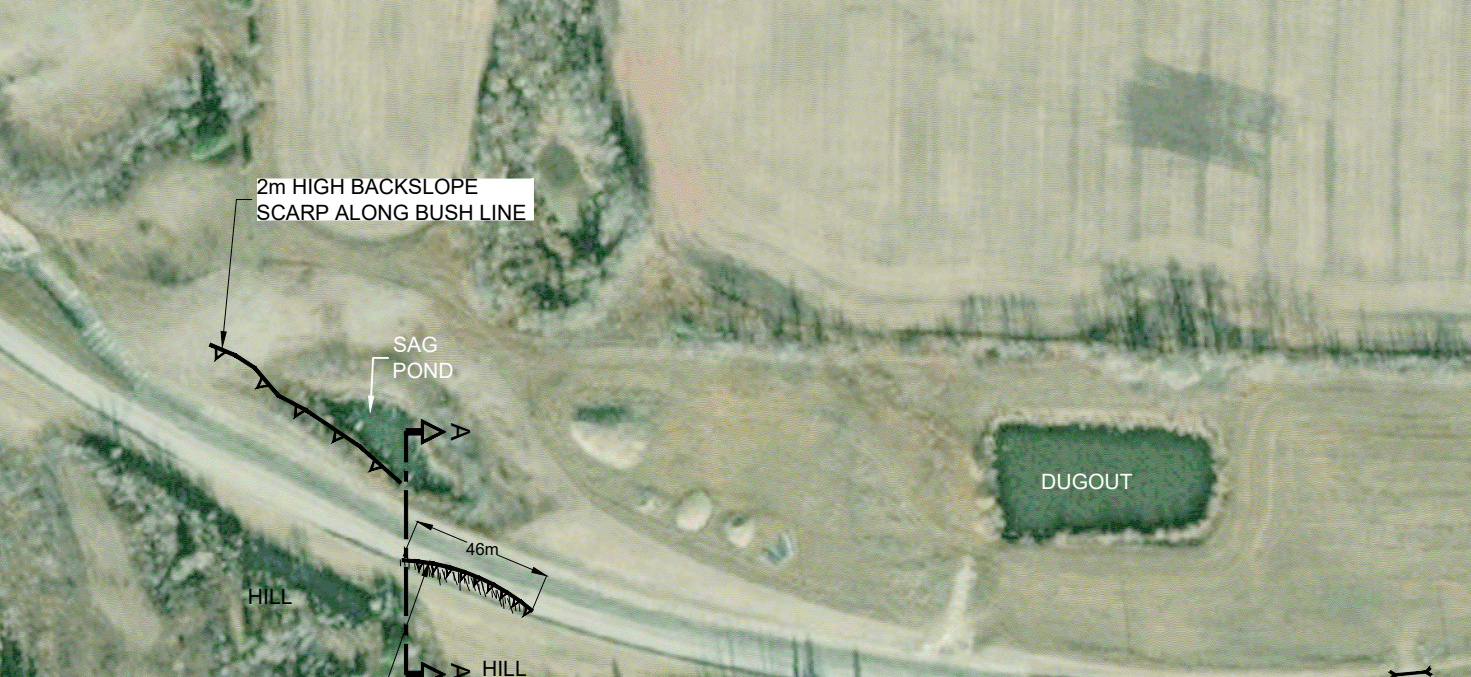
PH067-1: HWY 682:02 km 11.6 TO 14.1  
DITCH EROSION REPAIRS  
SITE 3

- NOTES :**
1. FEATURE LOCATIONS ARE APPROXIMATE
  2. PREVIOUS OBSERVATIONS SHOWN IN BLACK
  3. MAY 7, 2024 FEATURES SHOWN IN RED
  4. ADVANCED ABRASION & SPALLING OF ACB MAT BLOCKS AND MANY BROKEN BLOCKS ALONG CENTER BASE OF CHANNEL; SOME MATS WORSE THAN OTHERS.
  5. HIGHWAY SAND / SALT STAINING ALONG BASE & HIGHWAY SIDE OF ACB MATS IN CHANNEL.
