File: 2012-1002-Callout

Date: Sept 1, 2014

Re: **Call-out Inspection Report** (Currently GP-21a- Erosion of w. ditch of N. Approach)
(Previously GP-21 Slide at previous twin culvert)
Hwy 719:02 at Henderson Creek Bridge
- Erosion distress along
Site (1) west ditch (riprap) down valley along North Approach to bridge
Site (2) east ditch (grassed) down valley along North Approach to bridge

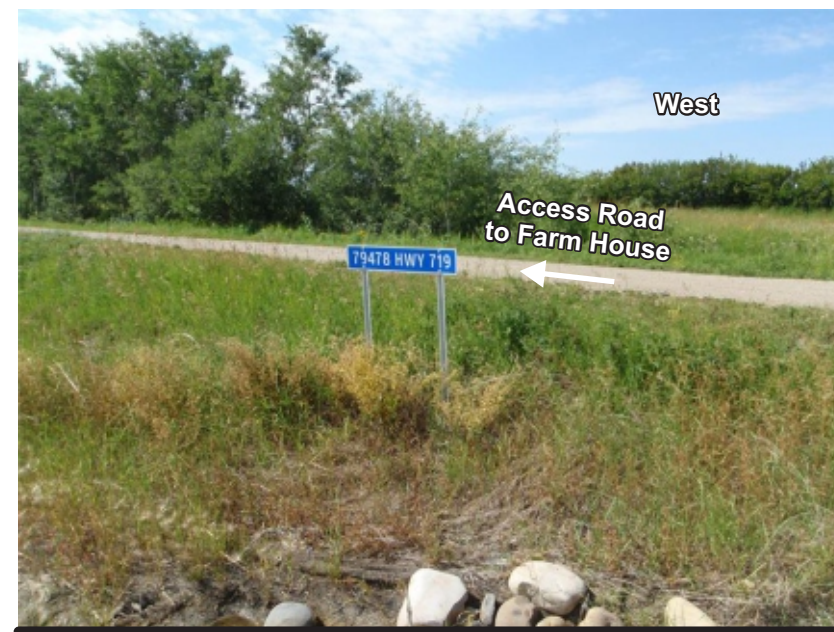
Photo3b

Looking north (at access to farm house) – an access culvert to channel flow onto west ditch

- Culvert apparently under full flow distress to scour flow onto west ditch
- A need to review actual flows accepted onto this west ditch via this culvert
