**ALBERTA TRANSPORTATION AND
ECONOMIC CORRIDORS
GEOHAZARD ASSESSMENT PROGRAM
PEACE REGION (GRANDE PRAIRIE DISTRICT - NORTH)
2024 INSPECTION**

Site Number	Location	Name	Hwy	km
PH026	Eureka River North Hill	Sites #3, #5 and #6	726:02	10.1
Legal Description		UTM Co-ordinates (NAD83)		
SW13/SE14-86-8-W6		11 N 6258740	E 368408

2024 PH026 INSPECTION PLAN

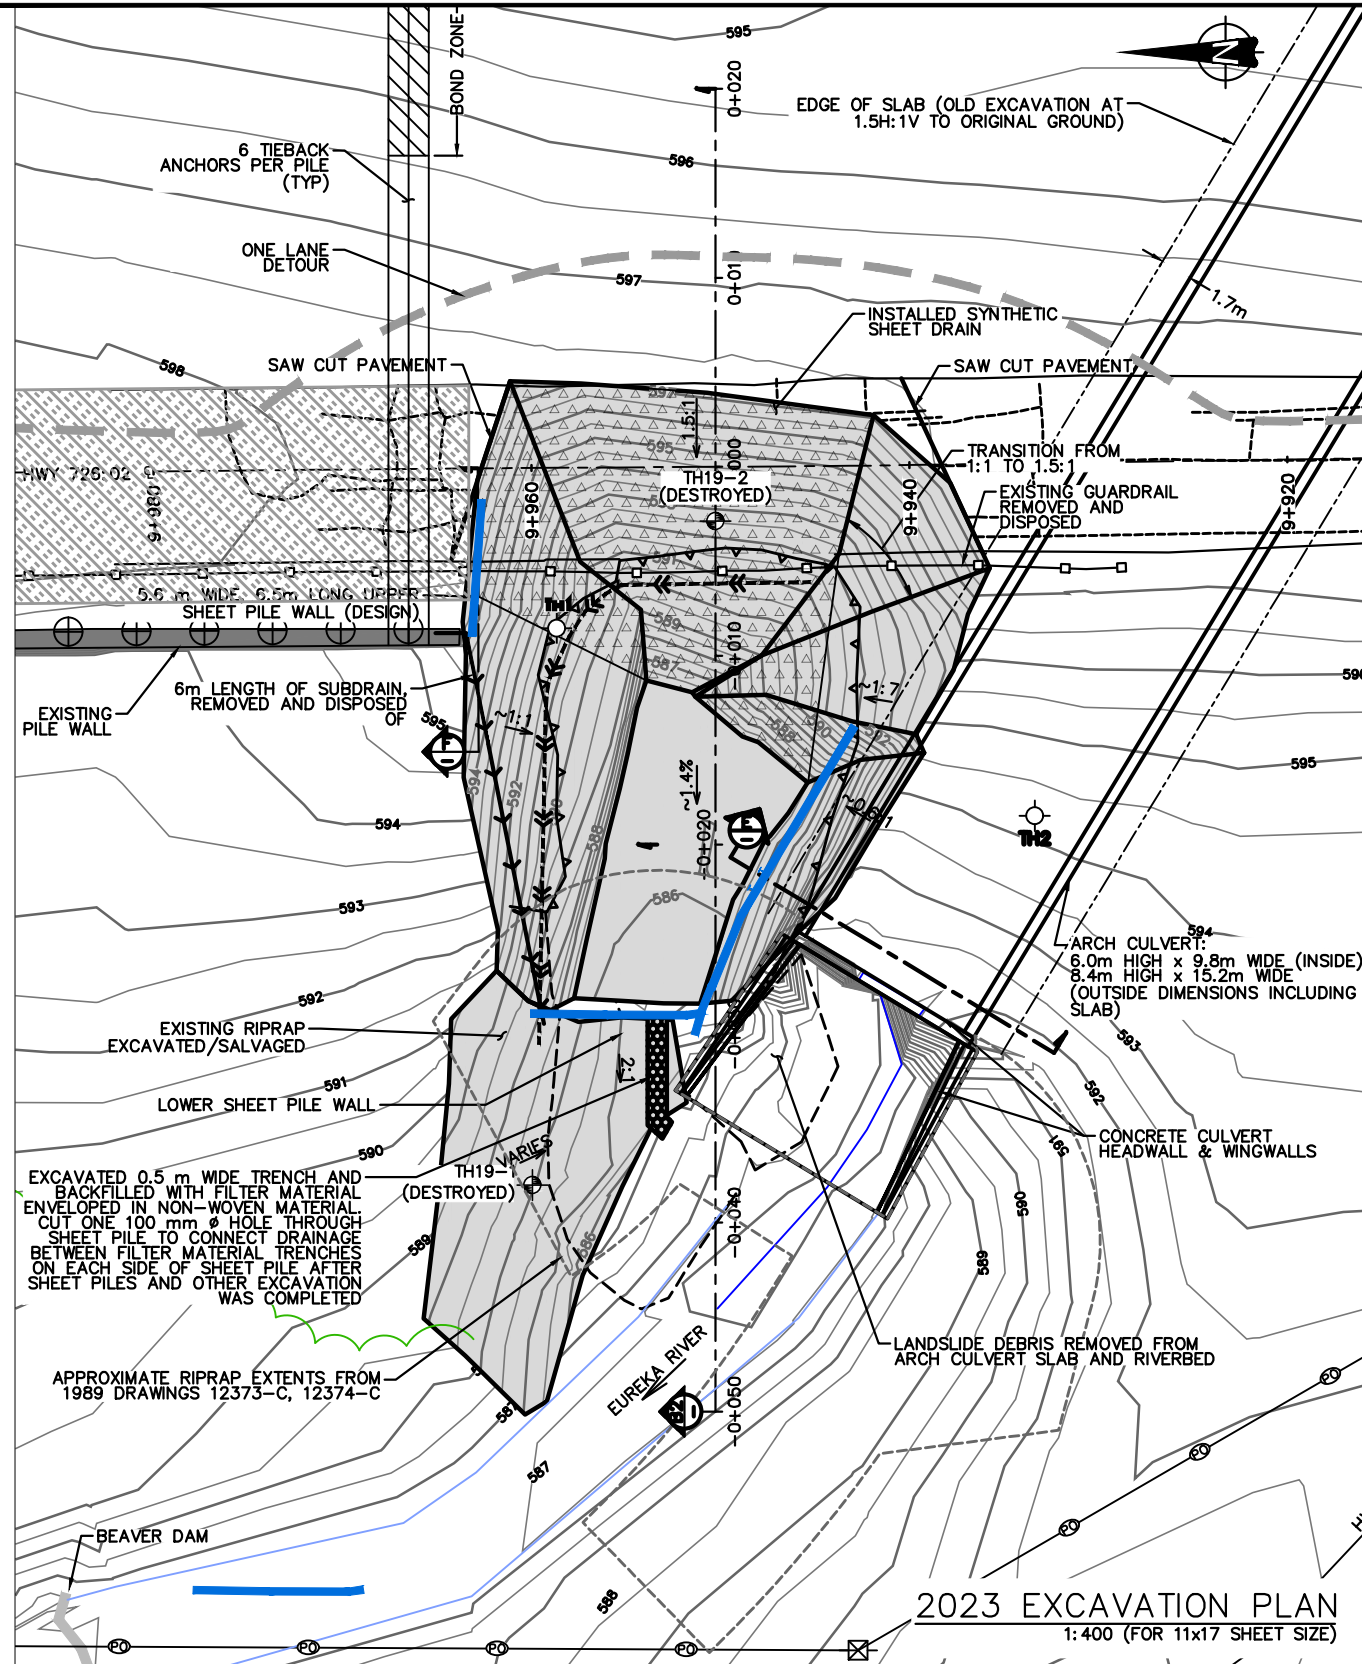
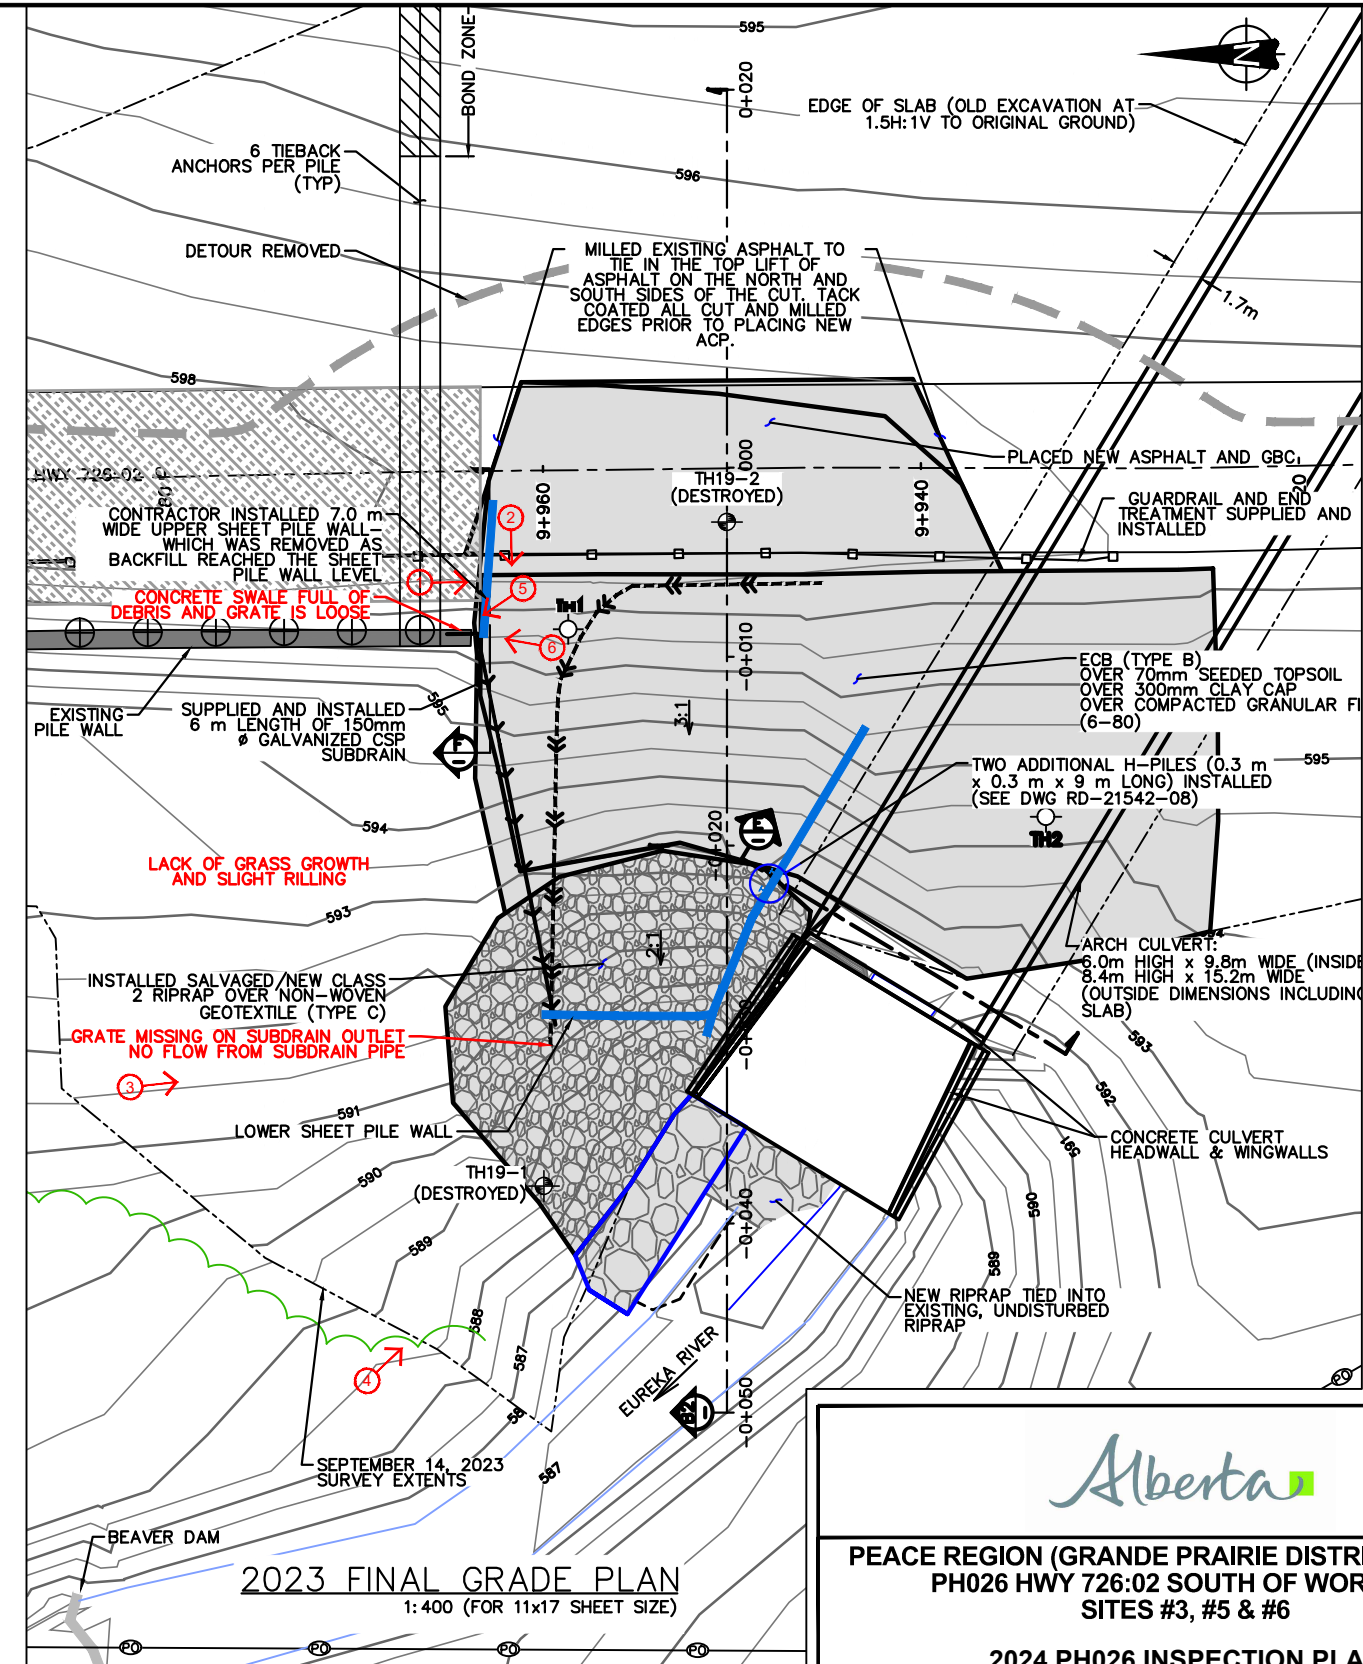
- NOTES:**
- CONDITIONS ON MAY 8, 2024 SHOWN IN RED.
 - GUTTER GRATE IS LOOSE AND GUTTER IS FULL OF DIRT AND NEEDS CLEANING (AT MAINTENANCE).
 - HIGHWAY 726:02 WAS OVERLAYED IN FALL OF 2023.
 - REFER TO DWG NO. 32123 PH026-4 FOR ADDITIONAL DETAILS OF 2023 SLIDE REPAIRS BETWEEN ARCH CULVERT AND UPPER PILE WALL.
