ALBERTA TRANSPORTATION AND
ECONOMIC CORRIDORS GRMP
GRANDE PRAIRIE REGION –
(GRANDE PRAIRIE NORTH)
INSTRUMENTATION MONITORING - SPRING 2024

Site Number	Location	Name	Hwy	km
PH026	HWY 726:02 km 9.91, 10.30	North Eureka River Slide	726:02	Km 9.9, 10.3
Legal Description: 8-14-86-8 W6		UTM Co-ordinates		
		11U E 368433	N	6258811

Current Monitoring:	27-May-2024	Previous Monitoring	13-Oct-2023
Instruments Read By:	Mr. Niraj Regmi, G.I.T and Mr. Nixson Mationg, of Thurber

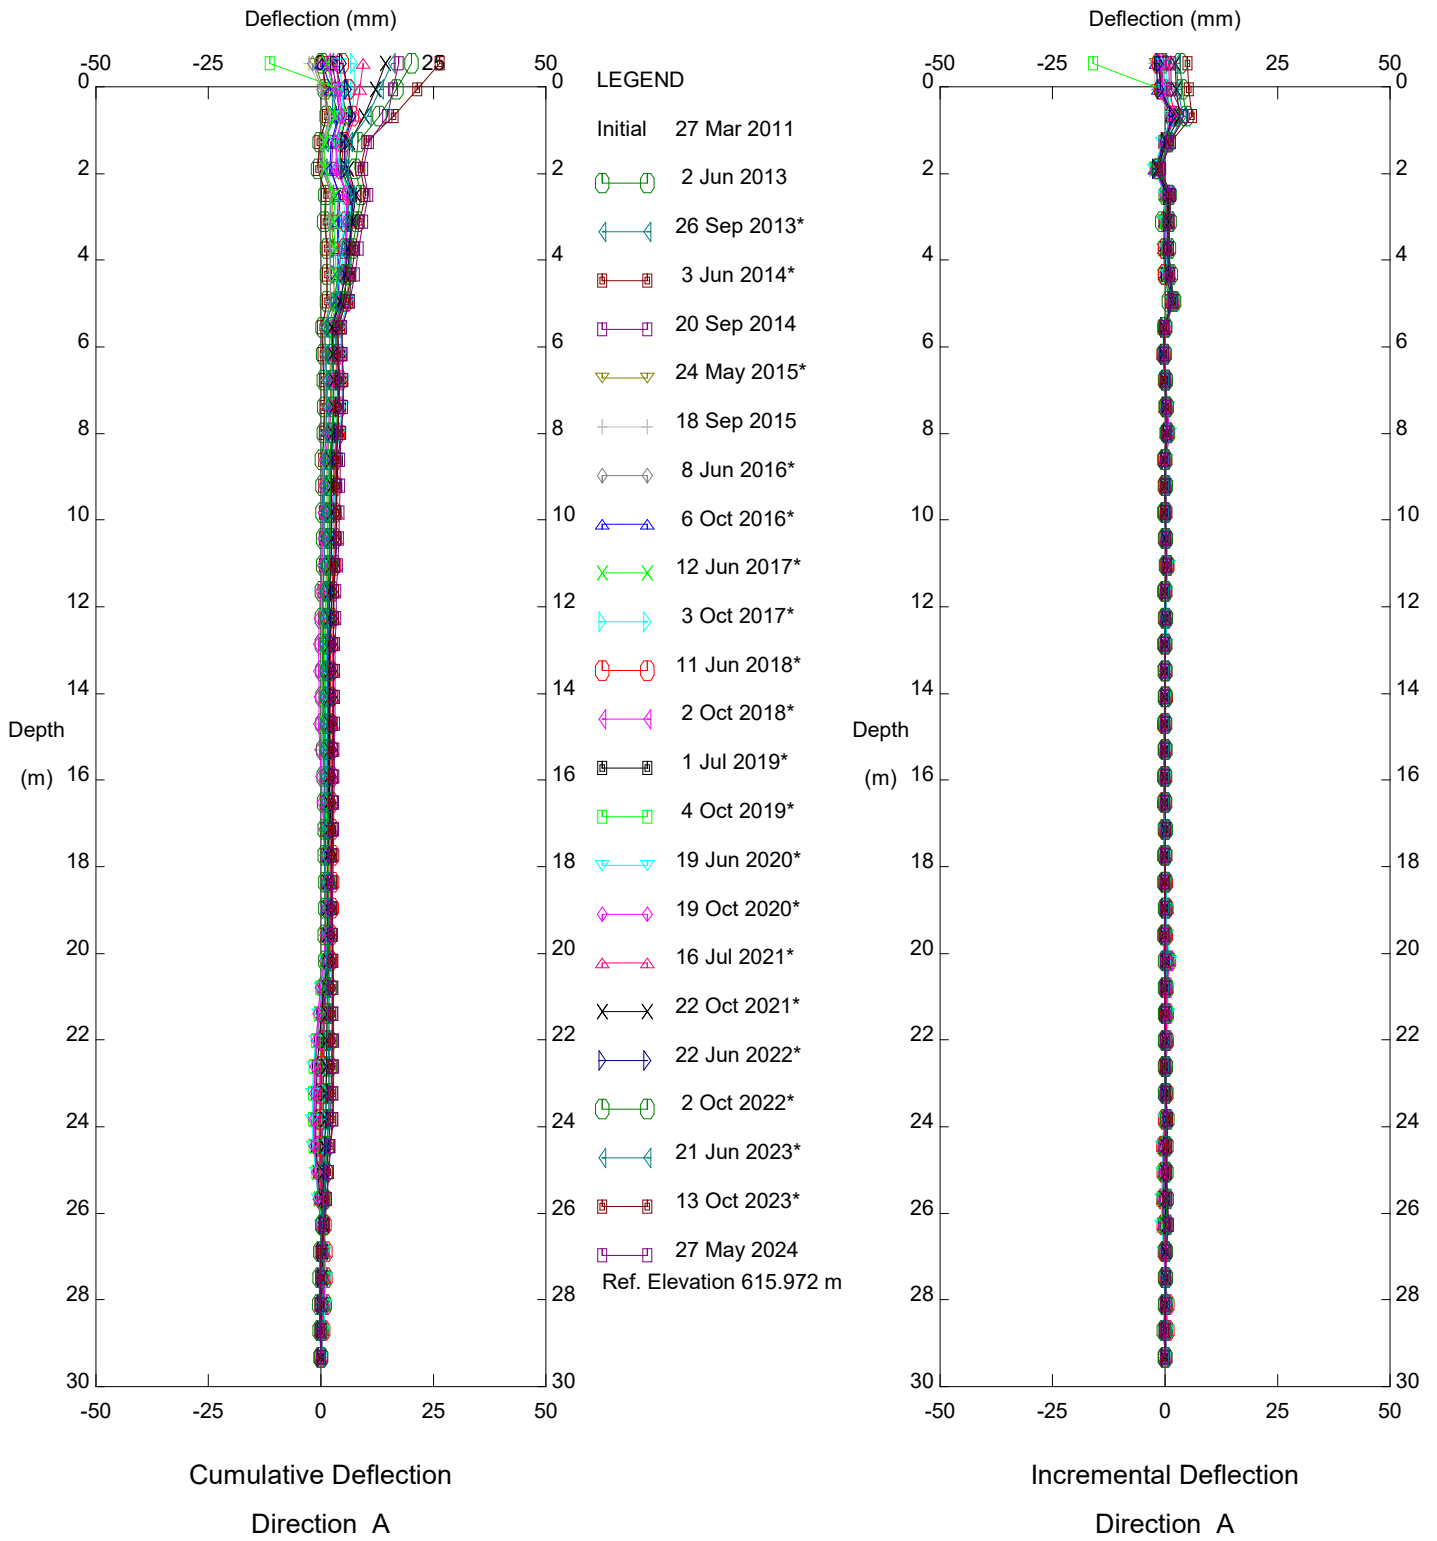
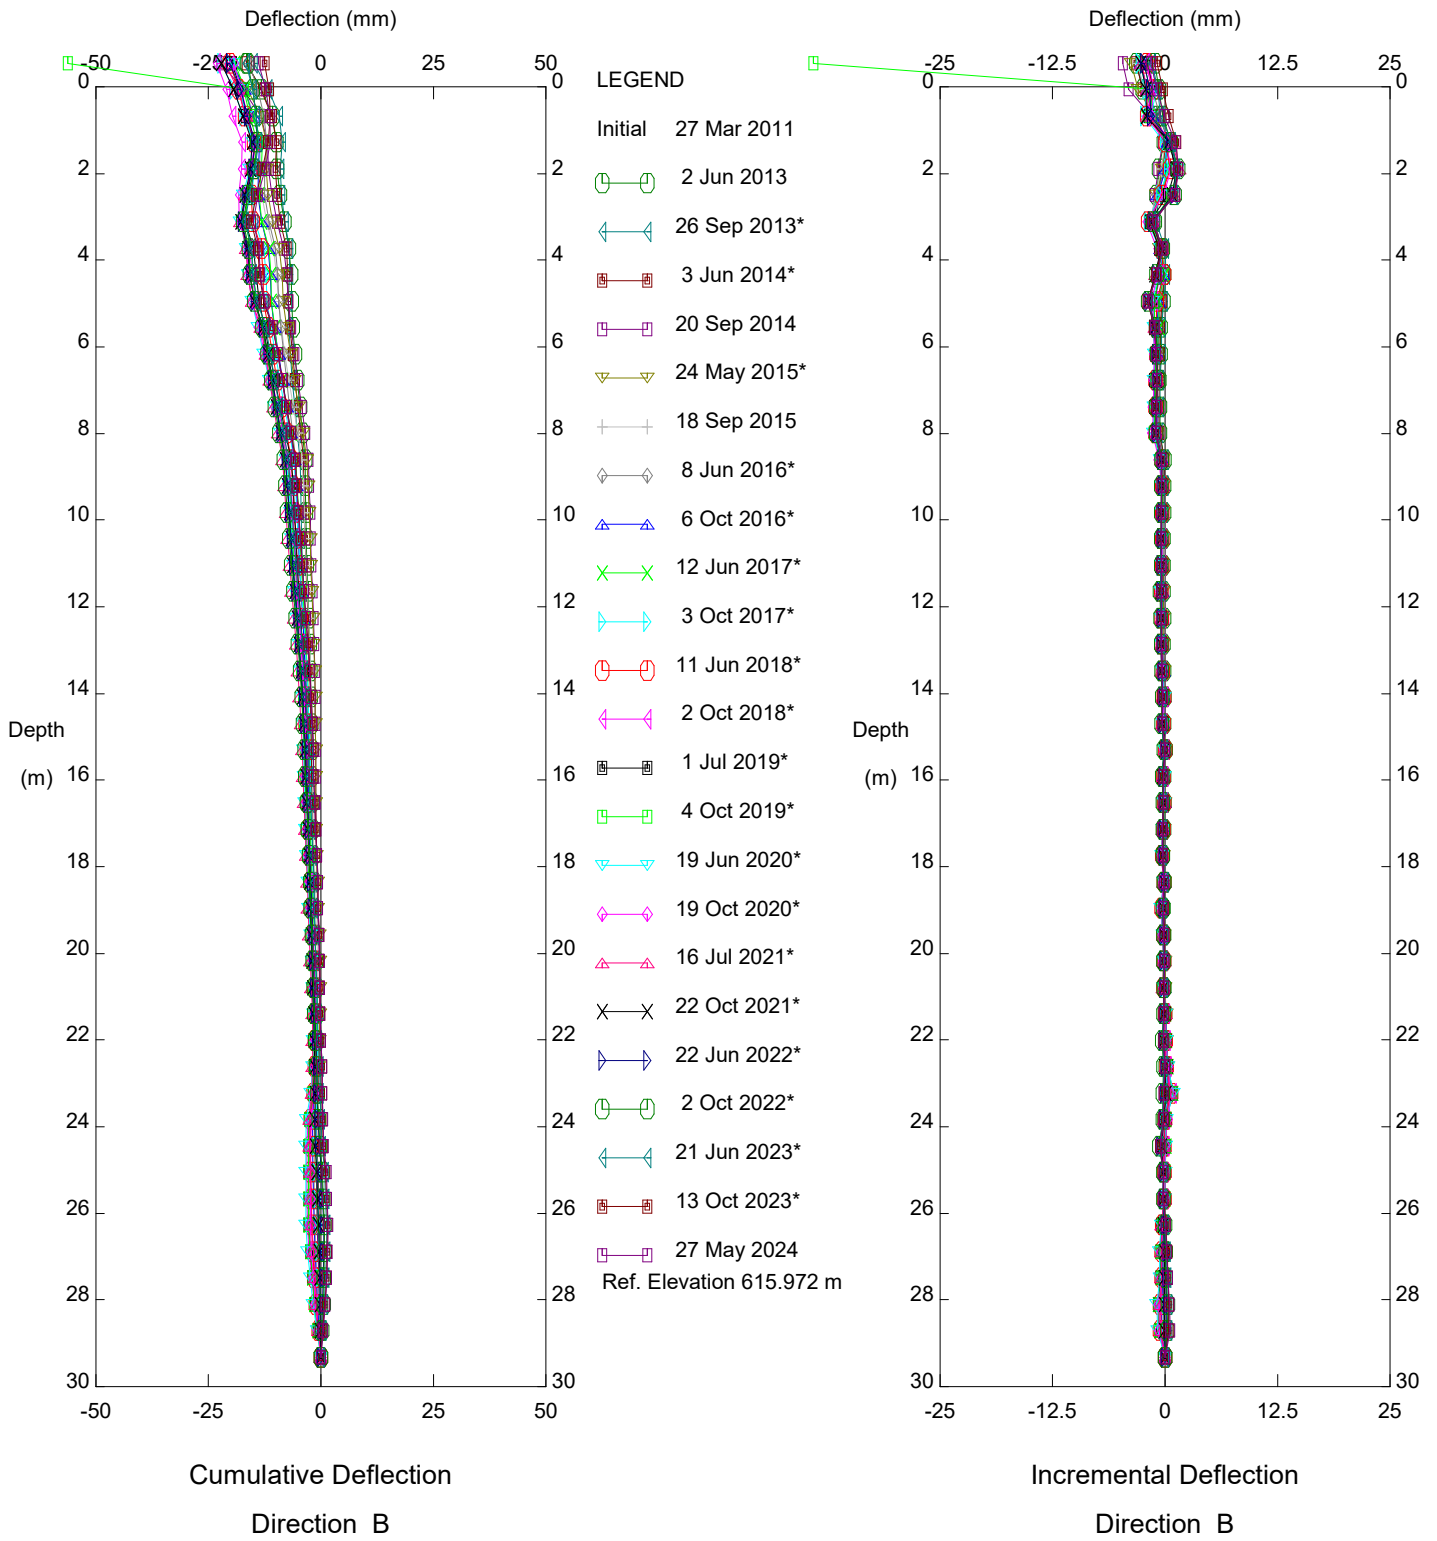
Hwy 726:02 Eureka River, PH026, Inclinometer SI11-4

Discussion	
Zones of New Movement:	None
Interpretation of Monitoring Results:	<p>Slope inclinometer SI11-3 showed a rate of movement of 2.6 mm/yr over 0.5 m to 3.5 m depth since the fall of 2023 readings. This rate of movement has held more or less steady since 2013.</p> <p>SI11-4 continued to show no discernible movement.</p> <p>Slope inclinometers SI12-P9U, SI12-P17U, SI12-P26U were installed in the upper wall.</p> <p>Since the fall of 2023, SI12-P9U has shown barely discernible movement. The total pile head movement to date has been 15.9 mm in the upslope direction of about 2 mm of movement has occurred since 2014.</p>
