**CON0022166 Peace Region
(Grand Prairie – South) GRMP**

GP017 - Hwy 40:34, km 26.7

Call-Out Report

CON0022166 Peace Region (Grande Prairie – South) GRMP
GP017 – Hwy 40:34, km 26.7
Call-Out Report

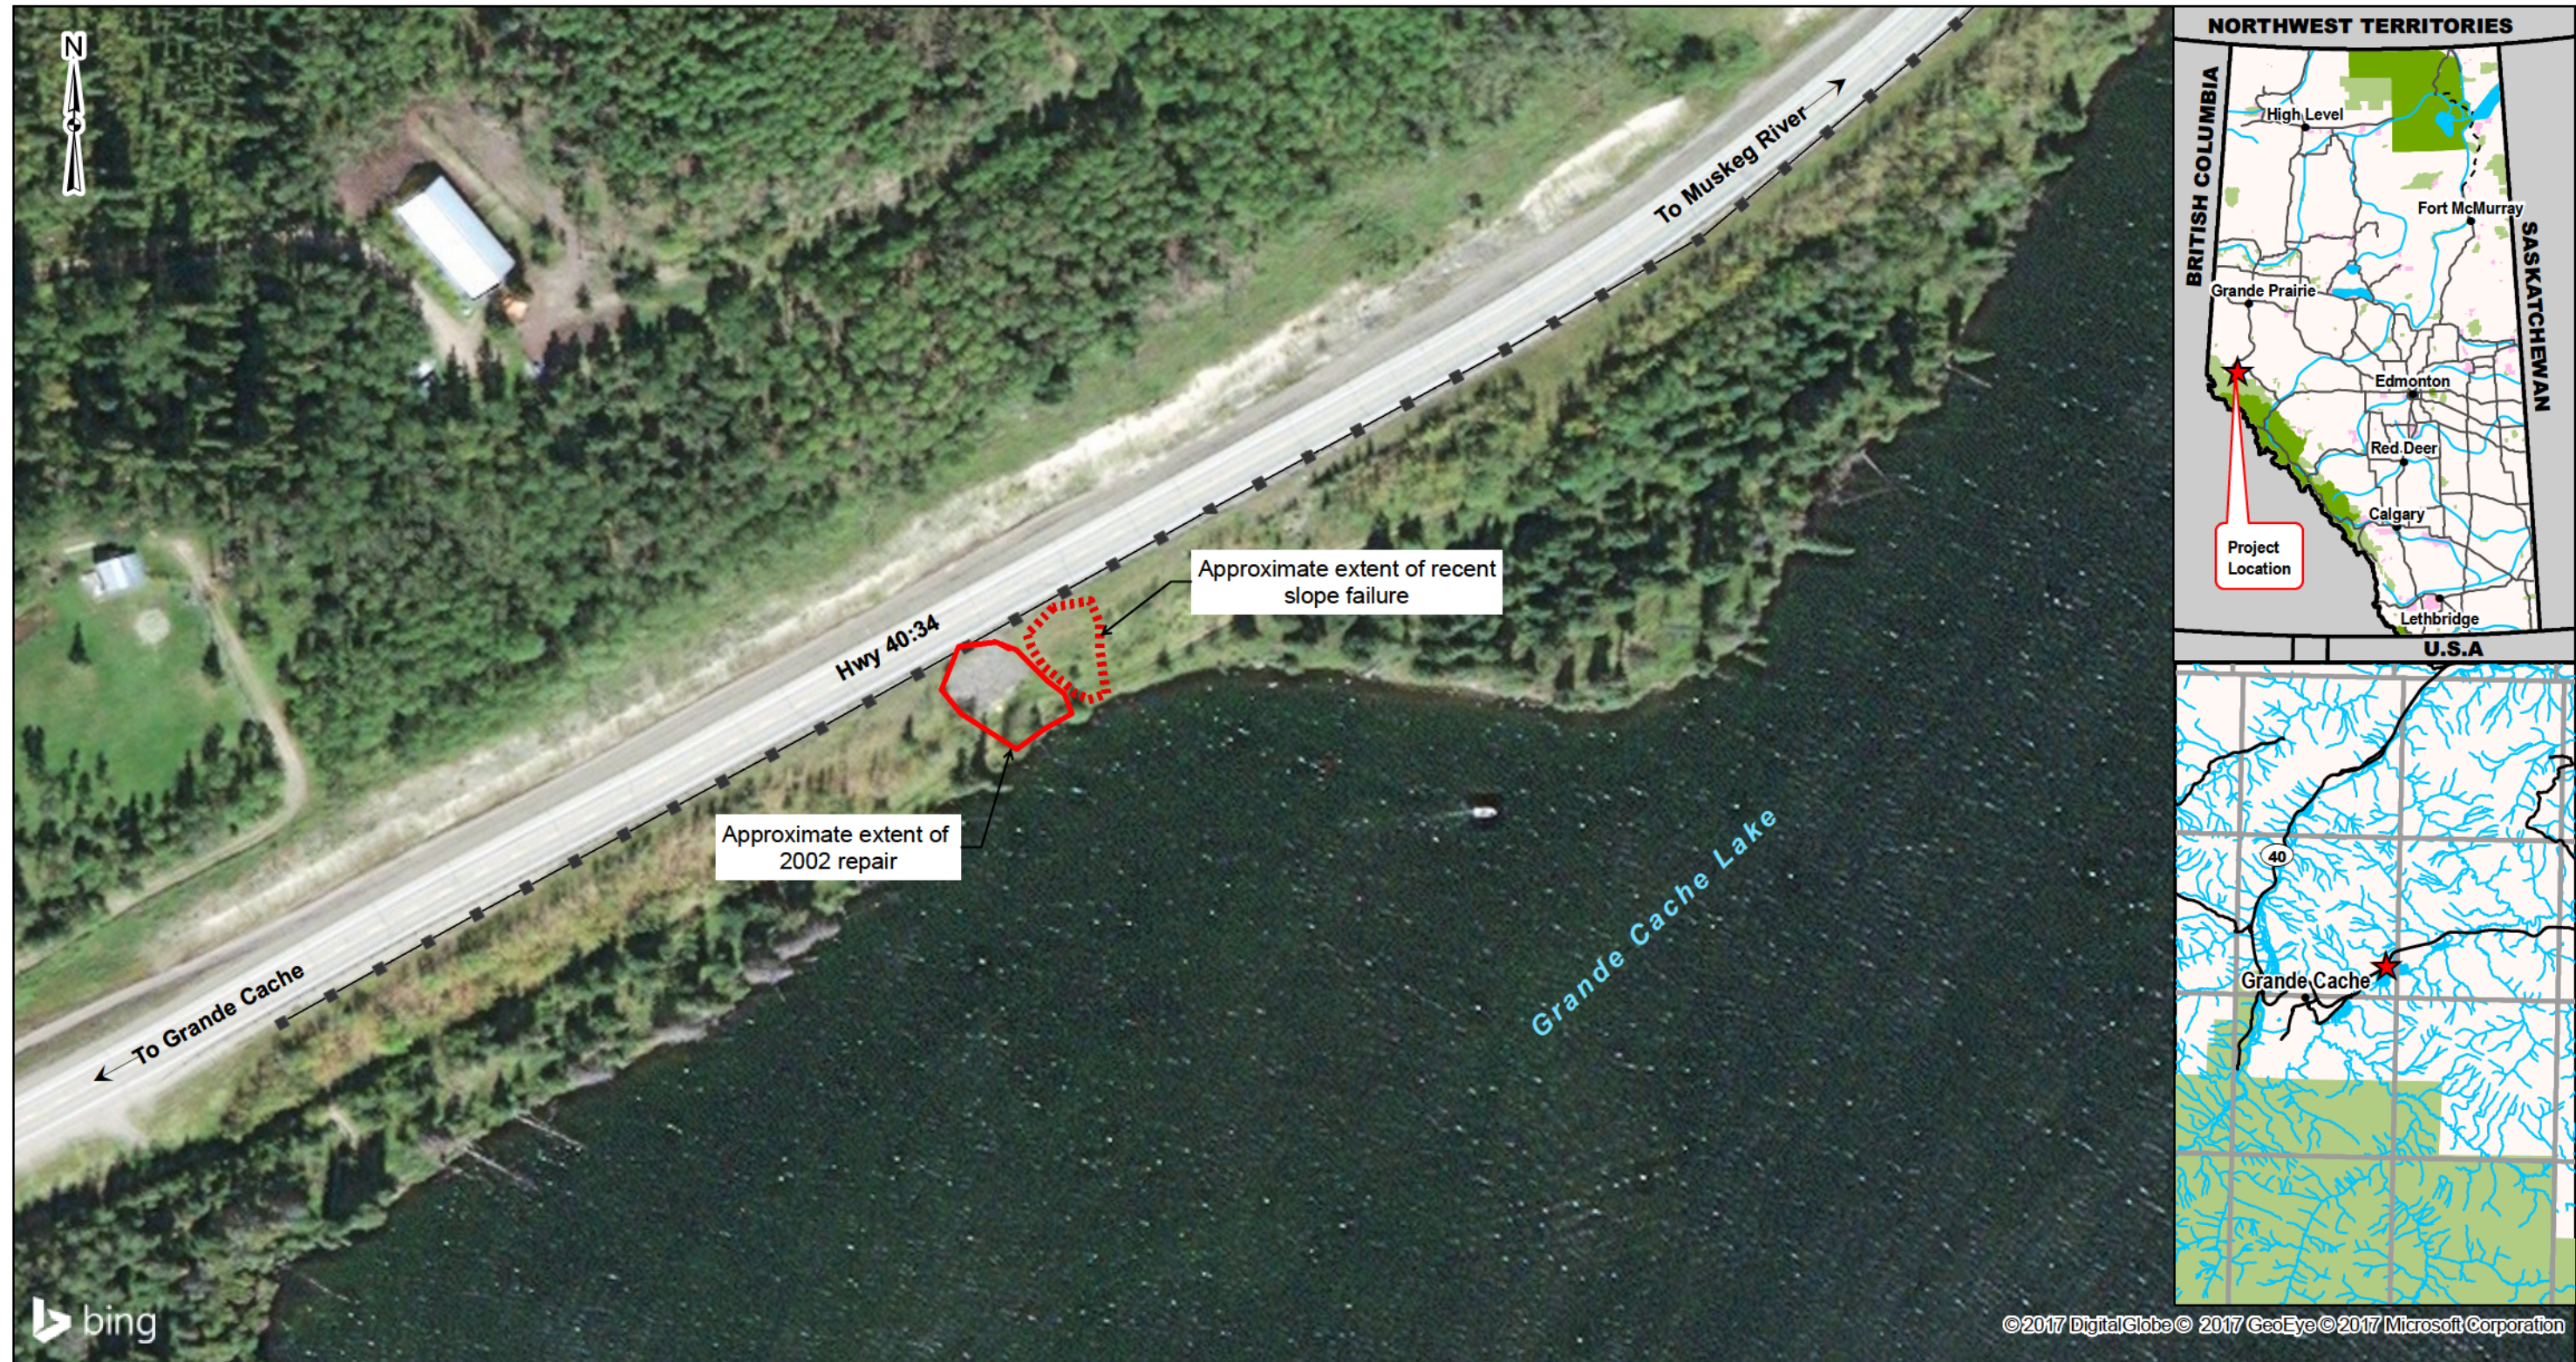
FIGURE

- The slope failure is approximately 15 m wide at the edge of the pavement and 4 to 6 m wide near the gabion wall (the slope failure is wider at top of slope than at bottom, as shown in Photo 2).

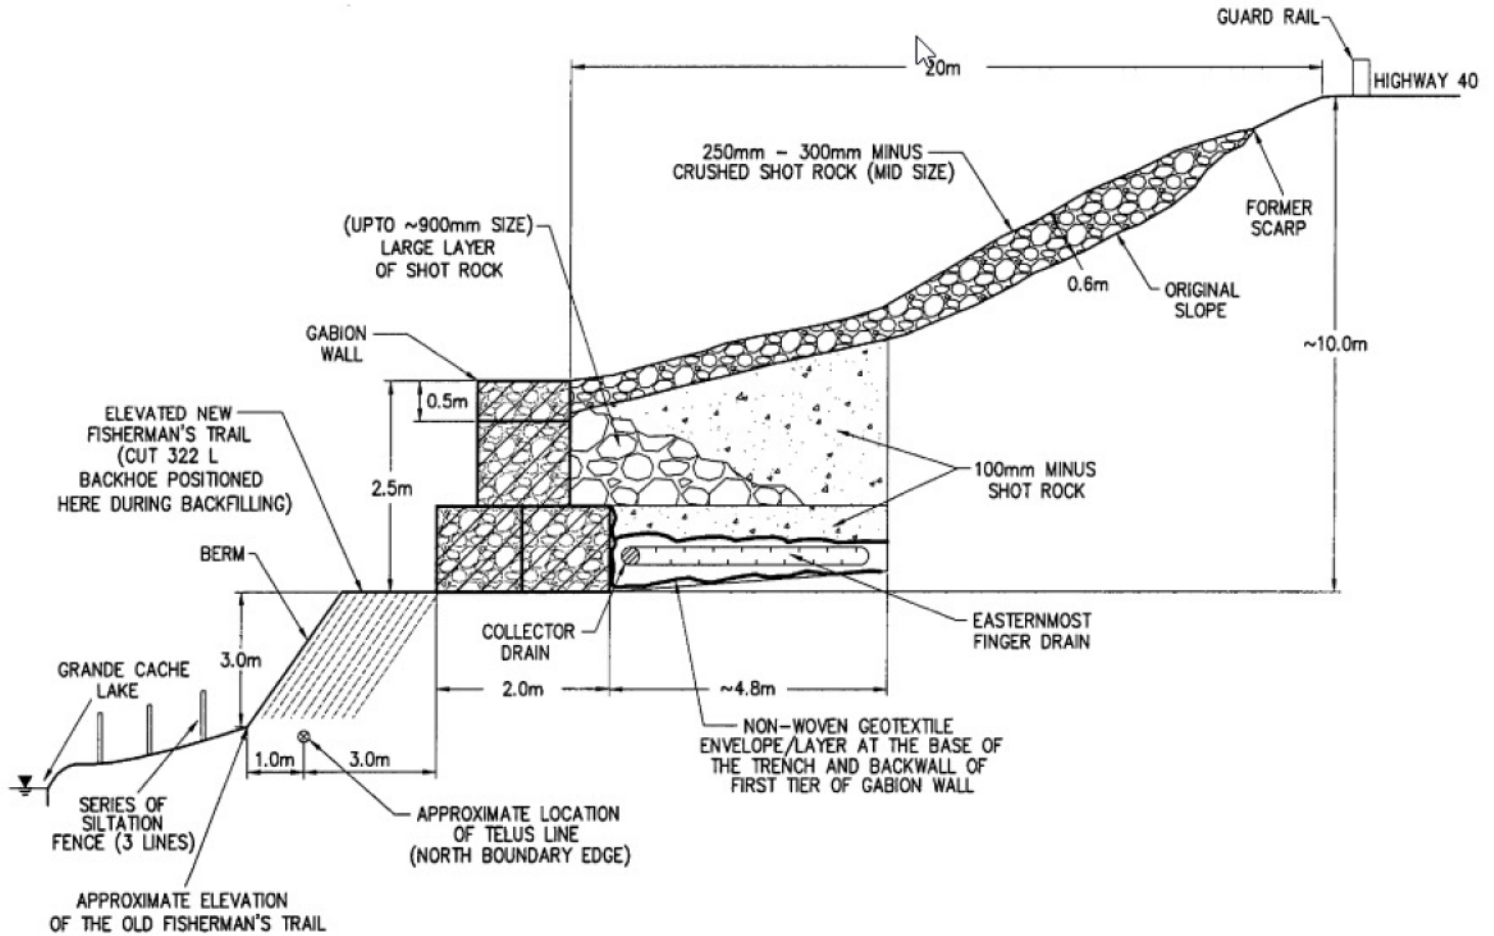
Figure 1
Plan View
As-Built Slope Reconstruction

The 2002 repair work has been successful in stabilizing the original slide. A cross section of the 2002 repair is included in Appendix II.

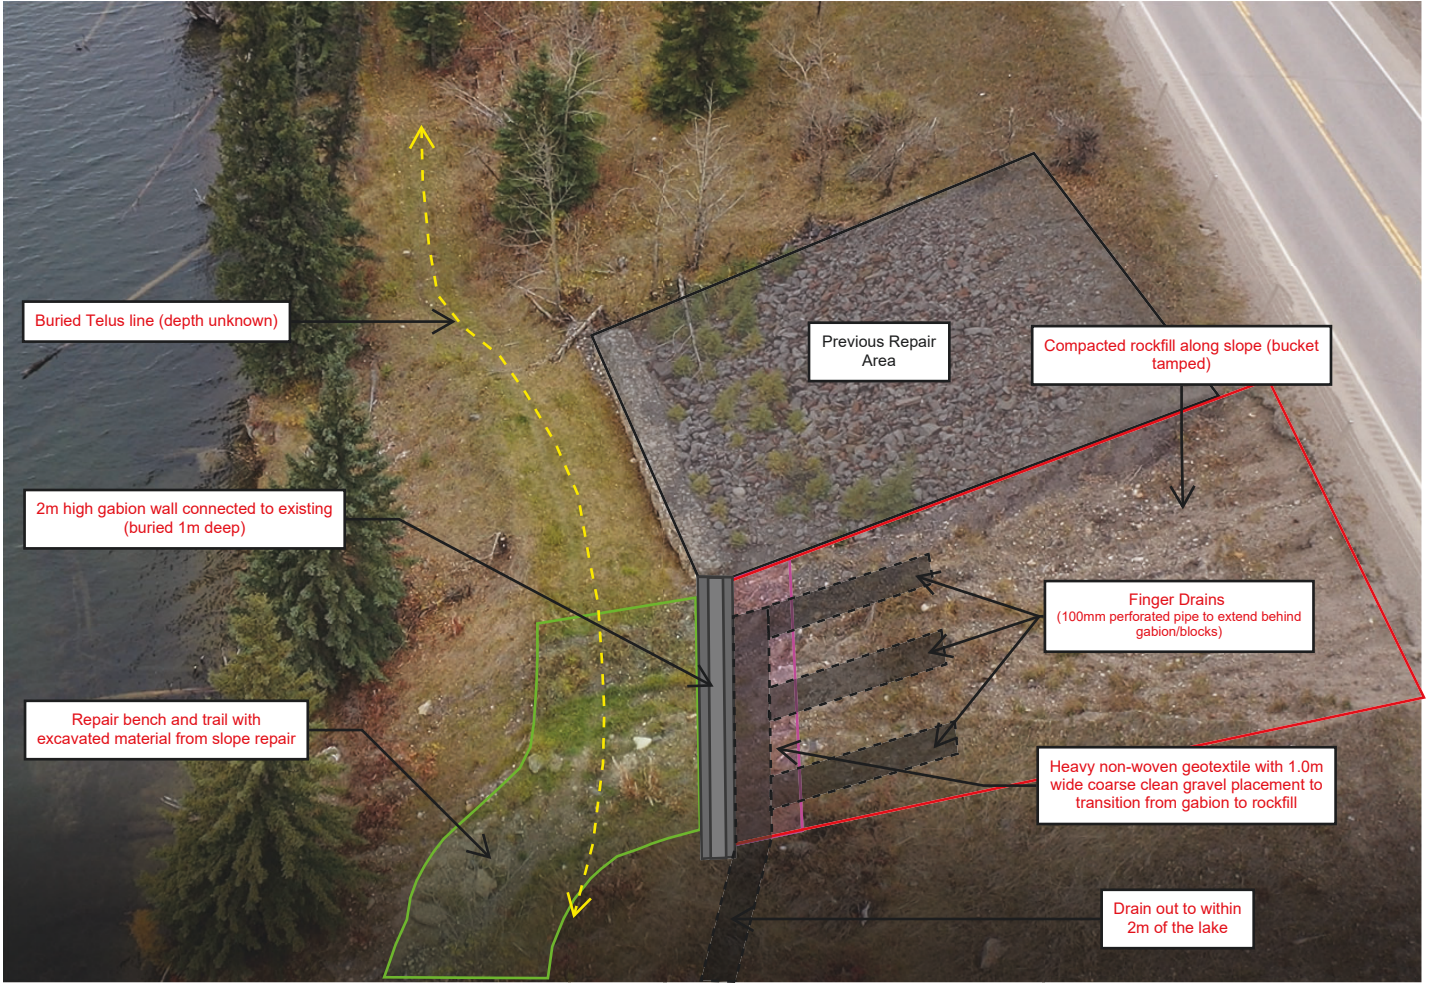
- Sketch made in reference to Figure 1 - Plan View - As-Built Slope Reconstruction from the 2002 EBA Construction Supervision Report for Grande Cache Lake and Hwy 40
- Original embankment slope estimated based on field observation
