**ALBERTA TRANSPORTATION  
GEOHAZARD ASSESSMENT PROGRAM  
PEACE REGION – GRANDE PRAIRIE DISTRICT  
2020 CALL OUT**

<b>Site Number</b>	<b>Location</b>	<b>Name</b>	<b>Hwy</b>	<b>km</b>
Call Out	W of Grande Cache	Backslope Mudflows	40:34	35.0
<b>Legal Description</b>		<b>UTM Co-ordinates (NAD 83)</b>		
Km 35.0: SE32-56-8-W6		11U N 5,973,287	E 358,670

**PEACE REGION (GRANDE PRAIRIE)  
CALLOUT: HWY 40:34 km 35**

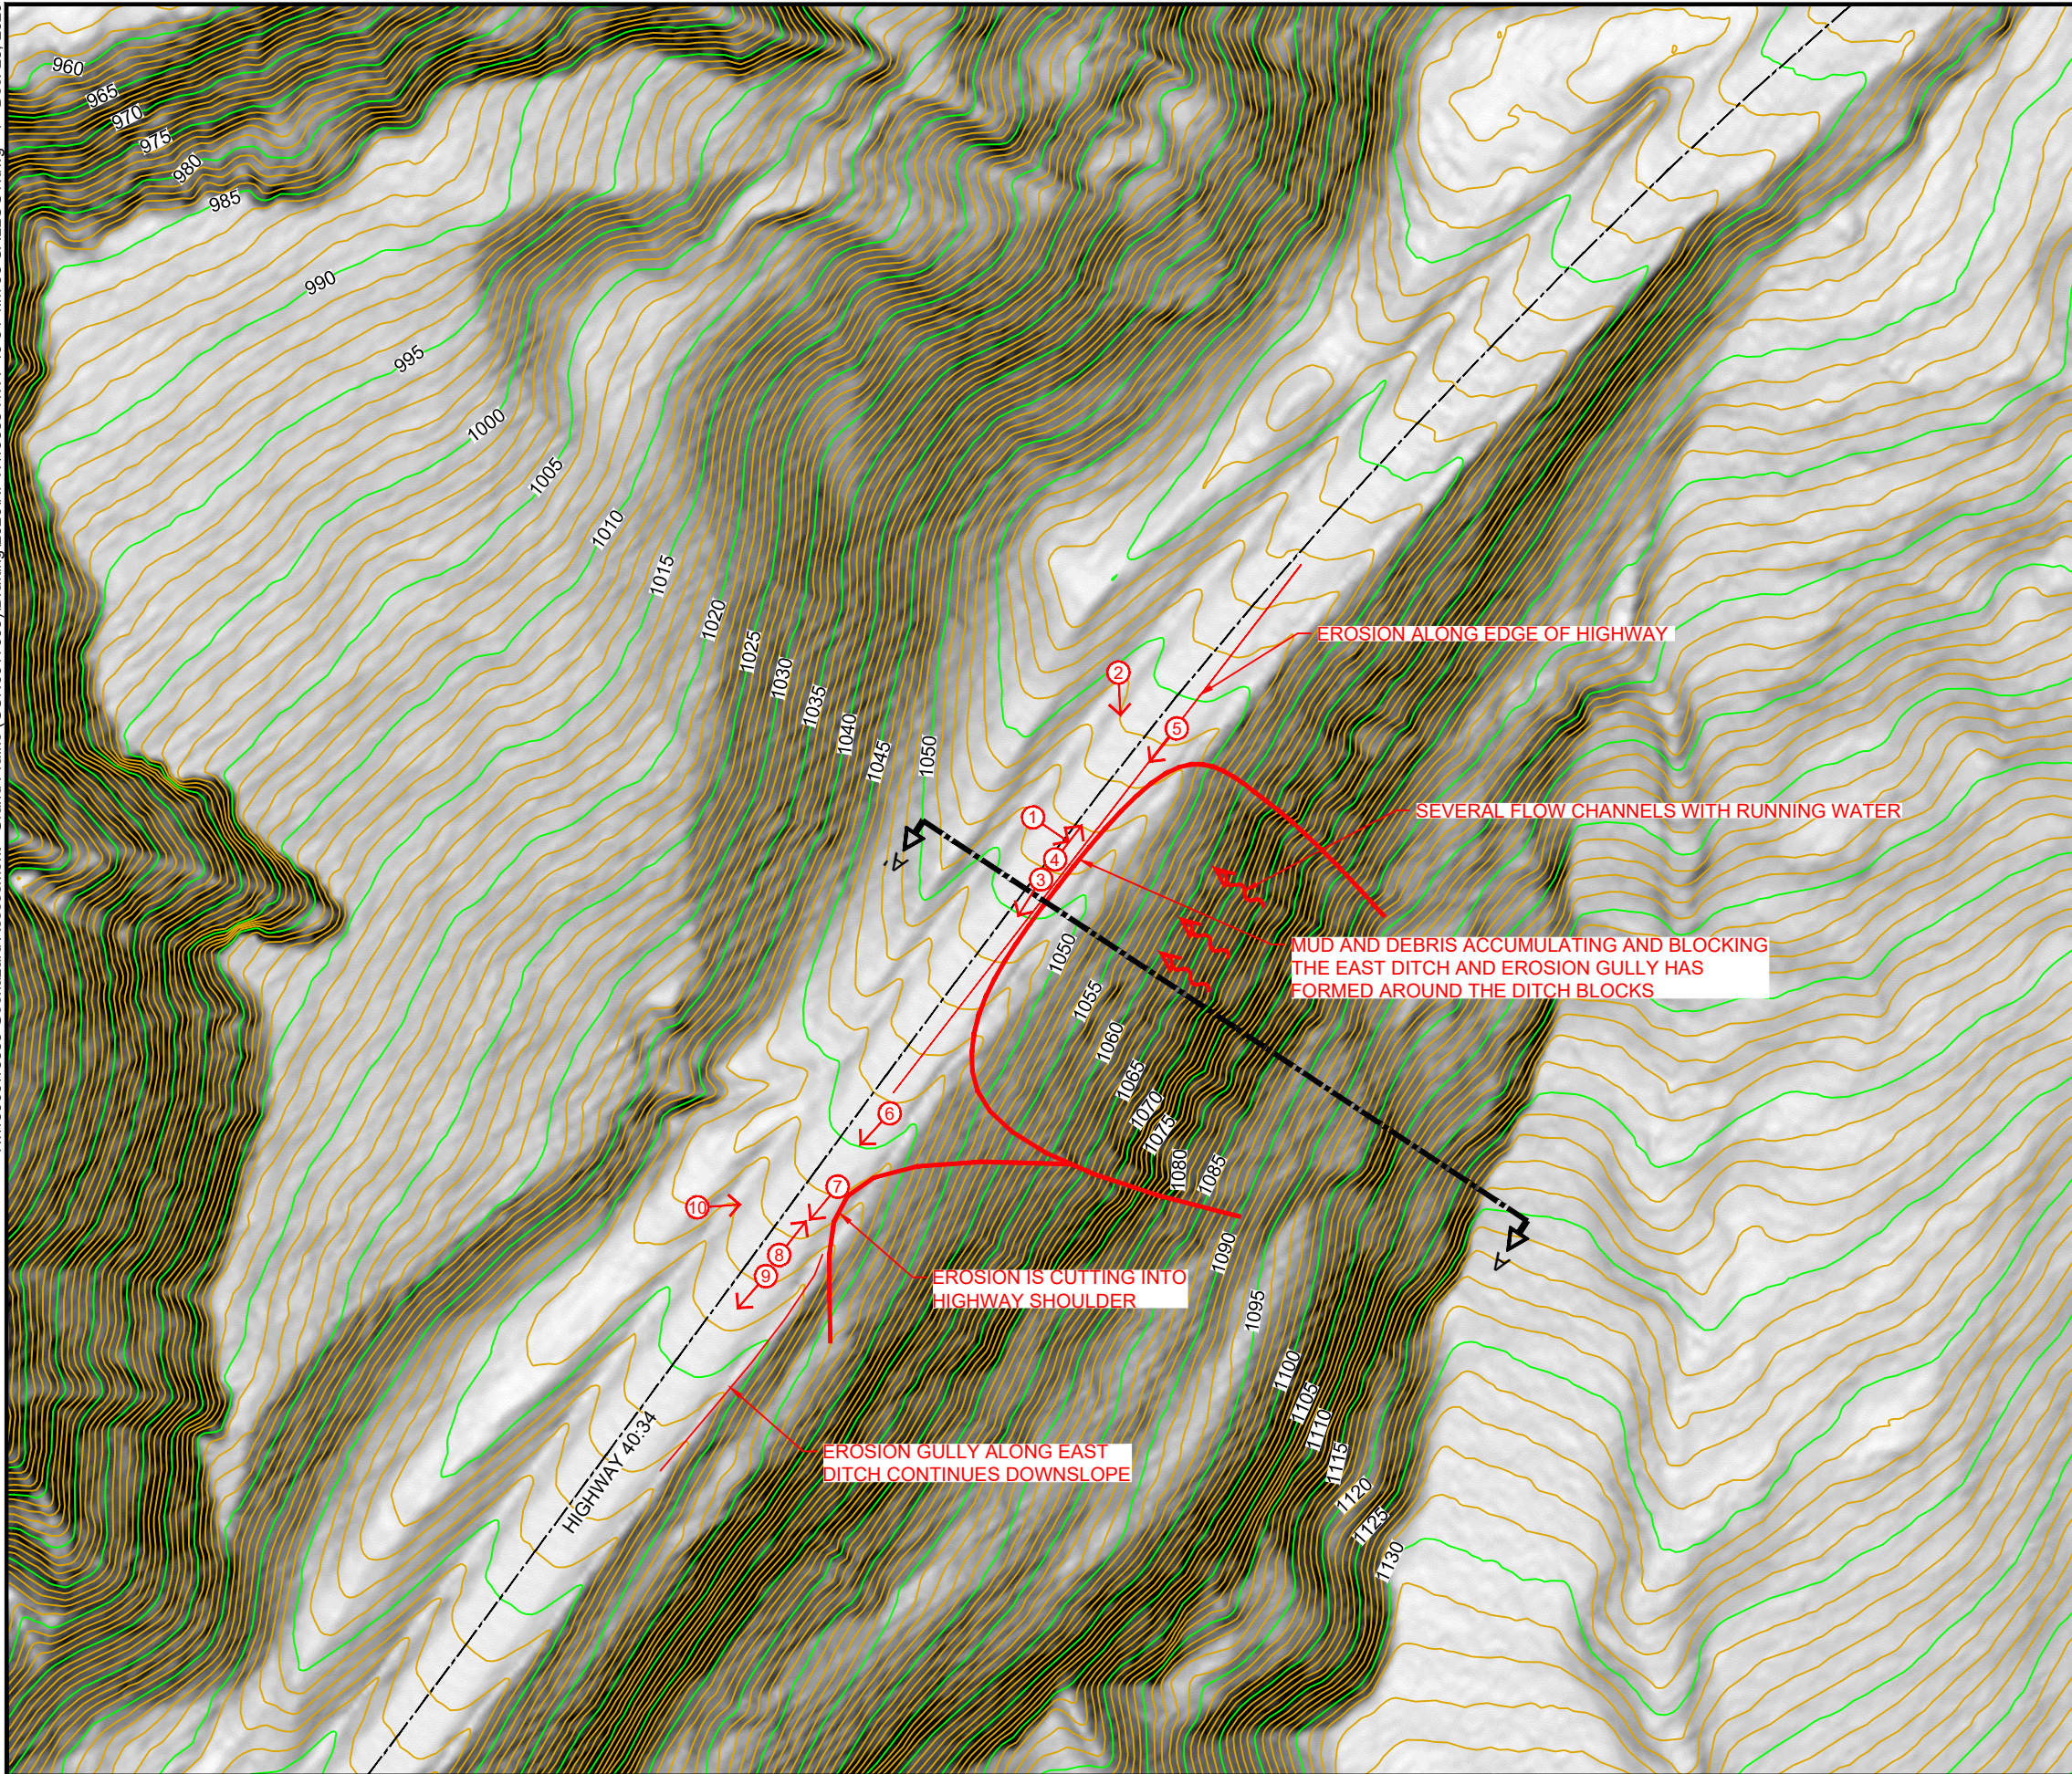
**DWG No. 13353-HWY 40:34-1**

<b>Primary Site Issue:</b>	A high and steep backslope is being affected by shallow landslides/mudflows that are accumulating and blocking the east highway ditch.	
<b>Dimensions:</b>	Debris/mud and water accumulation in the east ditch is about 175 m in length. The highway backslope cut is about 40 m high in a 70 m high valley slope.	
<b>Date of any remediation:</b>		
<b>Maintenance:</b>		
<b>Observations:</b>	<b>Description</b>	<b>Worse?</b>
<input checked="" type="checkbox"/> Pavement Distress	Ditch erosion is starting to affect the edge of pavement.	<input type="checkbox"/>
<input checked="" type="checkbox"/> Slope Movement	Several active shallow landslides/mudslides are moving down the backslope and are accumulating in the highway ditch.	<input type="checkbox"/>
<input checked="" type="checkbox"/> Erosion	Backslope erosion and surficial slumping has occurred and continues to as water was actively flowing down the face and eroding sediments. An erosion gully exists in the east ditch which is eroding the highway shoulder.	<input type="checkbox"/>

<input checked="" type="checkbox"/> Seepage	Water was also observed trickling down the backslope at several different runoff channels. Water was running along the ditch erosion as well.	<input type="checkbox"/>
<input type="checkbox"/> Bridge/Culvert Distress		<input type="checkbox"/>
<input type="checkbox"/> Other		<input type="checkbox"/>
<b>Instrumentation:</b> None		
<b>Assessment:</b>		
<p>The mud flows are likely due to saturation and softening of the slope surface by heavy rainfall combined with runoff coming down the slope. The backslope is high (40 m) and steep (1.3H:1V). Changes in surface soil moisture content and strength will result in these shallow types of landslides. It is possible that overland flow is also flowing over the crest of the 70 m high natural slope.</p> <p>The debris accumulation existing in the east ditch was generally fan shaped and progressively finer material has been deposited towards the lower end extremities and extended over a length of about 175 m. The mud/debris accumulation in the east ditch has forced runoff around the west edge of the debris and up against the edge of the highway shoulder and has now cut into the highway shoulder. Additional</p>

sloughing of material should be expected as the runoff channels were flowing during our inspection and will likely continue to bring sediments downslope especially during precipitation events.

The short-term recommendation is to remove the built-up debris as noted above and dispose of it in stable areas outside the valley. Also repair any damaged road sideslopes or ditch erosion (using gravel and soil coverings).
