**ALBERTA TRANSPORTATION AND  
ECONOMIC CORRIDORS GRMP  
GRANDE PRAIRIE REGION –  
(GRANDE PRAIRIE SOUTH)  
INSTRUMENTATION MONITORING - SPRING 2024**

Site Number	Location	Name	Hwy	km
GP042	HWY 40:36	GP042 Landslide Repairs	40:36	Km 37.4 to 38.2
<b>Legal Description:</b> 15-16-59-6 W6		<b>UTM Co-ordinates</b>		
		11U E 379994	N	5997080

<b>Current Monitoring:</b>	30-May-2024	<b>Previous Monitoring</b>	27-Jun-2023
<b>Instruments Read By:</b>	Mr. Niraj Regmi, G.I.T and Mr. Nixson Mationg, of Thurber		
<b>Instruments Read During This Site Visit</b>			
<b>Slope Inclinometers (SIs):</b> SI22-W2, SI22-W3, SI22-W4, SI22-W5, SI22-W6, SI22-W7	<b>Pneumatic Piezometers (PN):</b> N/A	<b>Vibrating Wire Piezometers (VW):</b> VW20-S1, VW20-S3, VW20-DS1A, VW20-DS1B, VW20-DS2A, VW20-DS2B, VW20-DS3, VW20-DS6A, VW20-D3, VW20-D4	<b>Standpipe Piezometers (SP):</b> N/A
<b>Load Cell (LC):</b> N/A	<b>Strain Gauges:</b> N/A	<b>SAA:</b> SAA22-P15	<b>Others:</b>

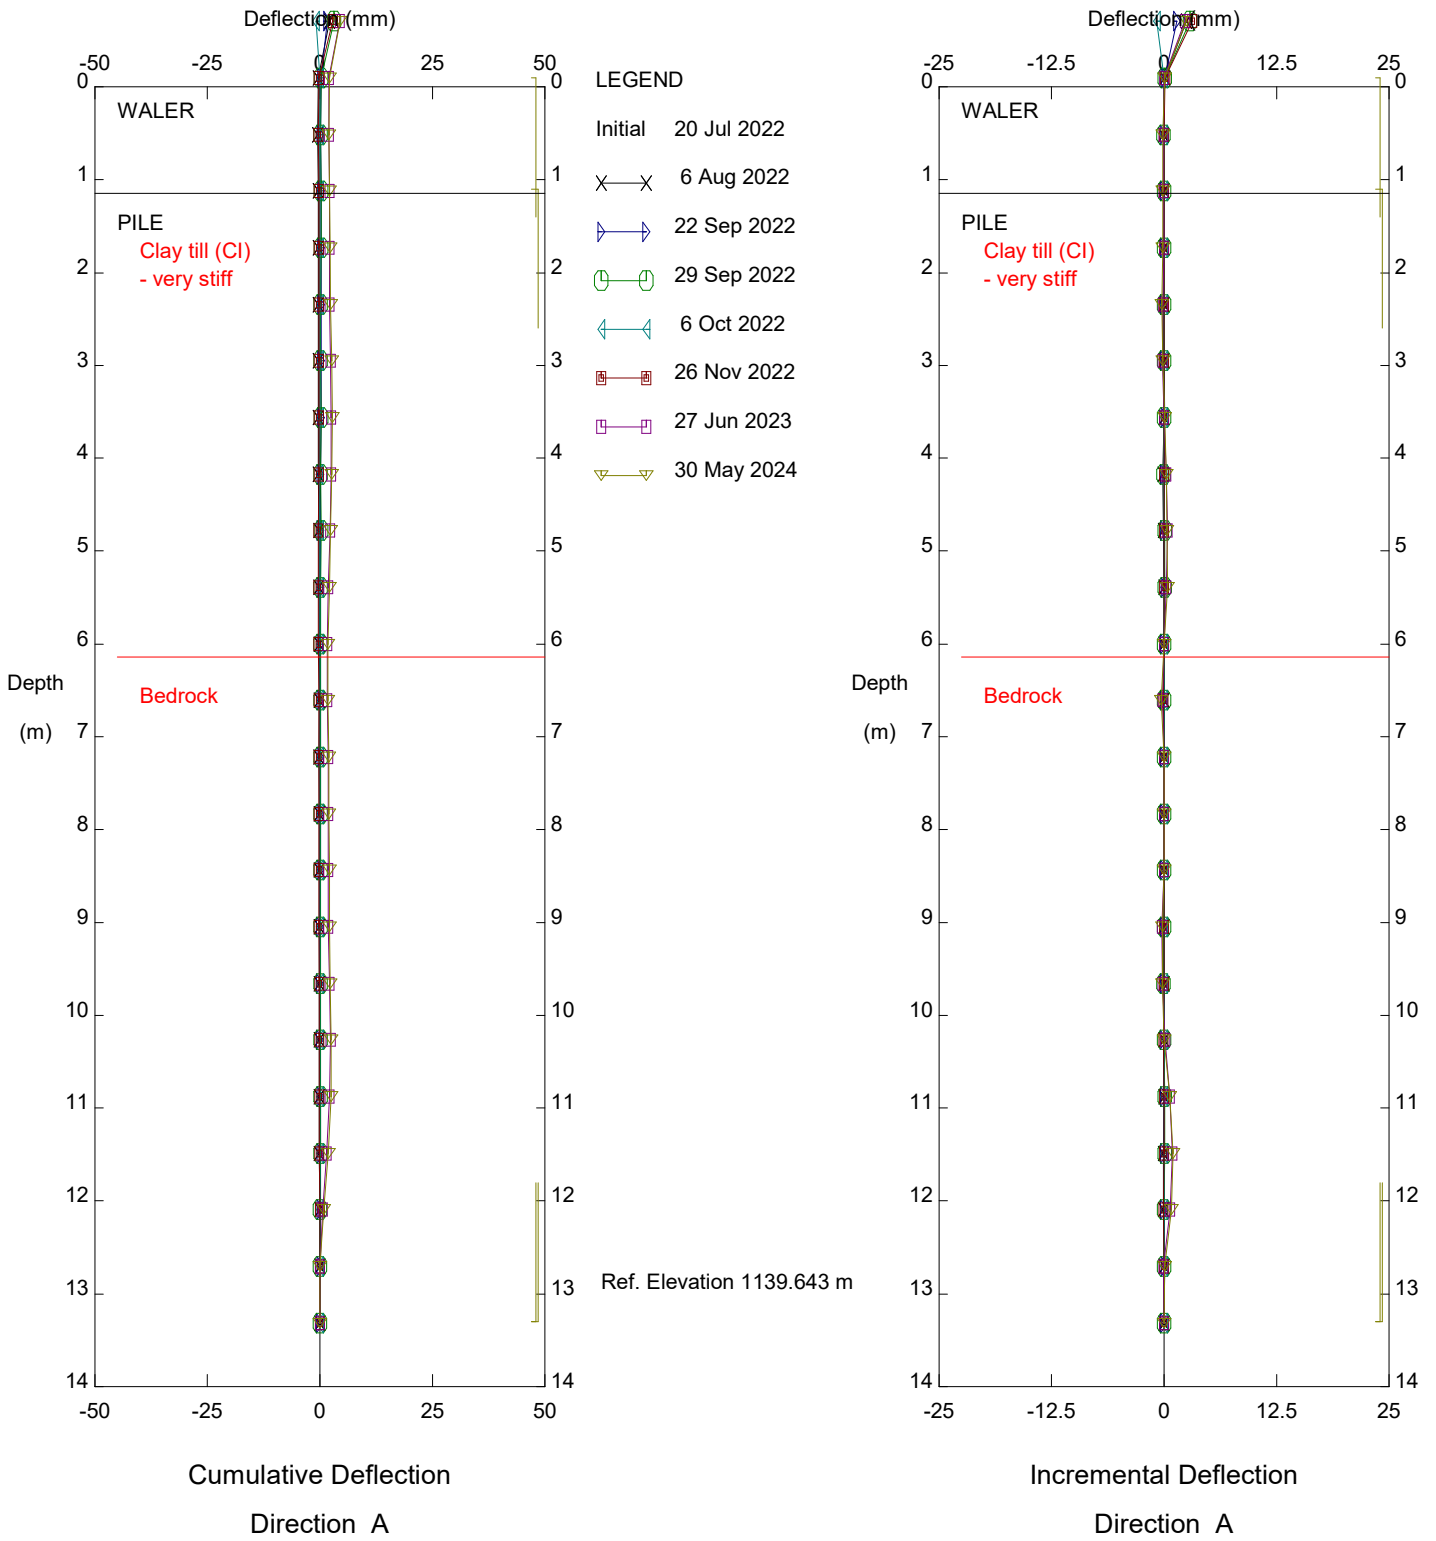
GP042 Slope Stabilization, Inclinator SI22-W3

<b>Discussion</b>	
<b>Zones of New Movement:</b>	None
<b>Interpretation of Monitoring Results:</b>	<p>SI22-W2 and SI22-W3, installed in Pile Wall 1, show total cumulative pile head movements of 3.2 mm and 1.6 mm, respectively, in the upslope direction. The upslope movements measured in these instruments likely reflects the effect of locking off the anchors.</p> <p>SI22-W4, SI22-W5 and SI22-W6, installed in Pile Wall 2, show total cumulative pile head movements of 0.2 mm, 4.3 mm and 7.0 mm, respectively, in the downslope direction. These instruments show current movement rates over the piles ranging between no discernible movement in SI22-W4 to 3.5 mm/yr in SI22-W6.</p> <p>SI22-W7 in Pile Wall 3 shows a total cumulative pile head movement of 1.9 mm in the downslope direction. The current rate of movement in SI22-W7 is 1.5 mm/yr, corresponding to an increase in rate of movement of 3.4 mm/yr since the previous readings on June 27, 2023.</p> <p>SAA22-P15 has shown a cumulative movement of 0.4 mm in the upslope direction over the length of the pile since it was initialized. SAA22-P15 showed no discernible movement since the previous readings on June 27, 2023. SAA22-P15 showed a trend of higher cumulative movement during the 2023 to 2024 winter months, before returning to a similar cumulative movement as spring 2023.</p>

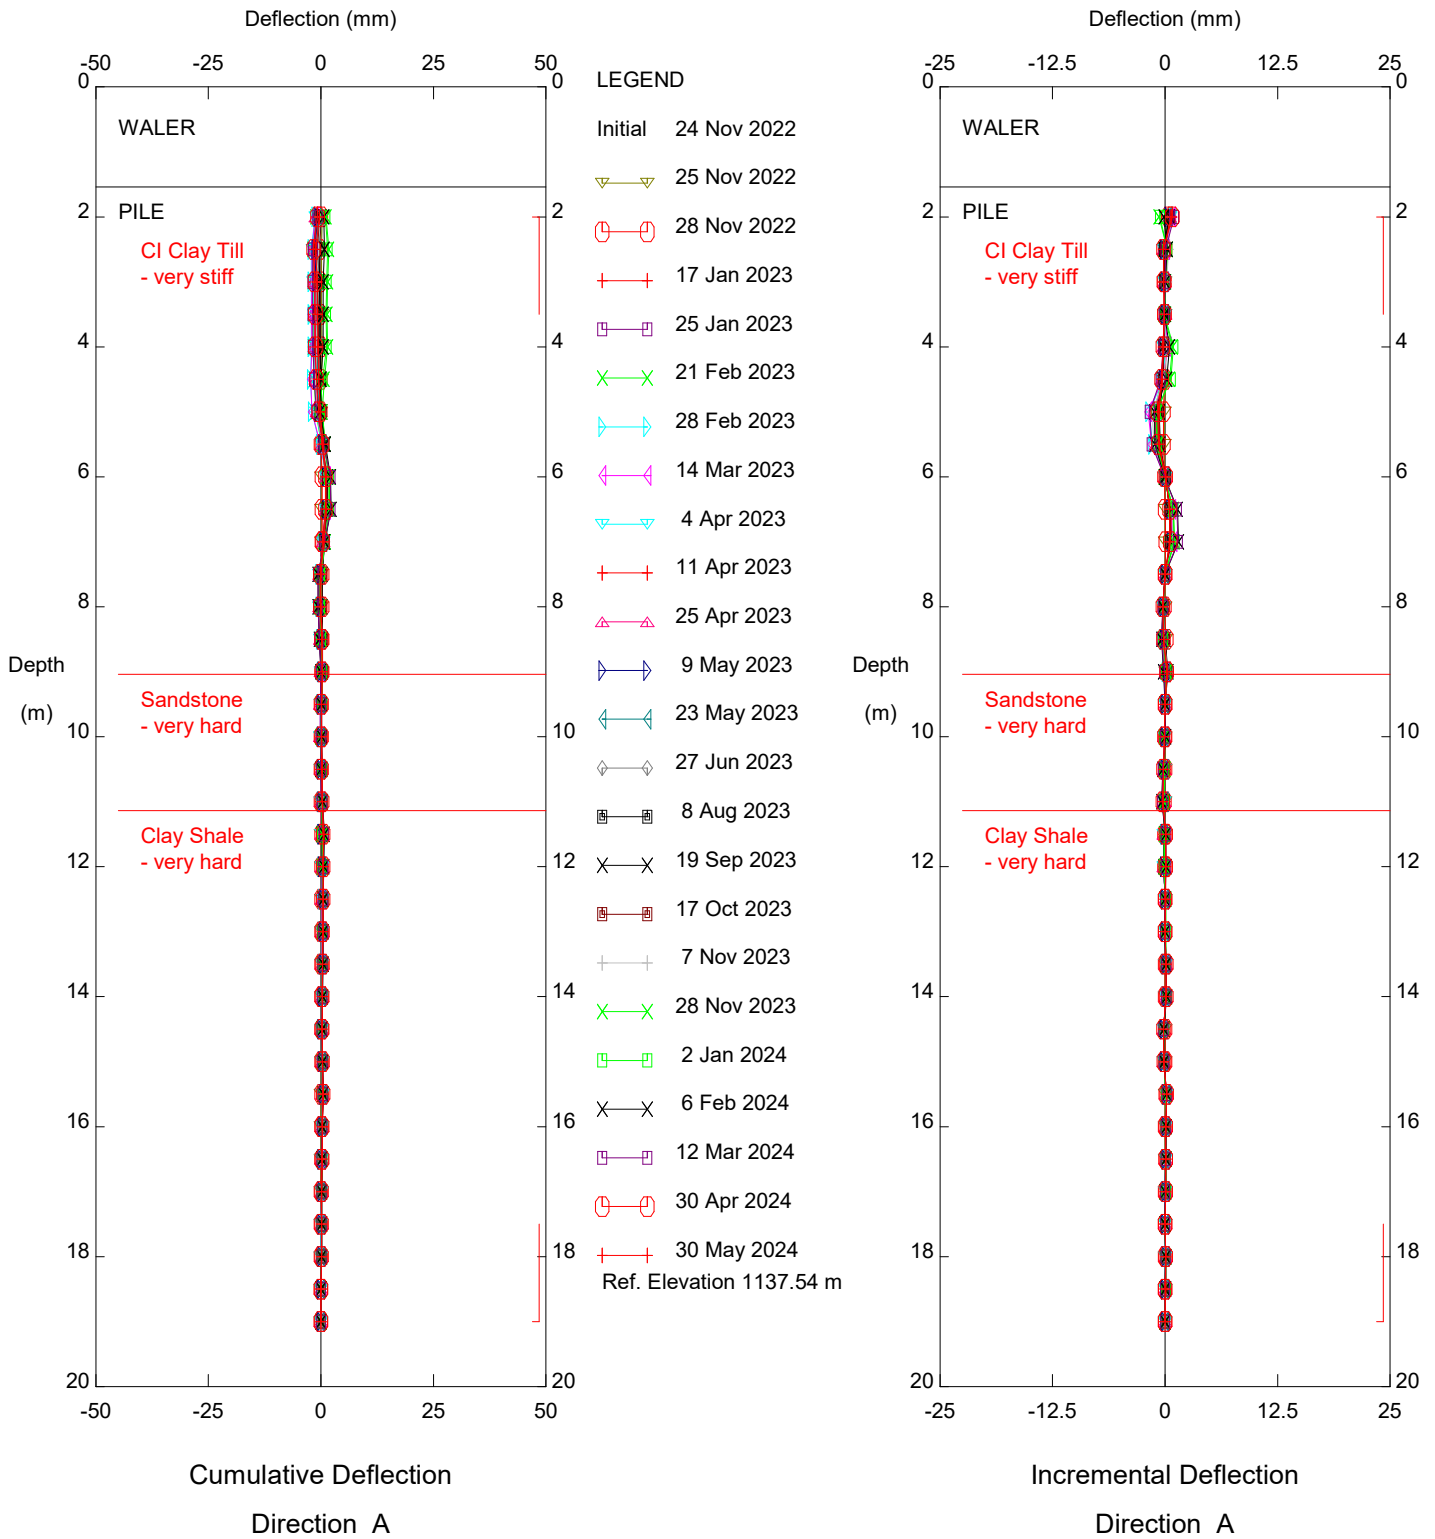
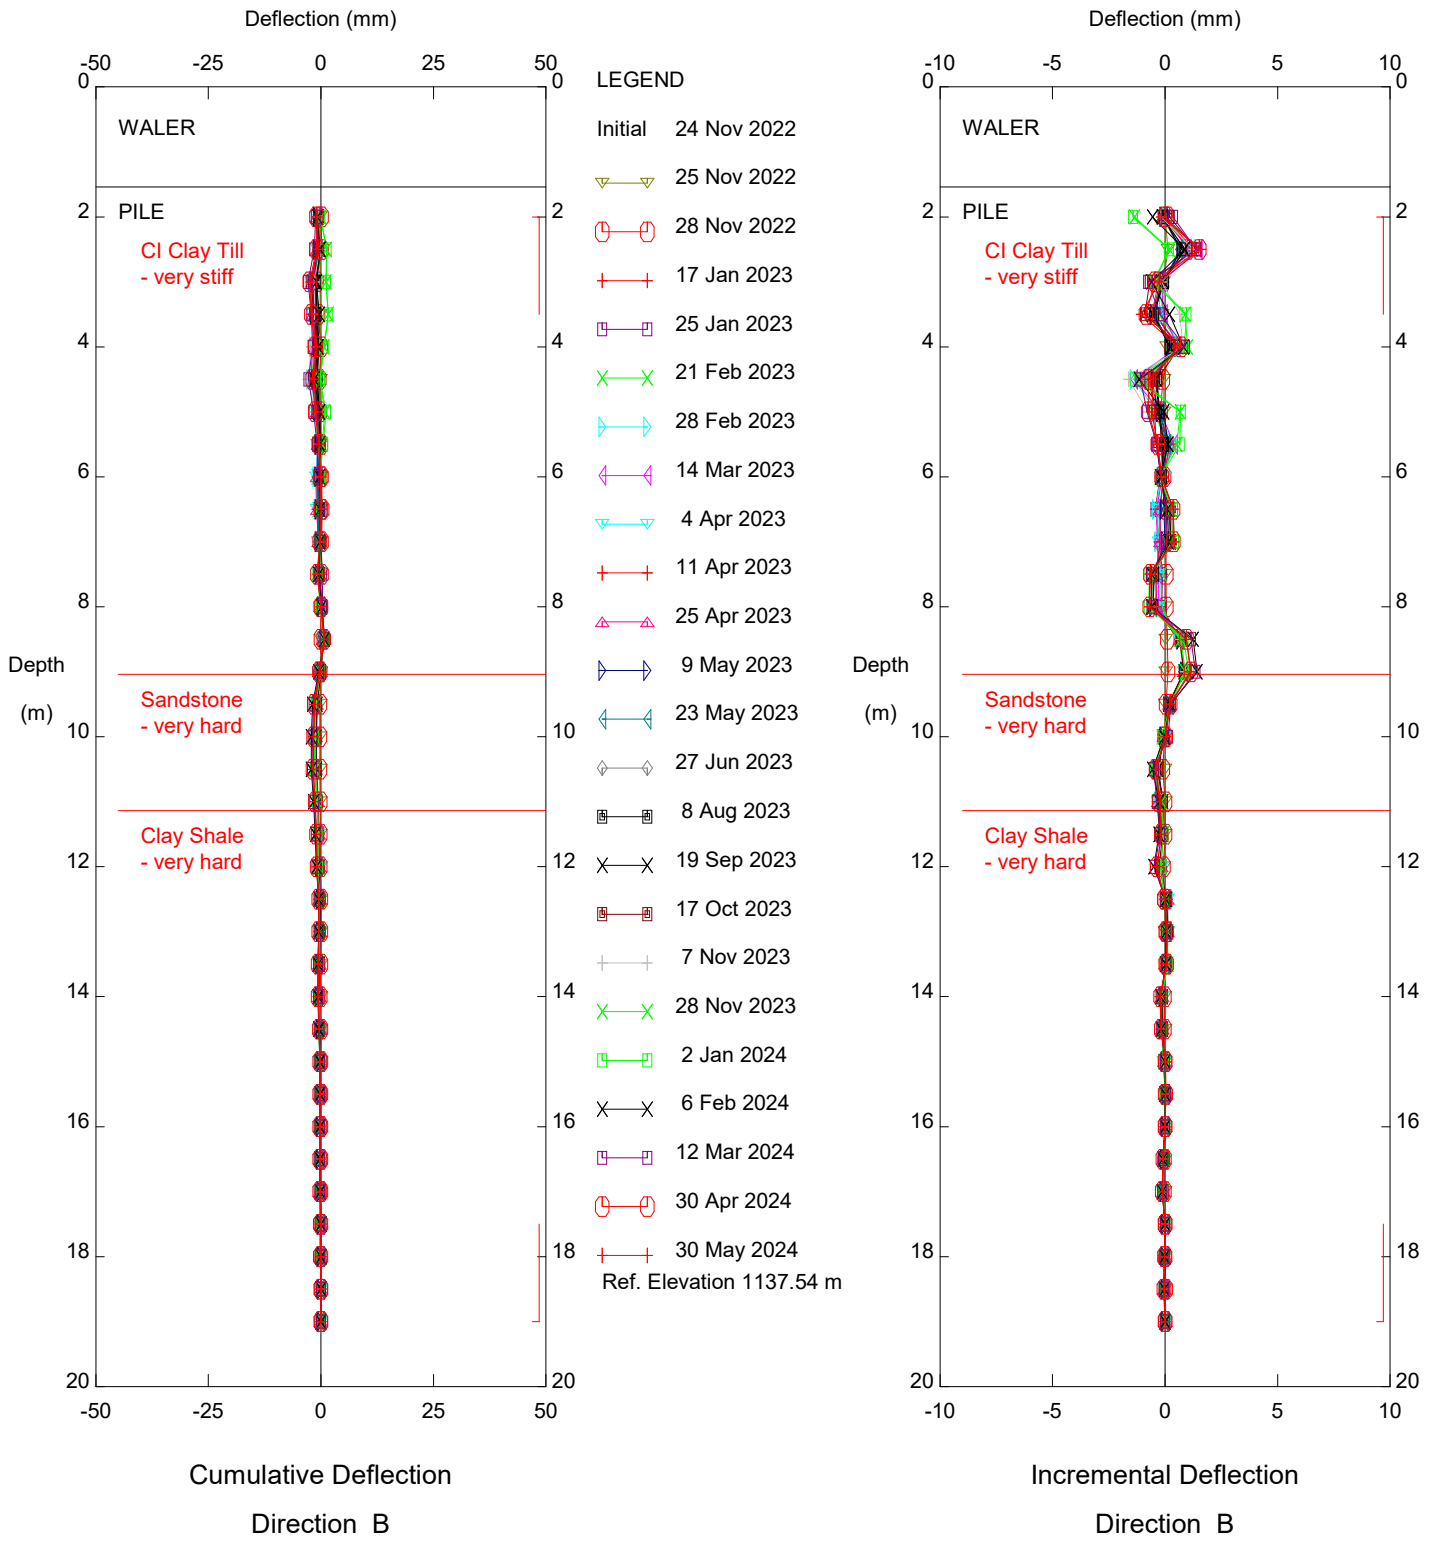
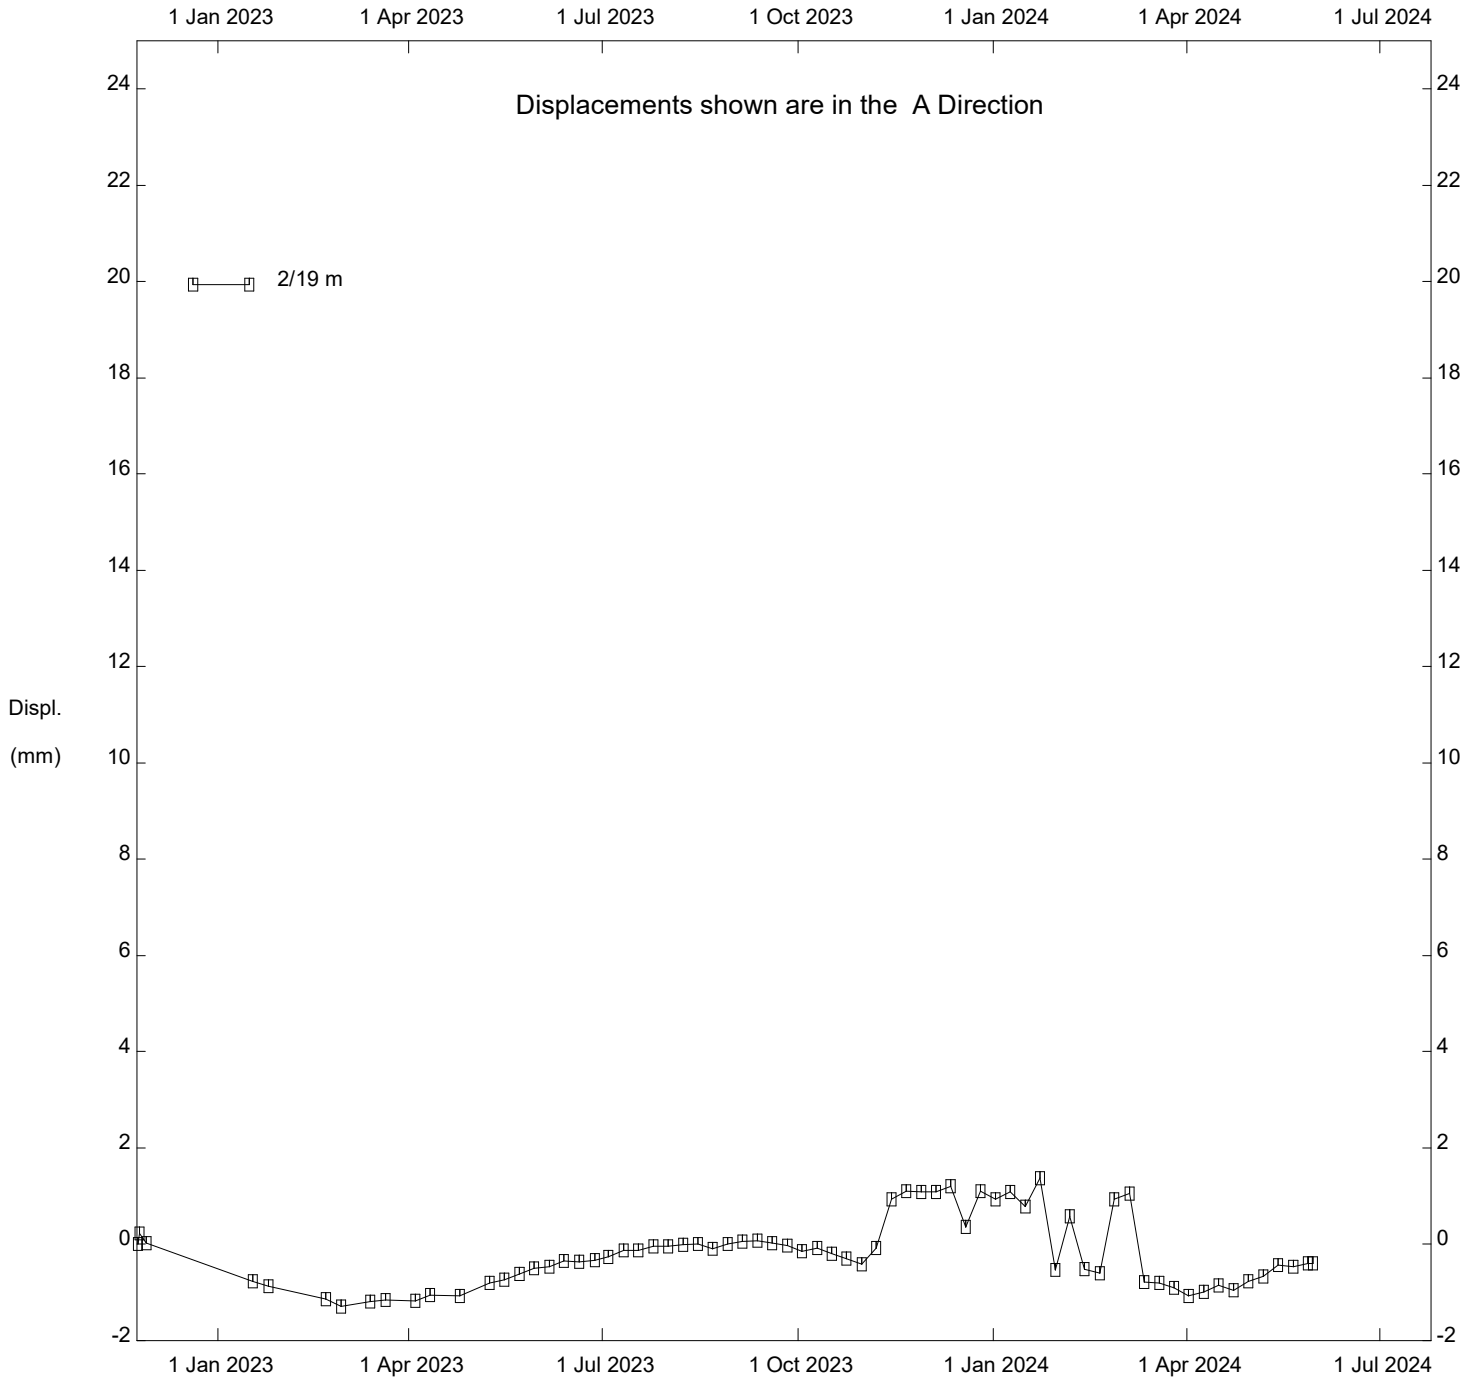
GP042 Slope Stabilization, Inclinometer SAA22-P15

<b>INSTRUMENT #</b>	<b>DATE INITIALIZED</b>	<b>TOTAL CUMULATIVE RESULTANT MOVEMENT AT NOTED DEPTH SINCE INITIAL READING (mm)</b>	<b>CURRENT STATUS</b>	<b>DATE OF PREVIOUS READING</b>	<b>INCREMENTAL MOVEMENT SINCE PREVIOUS READING (mm)</b>	<b>CURRENT RATE OF MOVEMENT (mm/yr)</b>	<b>CHANGE IN RATE OF MOVEMENT SINCE PREVIOUS READING (mm/yr)</b>
SAA22-P15	November 24, 2022	-0.4 over 2.0 to 19.0 m depth	Operational	June 27, 2023	No discernible movement	N/A	-3.5
