Alberta Transportation
Main Floor, Provincial Building
9621 96 Avenue
Peace River, Alberta
T8S 1T4

CON0022166 Peace Region (Grande Prairie South) GRMP
Hwy 40:36 rockfall, km 8.395 to 17.161
Call-Out Report

This call-out report was prepared for AT under Contract No. CON0022166. KCB's site observations, assessments, and recommendations for short-term and long-term remedial actions are presented in this report.

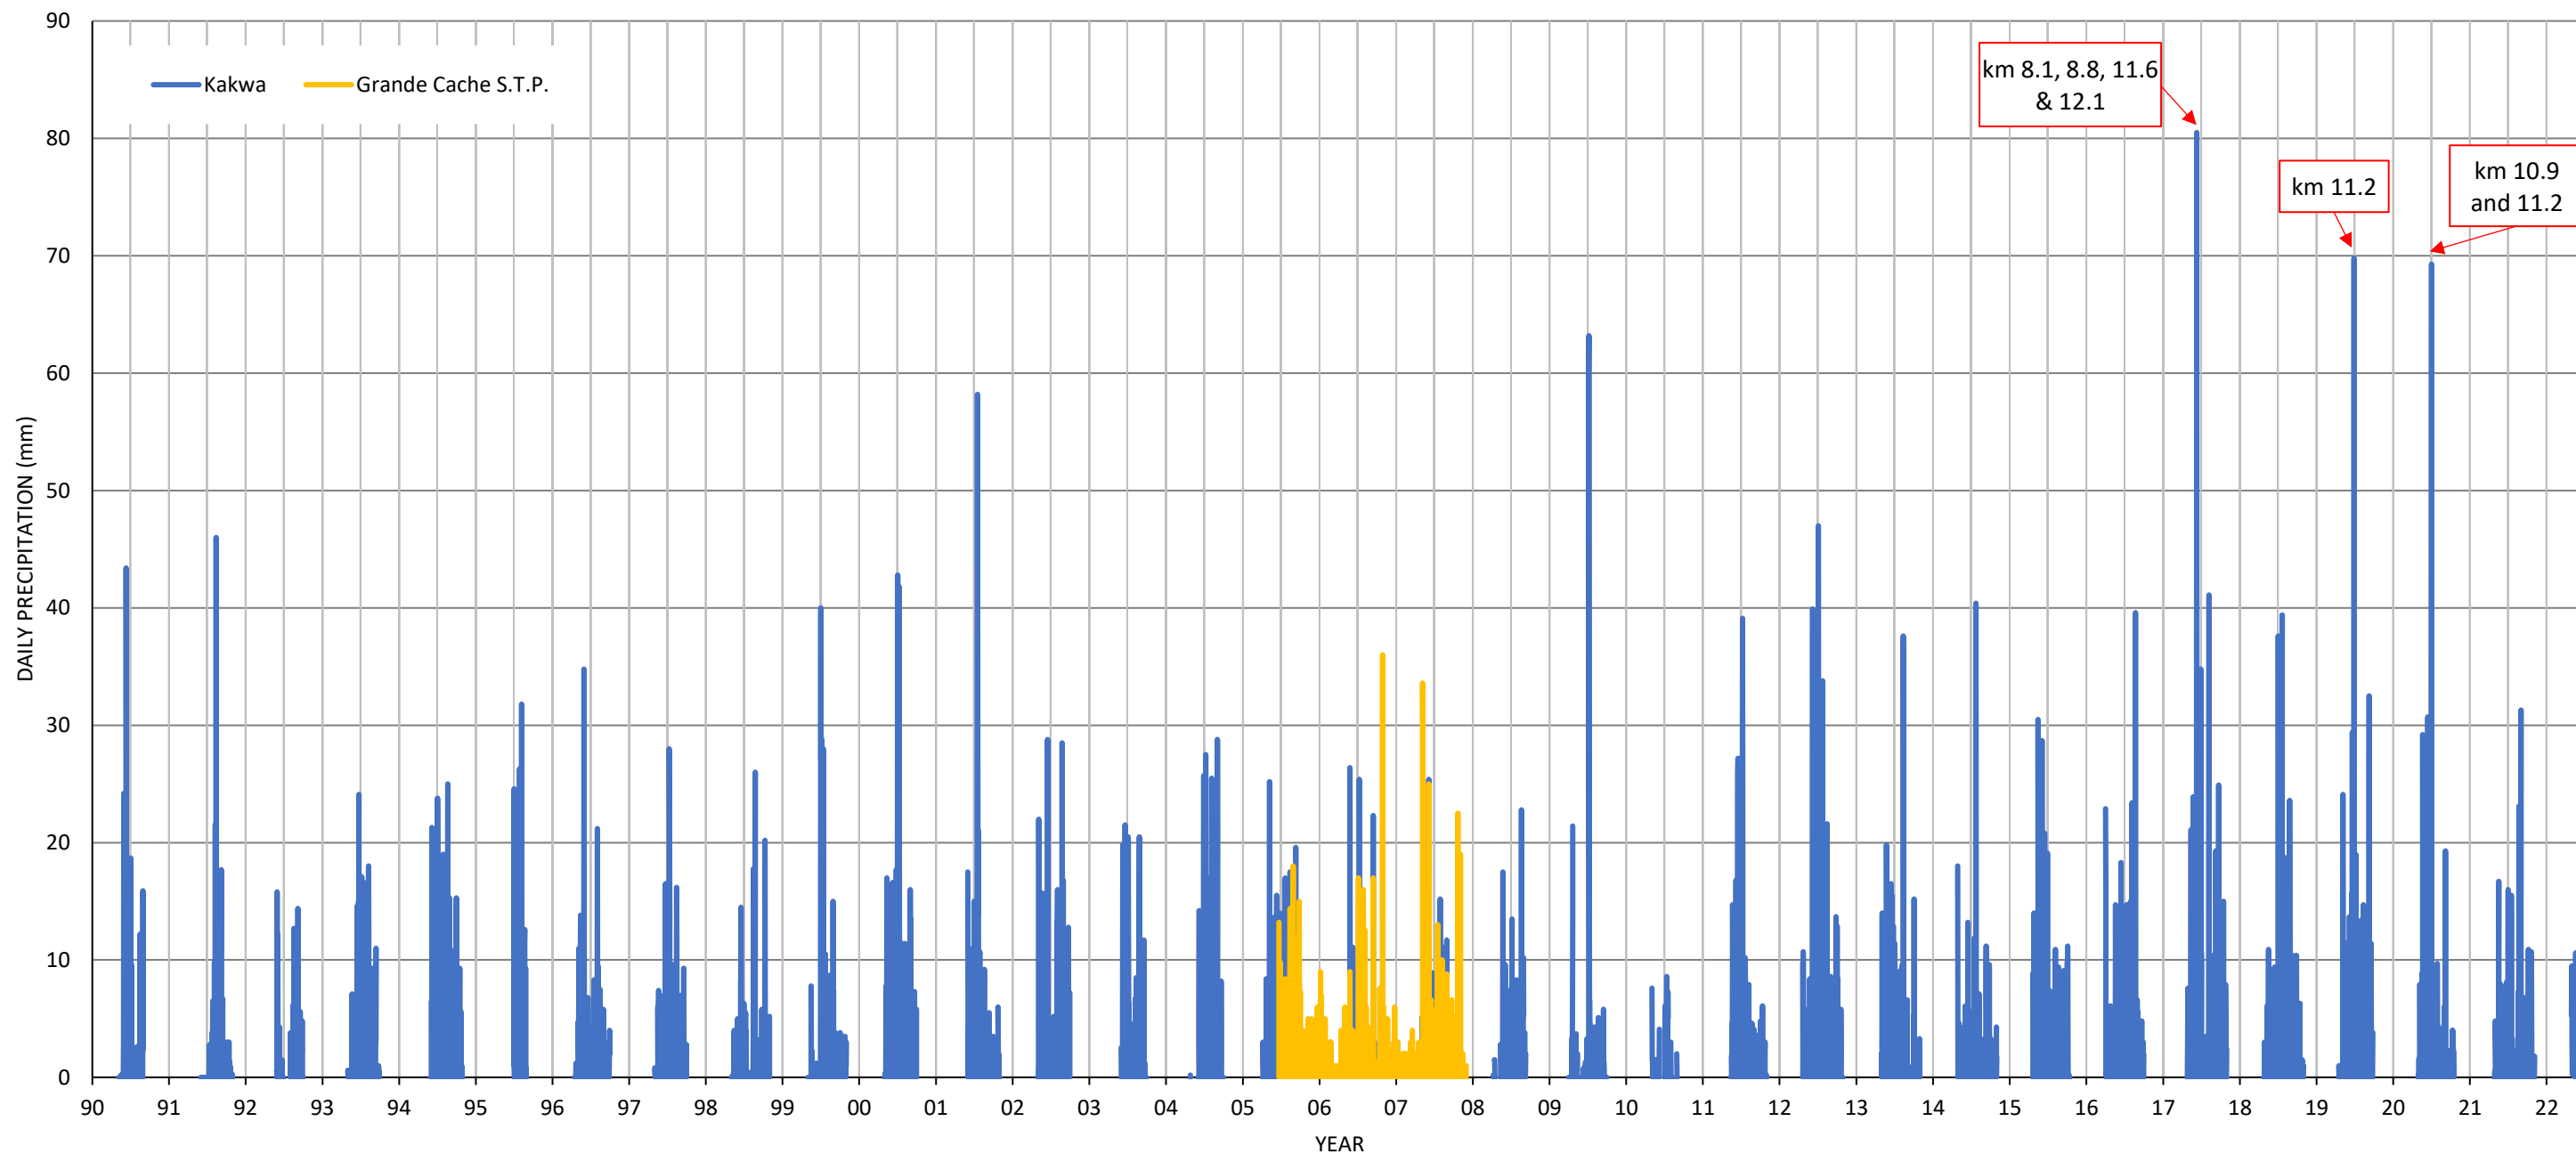
PROJECT		PEACE REGION (GRANDE PRAIRIE DISTRICT - SOUTH) GEOHAZARD RISK MANAGEMENT PROGRAM	
TITLE		Daily Rainfall Data Rockfall Sites Hwy 40:36; km 8.119 to 12.262	
SCALE	PROJECT No.	A05116A01	FIG No 2

We reviewed weather from nearby weather stations. Our review of daily precipitation data (i.e., total precipitation per day) is presented in Figure 2. Note that since 1990, the four highest daily precipitation events have occurred since 2017 with daily precipitation between approximately 69 mm to 81 mm and these corresponded to rockfall and debris flow events at various locations on Hwy 40:36 as shown on Figure 2. The intensity of daily rainfall events and the frequency of intense rainfall events also appears to have increased.

- Figure 2 indicates that the intensity and frequency of heavy rainfall events appears to be increasing in recent years.
- The rockfall and debris flow events that occurred in 2020 and 2022 appear to be likely to occur again in the future.
- Increased frequency or more intense rainfall may promote additional rockfall hazard and might cause existing problem areas to shed rock blocks sooner than during historical weather conditions. However, increased precipitation may also accelerate weathering of

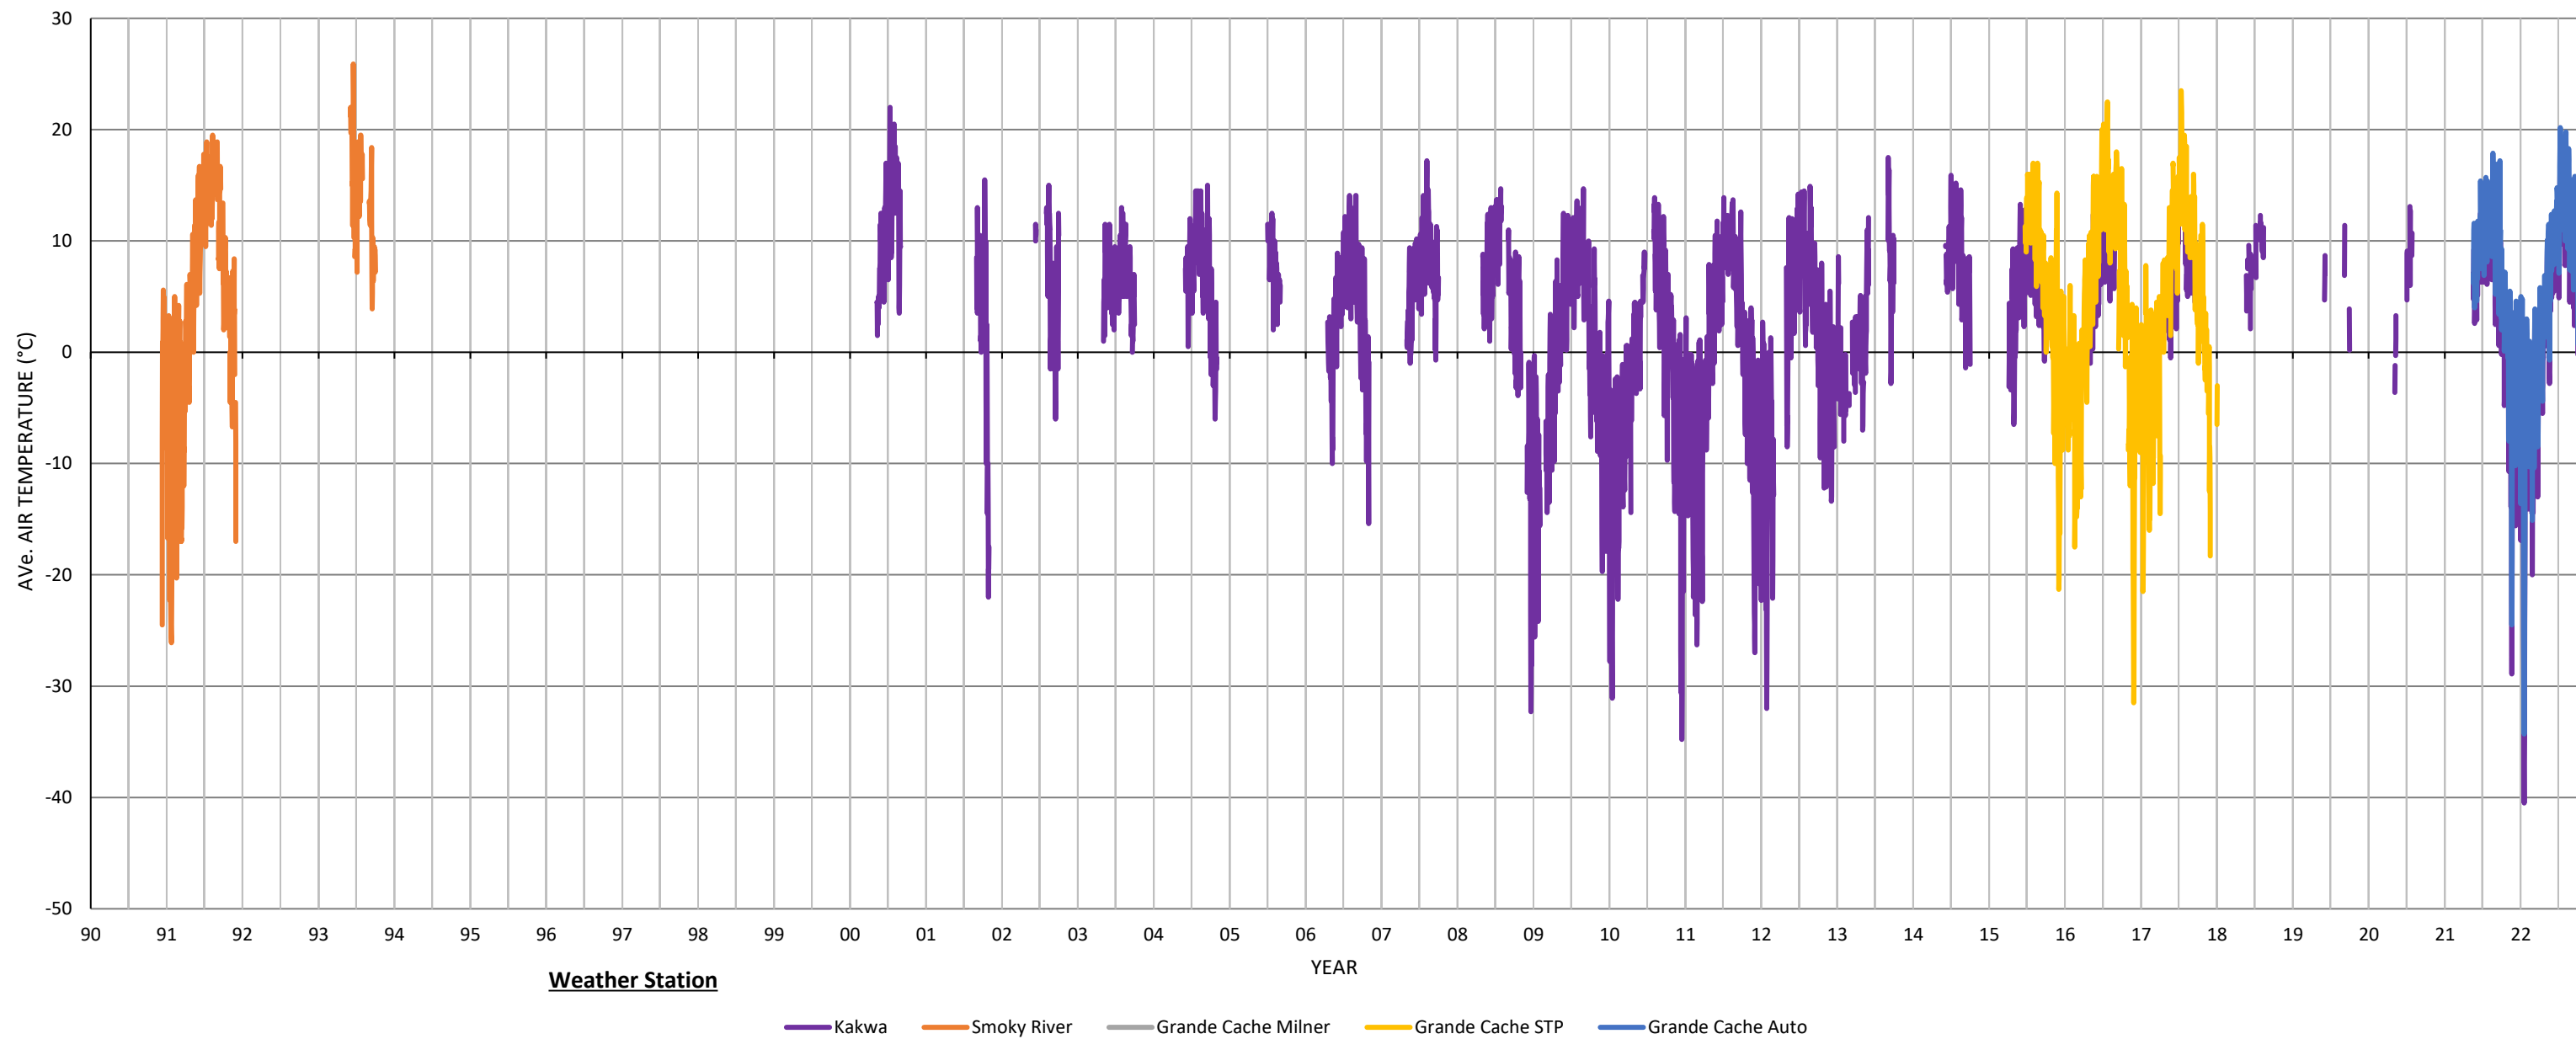
PROJECT PEACE REGION (GRANDE PRAIRIE DISTRICT - SOUTH) GEOHAZARD RISK MANAGEMENT PROGRAM		
	TITLE Daily Average Air Temperature Data Rockfall Sites Hwy 40:36; km 8.119 to 12.262		
SCALE	PROJECT No.	A05116A01	FIG No 3

Our daily average air temperature data review is presented in Figure 3. The daily average air temperature data appears to indicate that since 1999 the extreme temperatures appear to have increased (i.e., colder in winter, warmer in summer) but the locations of the available weather stations are on high ground compared to near valley bottom for the subject sites which could result in the available data not being representative of site conditions. AT reports that, anecdotally, in recent years (2019 for instance) there have been warmer winters with very little snow compared to previous years. Furthermore, and anecdotally, AT has observed water running down slope later in the year than usual, as late as the end of November and freezing and thawing conditions in the winter months that historically was not previously experienced in this area of the province.

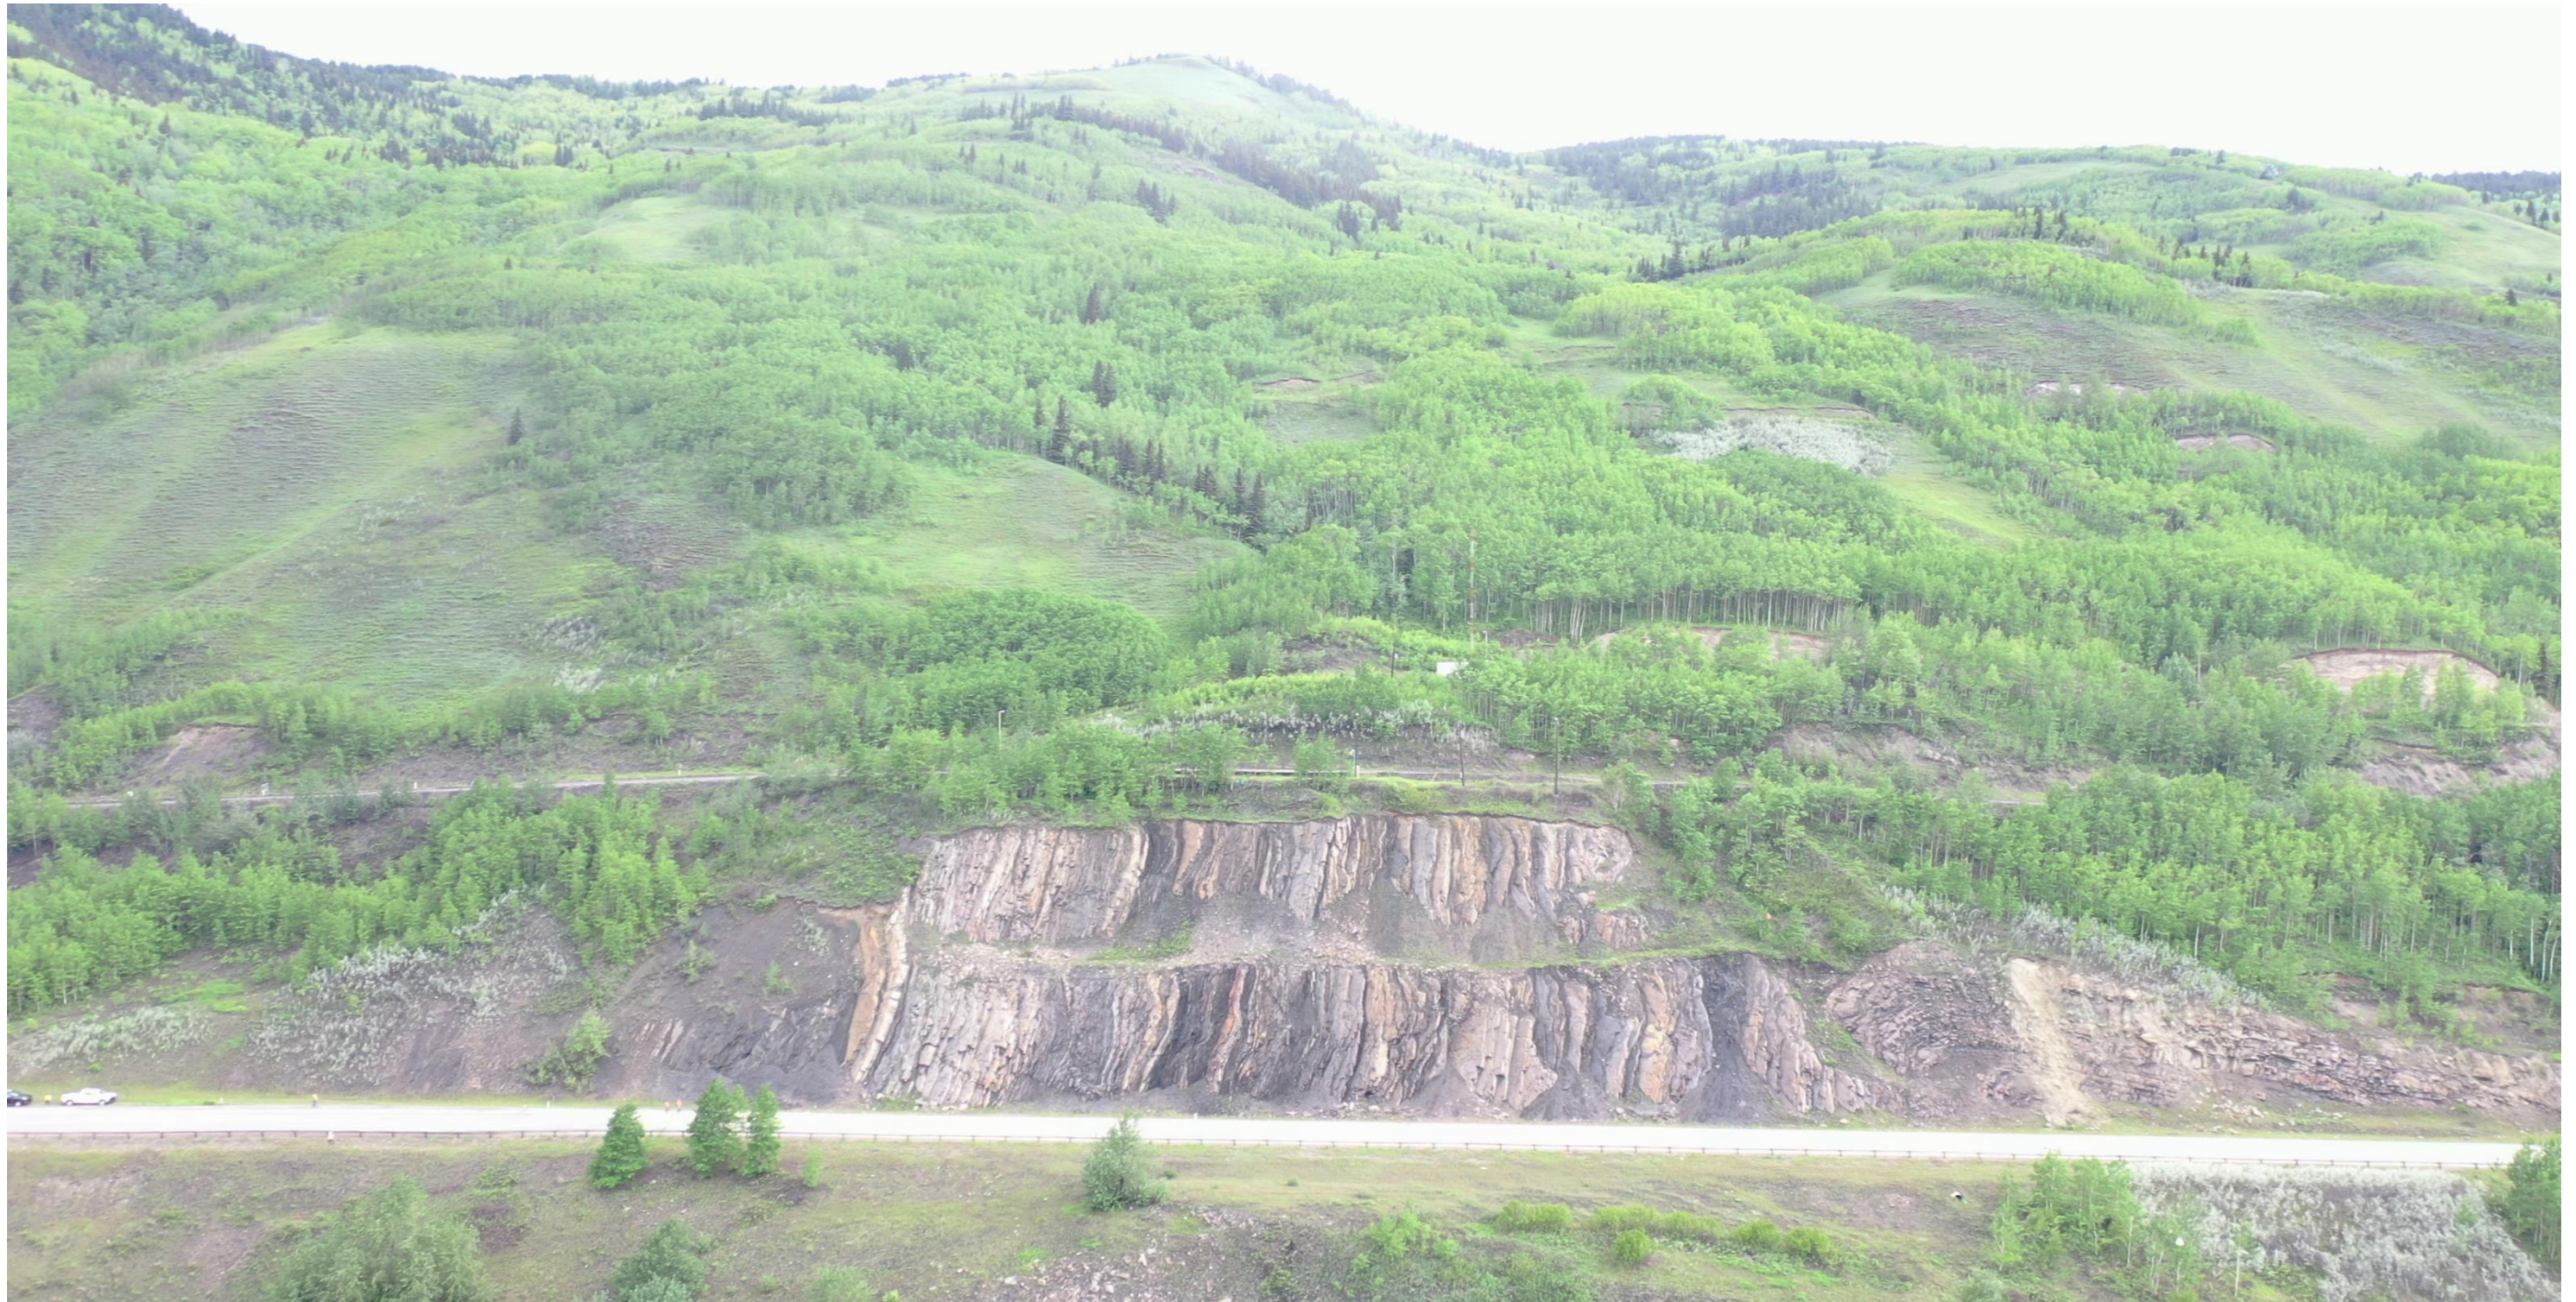
SCALE	PROJECT No. A05116A01
	FIG No. 7

- There is a mine road at the crest of the slope as shown in Figure 6 (wooden powerline poles are shown in Photo GP053-I-1).

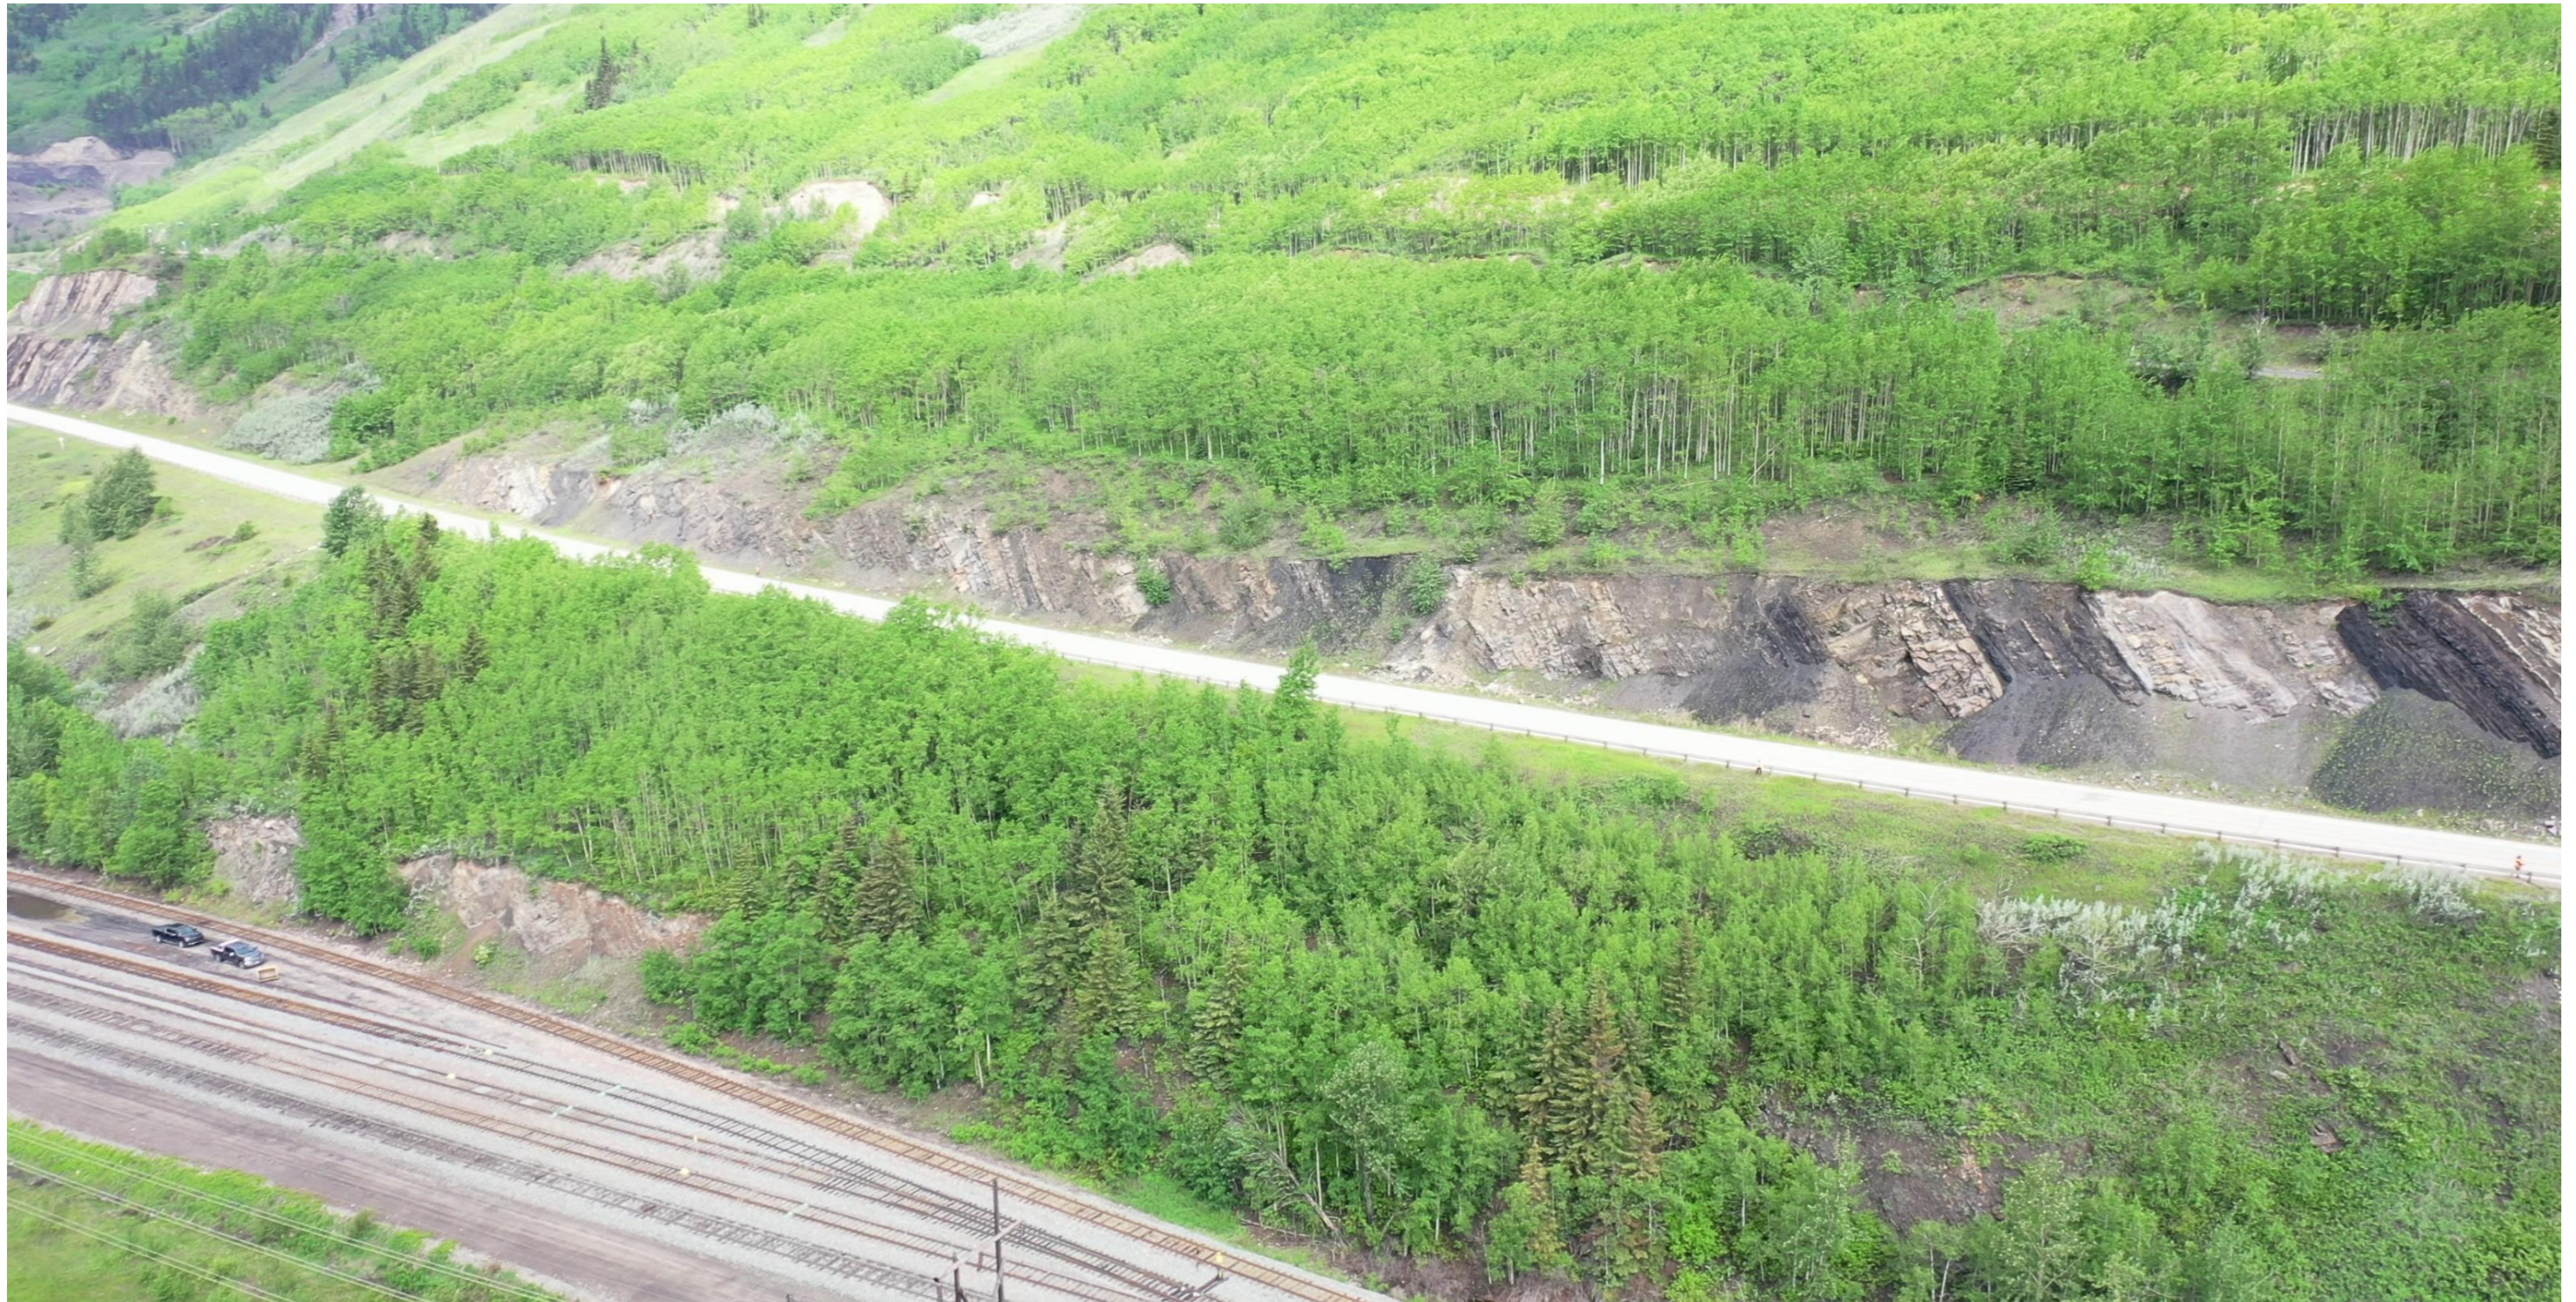
PROJECT		PEACE REGION (GRAND PRAIRIE DISTRICT - SOUTH) GEOHAZARD RISK MANAGEMENT PROGRAM	
TITLE		Site Plan	
		GP053-II Rock Slope Middle of McIntyre Mine Hwy 40:36, km 16.295 to 17.161	
SCALE	PROJECT No.	A05116A01	FIG No. 8

- The coal seams at this rock slope are eroding faster than the adjacent bedrock seams (Photos GP053-II-4, to -6). The talus cones in the ditch are largest near the coal seams as shown in Figure 7.

- ♦ *The slope should be scaled and the ditch cleaned of rockfall blocks and talus material.*
- A mine access road is located on the hillslope above the GP053-II rock slope. The mine access road is located at the crest of the rock slope in the north quarter of the rock slope (Photo GP053-II-6) and as shown in Figure 7. Soil located the brow of the slope might be fill associated with the mine access road. Mine-road grading and drainage practices might also contribute to rockfall or other debris falling over the crest of the road.
