July 15, 2024

## CON0022166 Peace Region (Grande Prairie District – South) GRMP Instrumentation Monitoring Site GP007; H40:36, km 29.339 Wanyandie Road Slide Section C – 2024 Spring Readings

Hwy 40:36, km 29.339

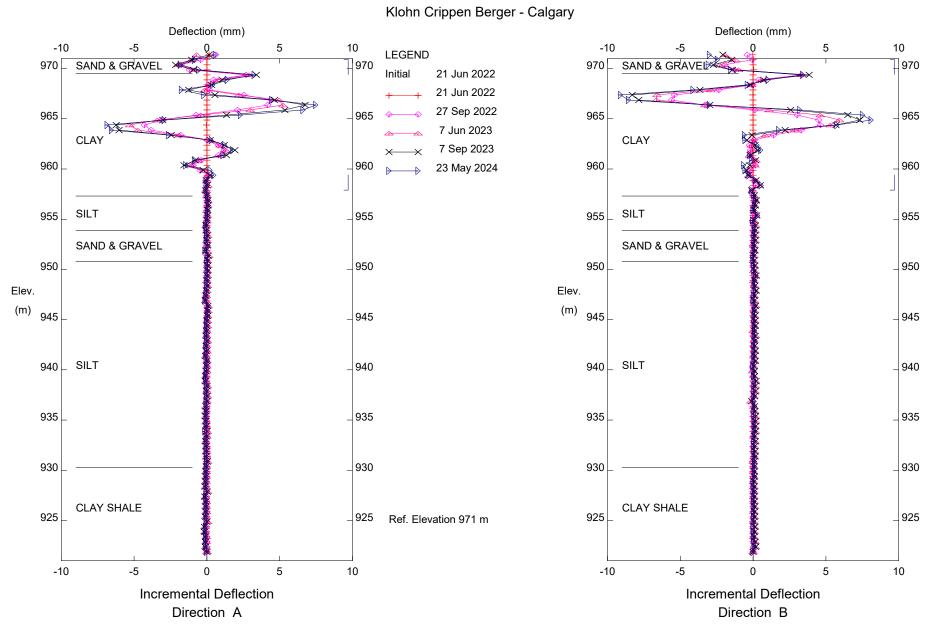
GP007; H40:36, Wanyandie Road Slide, Inclinometer SI22-03

In May 2022, two deeper SIs (SI22-2 and SI22-3) were installed in the north (westbound) highway ditch to assess if there were deeper failure planes in the middle of the site. SI22-2 has recorded distributed movement from an approximate depth of 6.6 m to 10.6 m below ground surface (elevation 959.4 m to 955.4 m) which is confined to the colluvium/till unit. SI22-3 appears to have recorded post-installation casing settlement/flexure at approximately 6 m below ground surface, which may be caused by grout loss in a more granular zone in the colluvium unit.

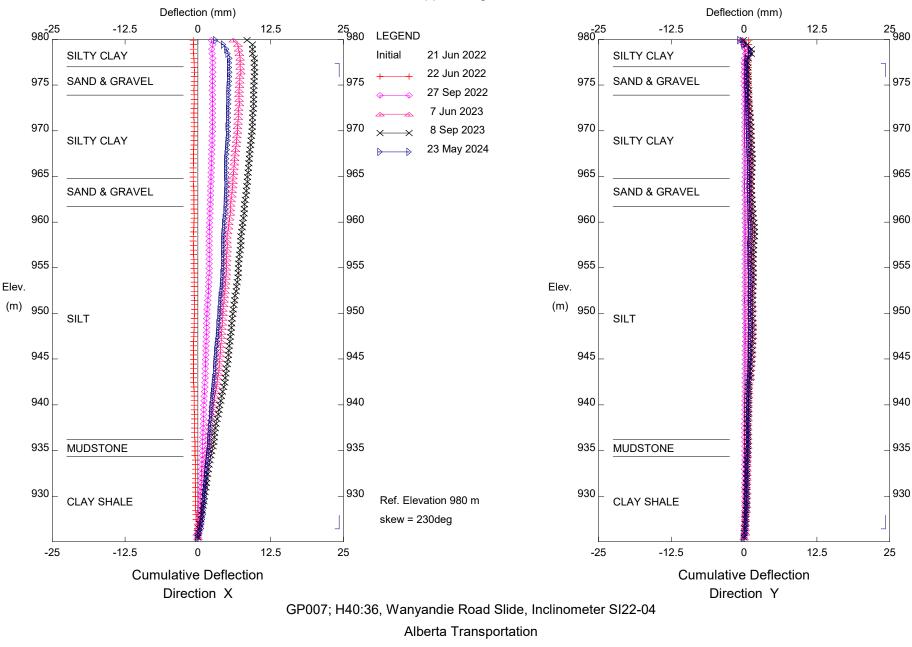
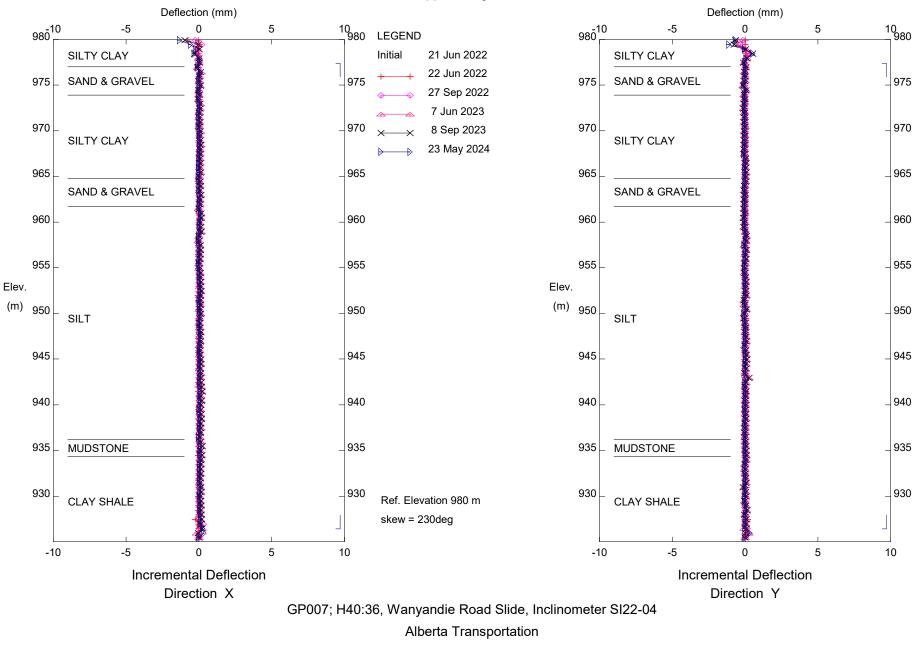
GP007; H40:36, Wanyandie Road Slide, Inclinometer SI22-04

In May 2022, a deeper SI (SI22-4) was installed to assess if a deeper failure plane was present at the eastern extent of the site. Distributed movement is being recorded along the entire length of the instrument (i.e., from near ground surface to the base of the instrument) since installation, with no discrete movement zones.
