**PEACE REGION  
(GRANDE PRAIRIE DISTRICT – SOUTH) GRMP**

**SITE INSPECTION FORM**

<b>SITE NUMBER AND NAME:</b> GP054 Debris Flow Corridor South of McIntyre Mine		<b>HIGHWAY &amp; KM:</b> 40:36, 8.119 to 12.262	<b>PREVIOUS INSPECTION DATE:</b> July 21, 2021	<b>INSPECTION DATE:</b> <b>June 14, 2022</b>
<b>LEGAL DESCRIPTION:</b>  South NW 29-57-08-W6M North NW 04-58-08-W6M	<b>NAD 83 COORDINATES:</b> UTM    Northing    Easting 11      5981027    358454 11      5984770    360291		<b>RISK ASSESSMENT:</b>  <b>No Recent Occurrence</b> PF: 7 CF: 6 TOTAL: 42 <b>Recent Occurrence</b> PF: 5 CF: 4 TOTAL: 20	
<b>AVERAGE ANNUAL DAILY TRAFFIC (AADT):</b> 820 (north) & 1020 (south) (Reference No. 25592, 2021)			<b>CONTRACT MAINTENANCE AREA (CMA):</b> 504

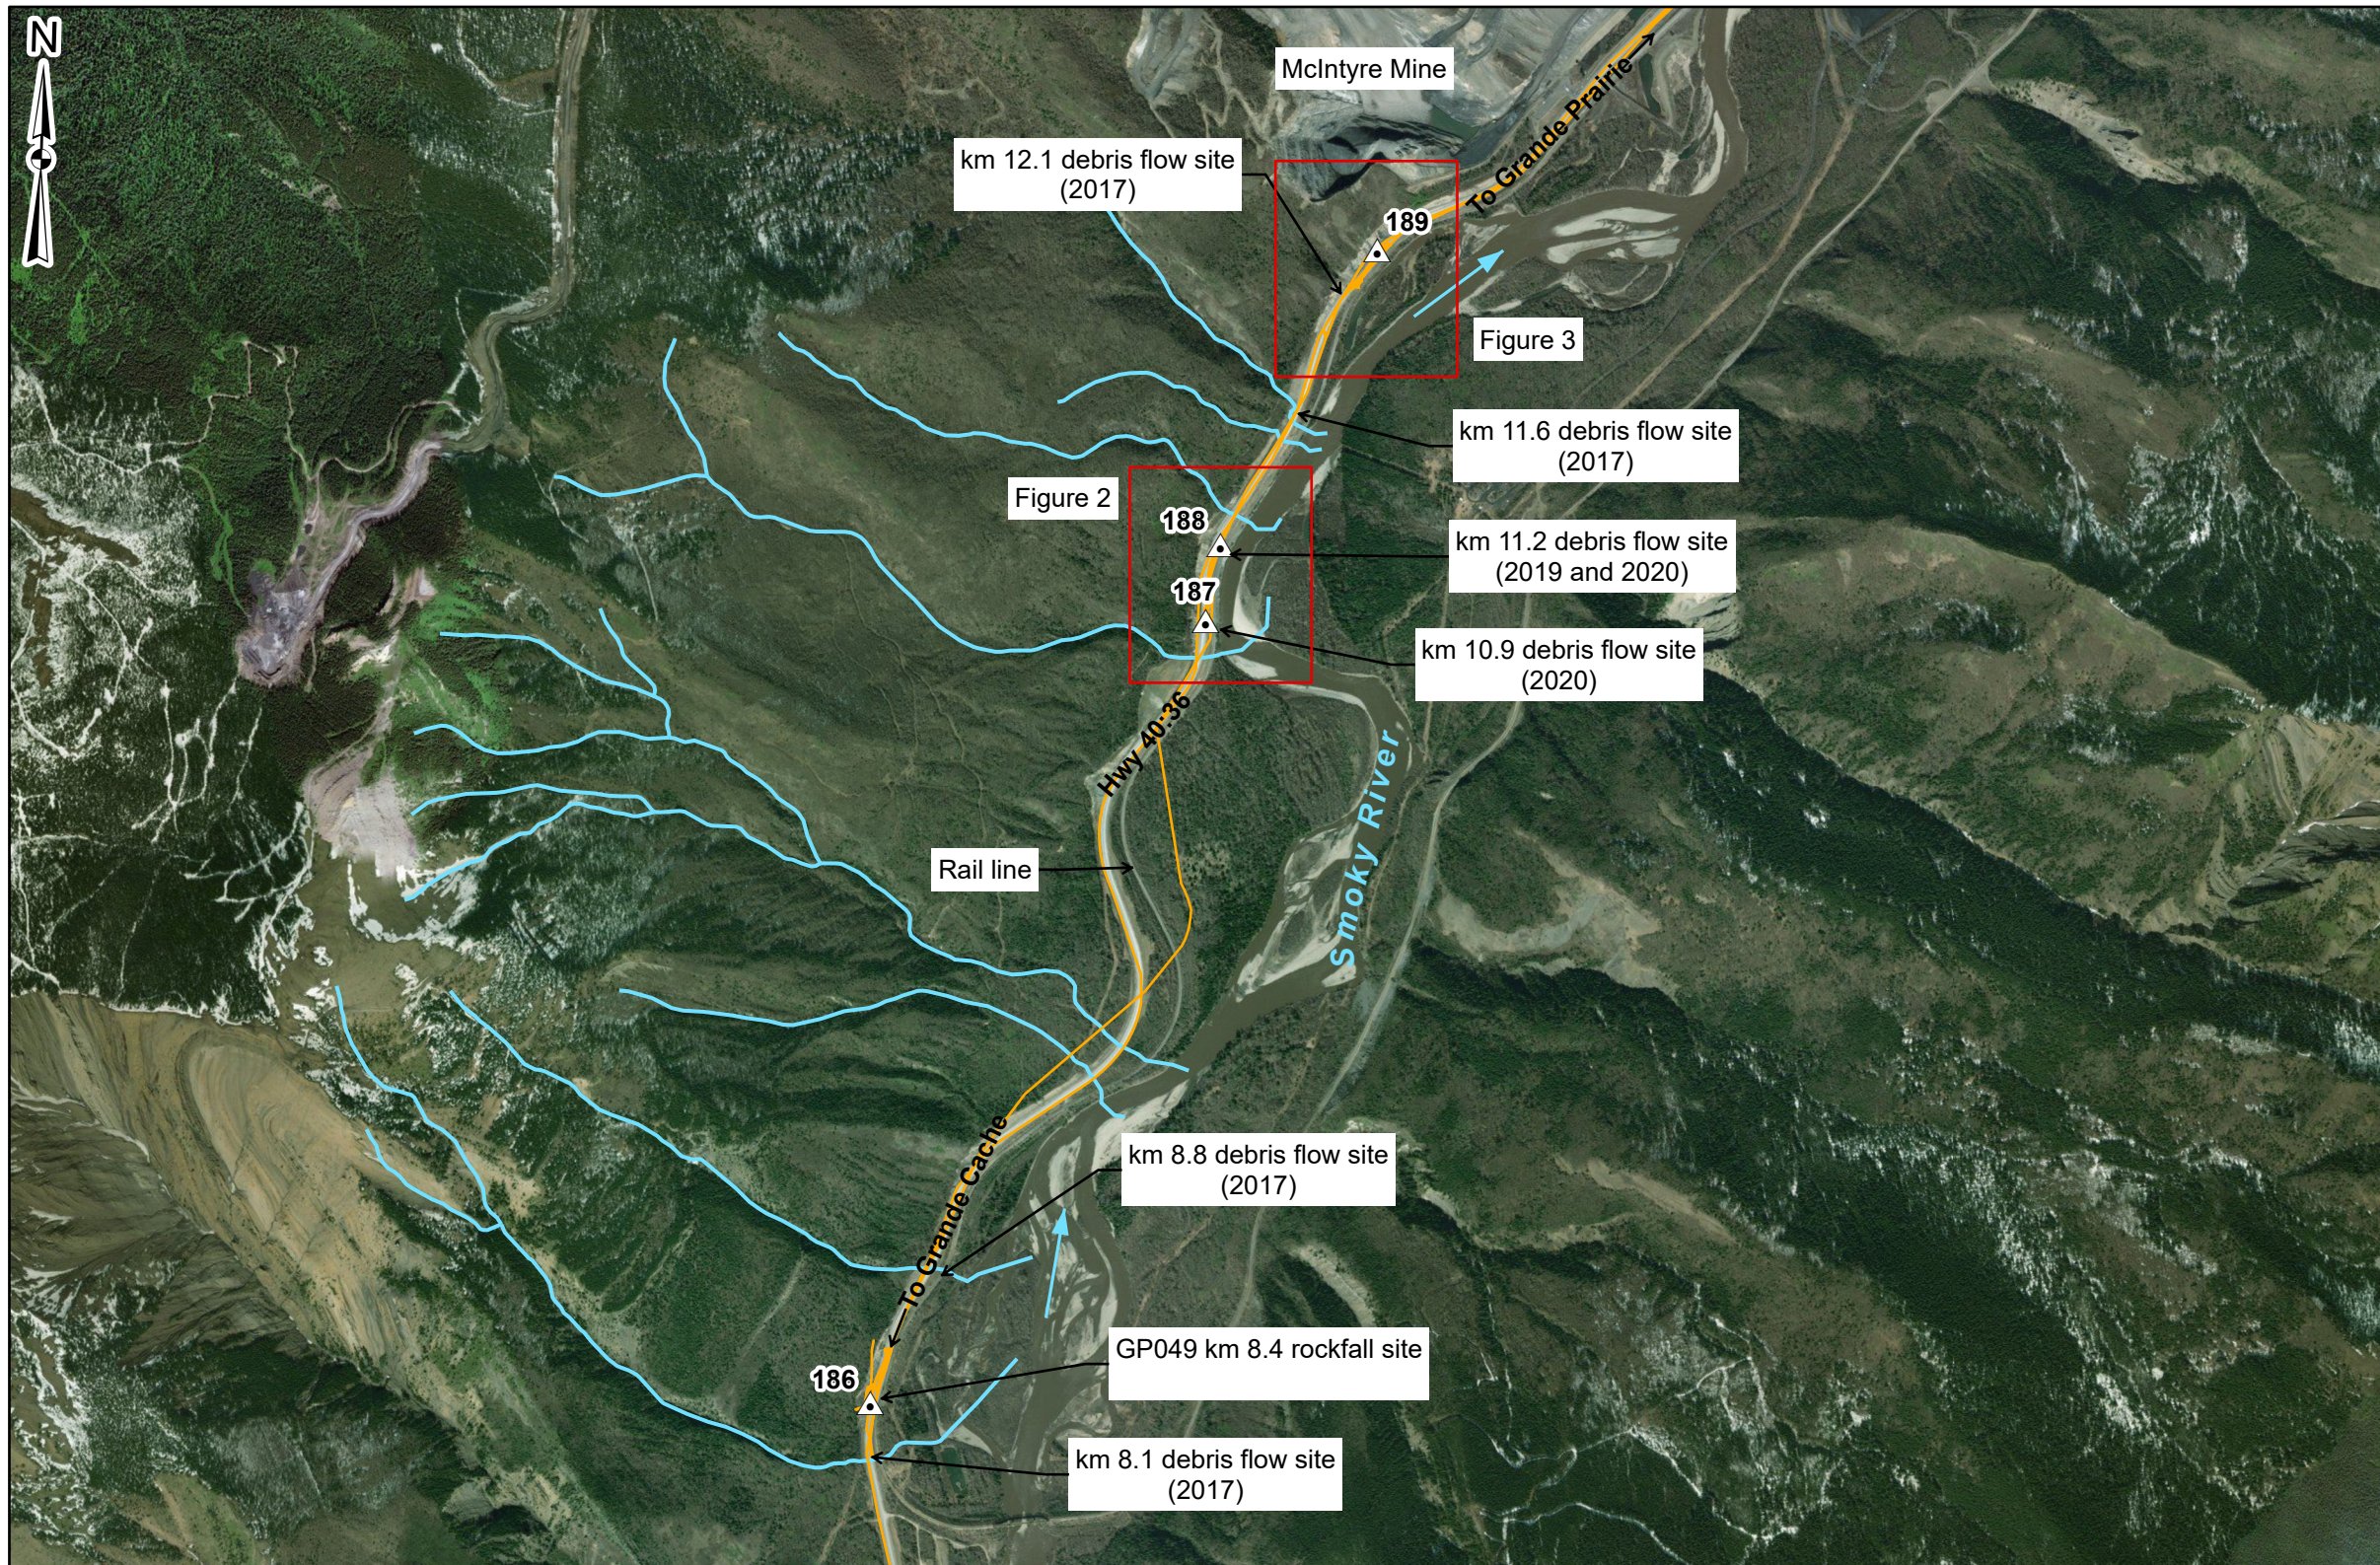
SCALE 1:21,000 PROJECT No. A05116A01 FIG No. 1

Three event sites visited, one at km 10.9 (WP187), km 11.2 (WP188), and km 12.1 (south of WP189). Several other event sites previously observed/inspected by others along corridor; e.g., km 8.1, 8.8, and 11.3 as shown in figure.

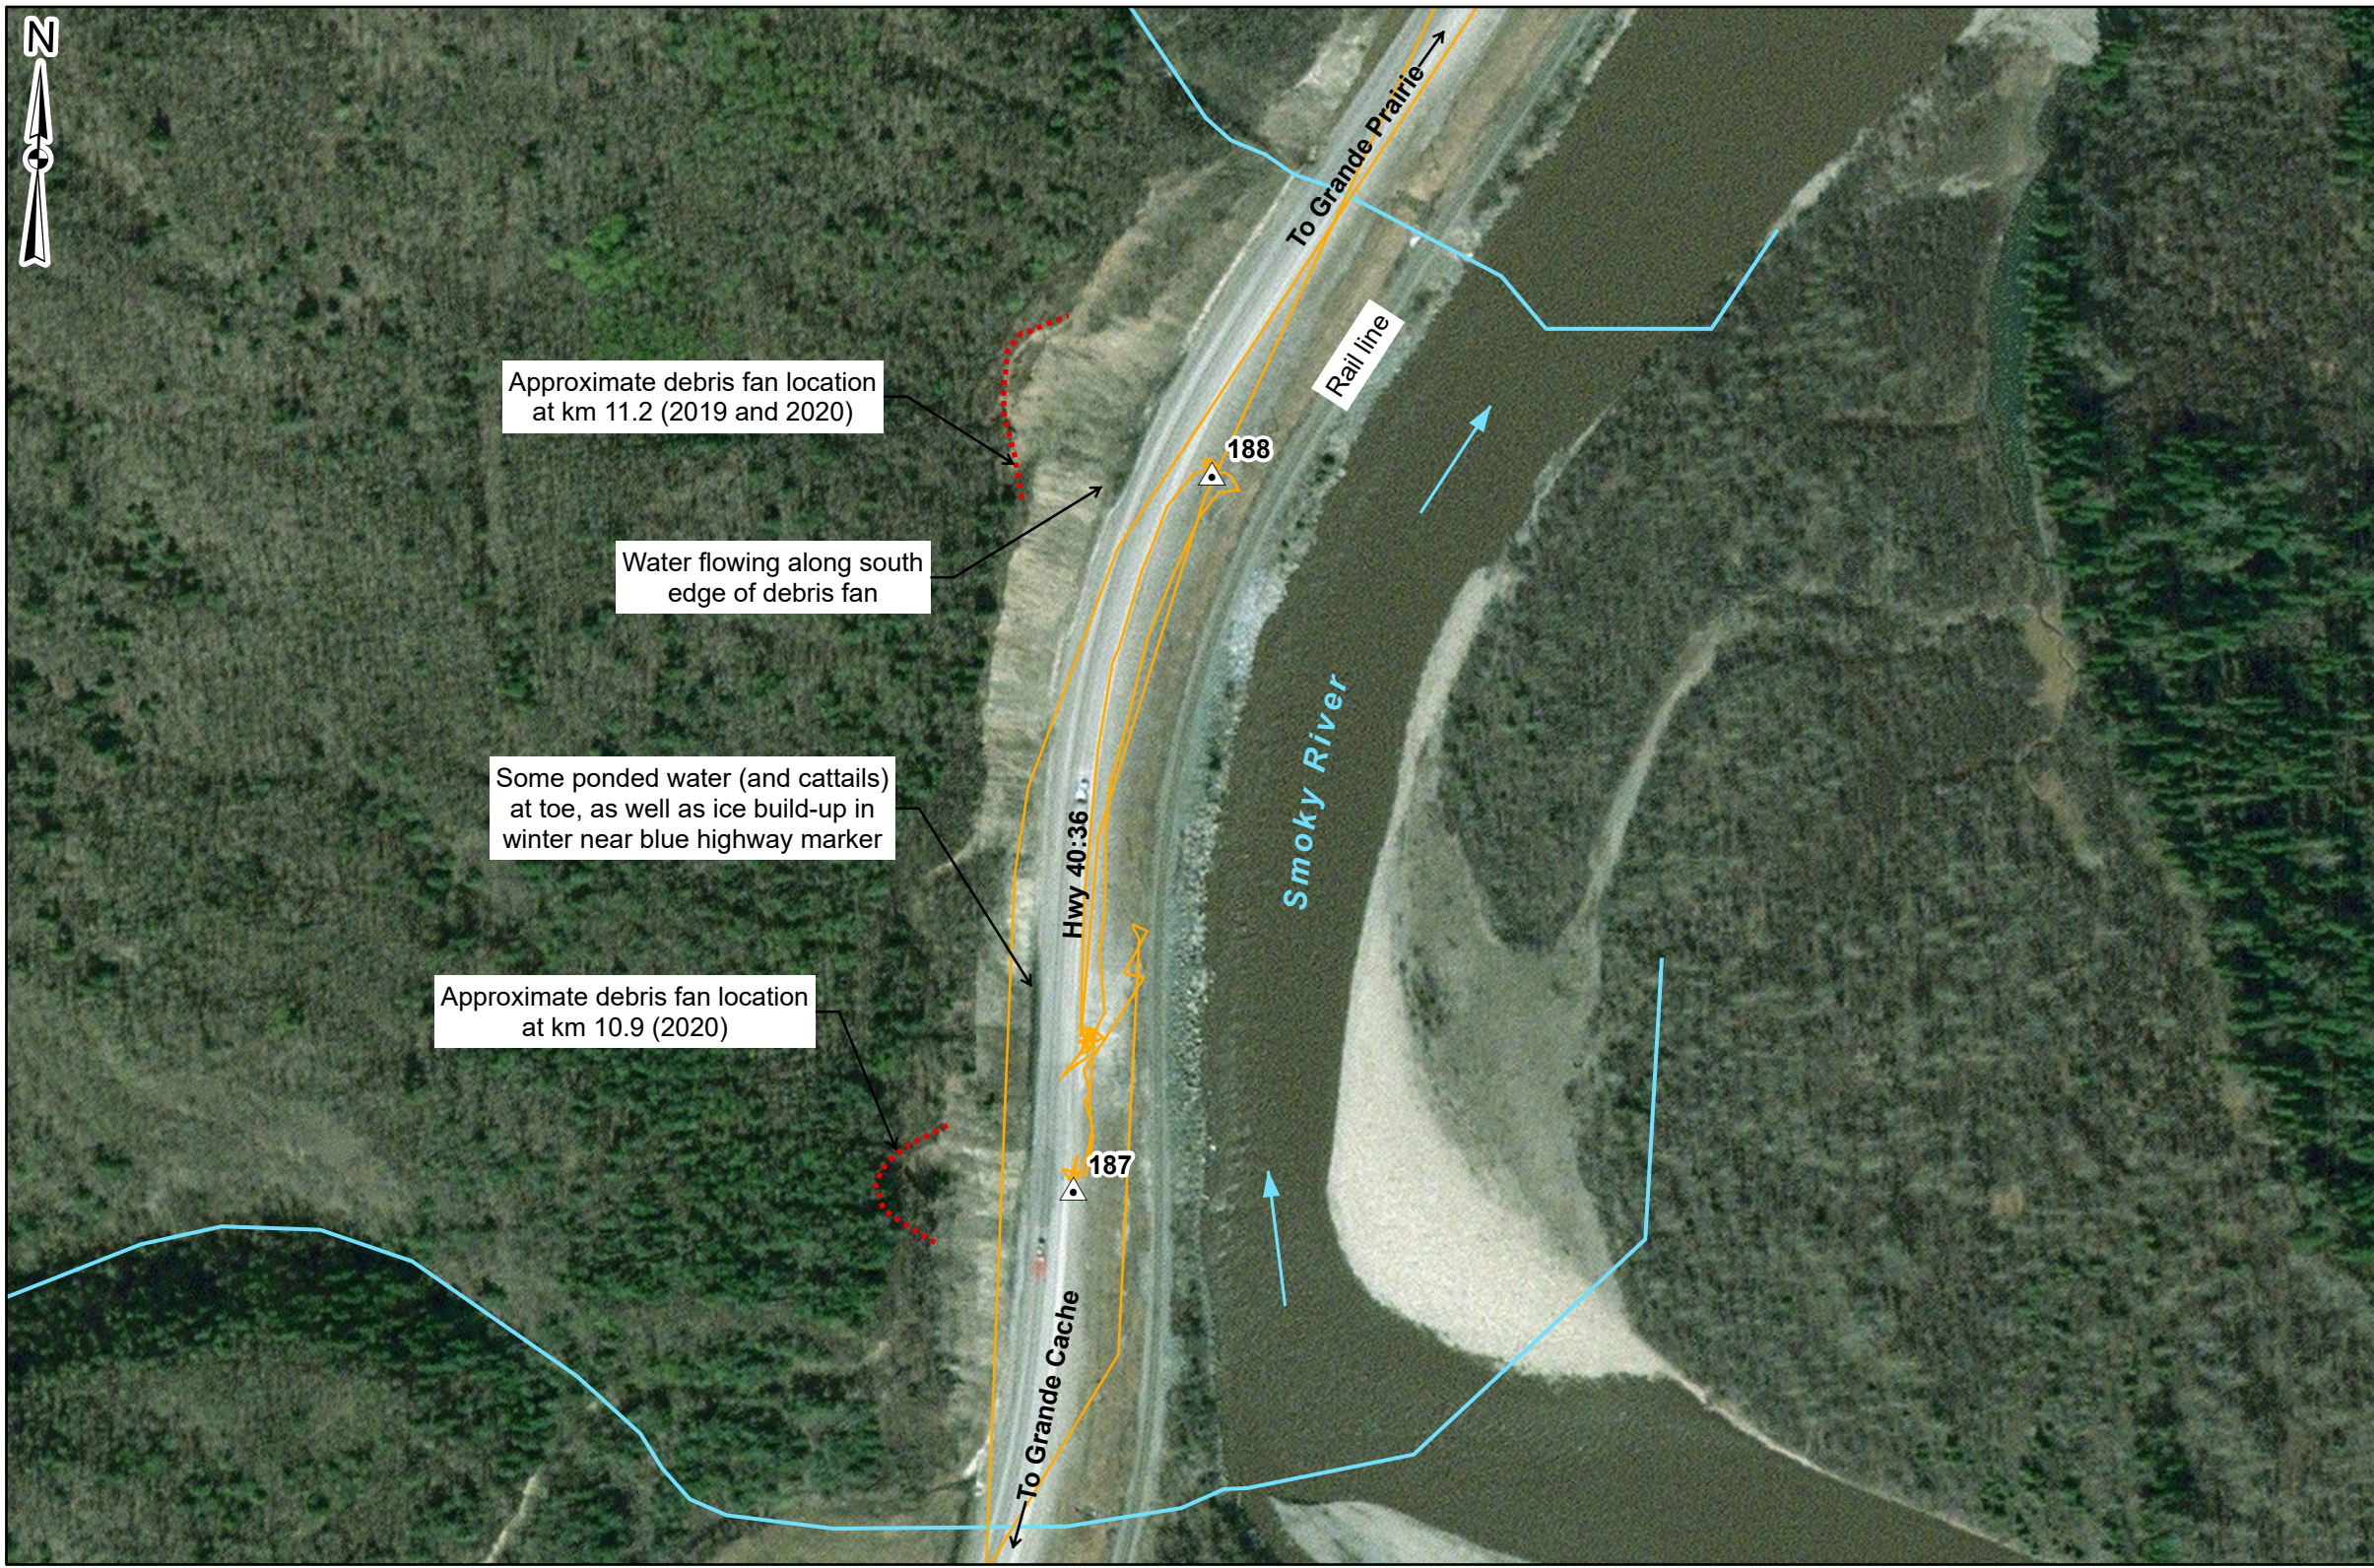
PROJECT	PEACE REGION (GRANDE PRAIRIE DISTRICT-SOUTH) GEOHAZARD RISK MANAGEMENT PROGRAM	
TITLE	Site Plan GP054- Debris Flow Corridor South of McIntyre Mine Hwy 40:36, km 10.9 and 11.2	
SCALE	PROJECT No.	FIG No.
1:2,250	A05116A01	2

- Last debris flows occurred at this location in 2019 and 2020.
- Main debris fan is approximately 20 m wide, but backslope failure around debris fan is approximately 50 m to 60 m. Slope is approximately 10 m high.
- Water observed flowing along south edge of main/largest debris fan.
- Fan is fairly well vegetated, indicating no recent debris flow activity.
