SITE INSPECTION FORM

SITE NUMBER AND NAME: GP054 Debris Flow Corridor South of McIntyre Mine		HIGHWAY & KM: 40:36, 8.119 to 12.262	PREVIOUS INSPECTION DATE: June 14, 2022	INSPECTION DATE: June 12, 2023
LEGAL DESCRIPTION: South NW 29-57-08-W6M North NW 04-58-08-W6M	NAD 83 COORDINATES: UTM Northing Easting 11 5981027 358454 11 5984770 360291		RISK ASSESSMENT: No Recent Occurrence PF: 7 CF: 6 TOTAL: 42 Recent Occurrence PF: 5 CF: 2 TOTAL: 10	
AVERAGE ANNUAL DAILY TRAFFIC (AADT): 780 (north) & 980 (south) (Reference No. 25592, 2022)			CONTRACT MAINTENANCE AREA (CMA): 504

TITLE
 Site Plan
 GP054- Debris Flow Corridor South of McIntyre Mine
 Hwy 40:36, km 8.119 to 12.262

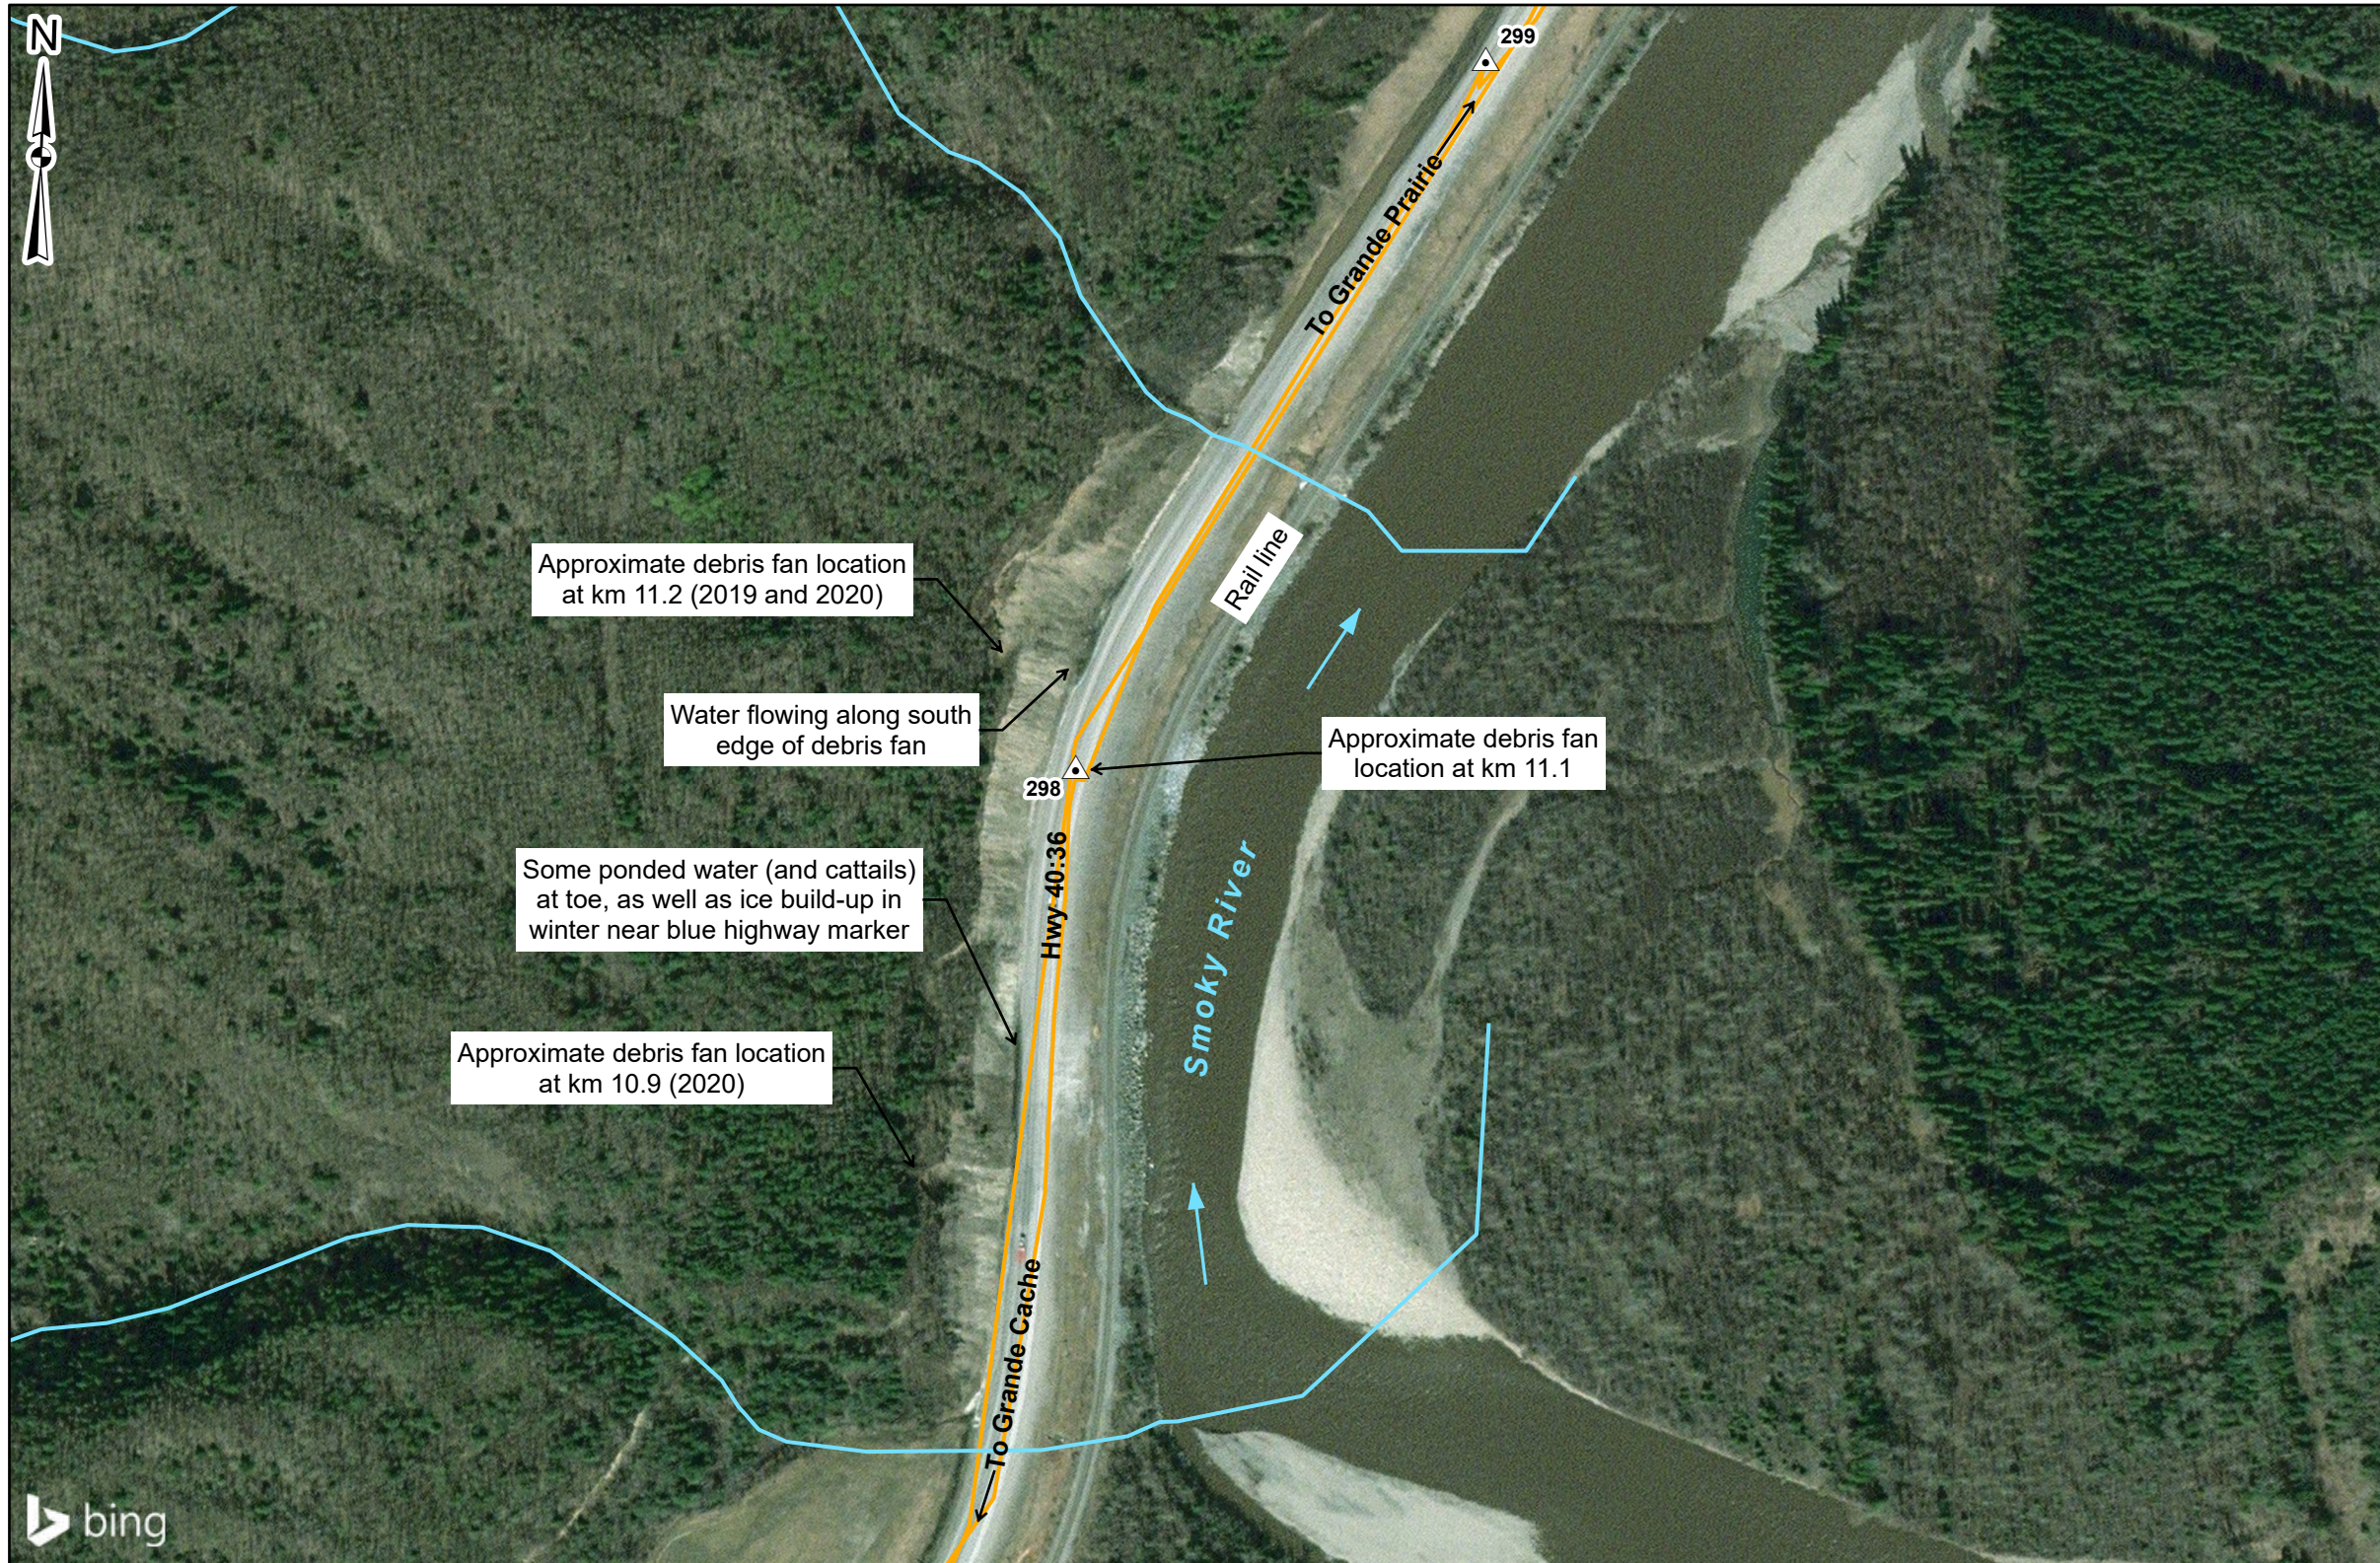
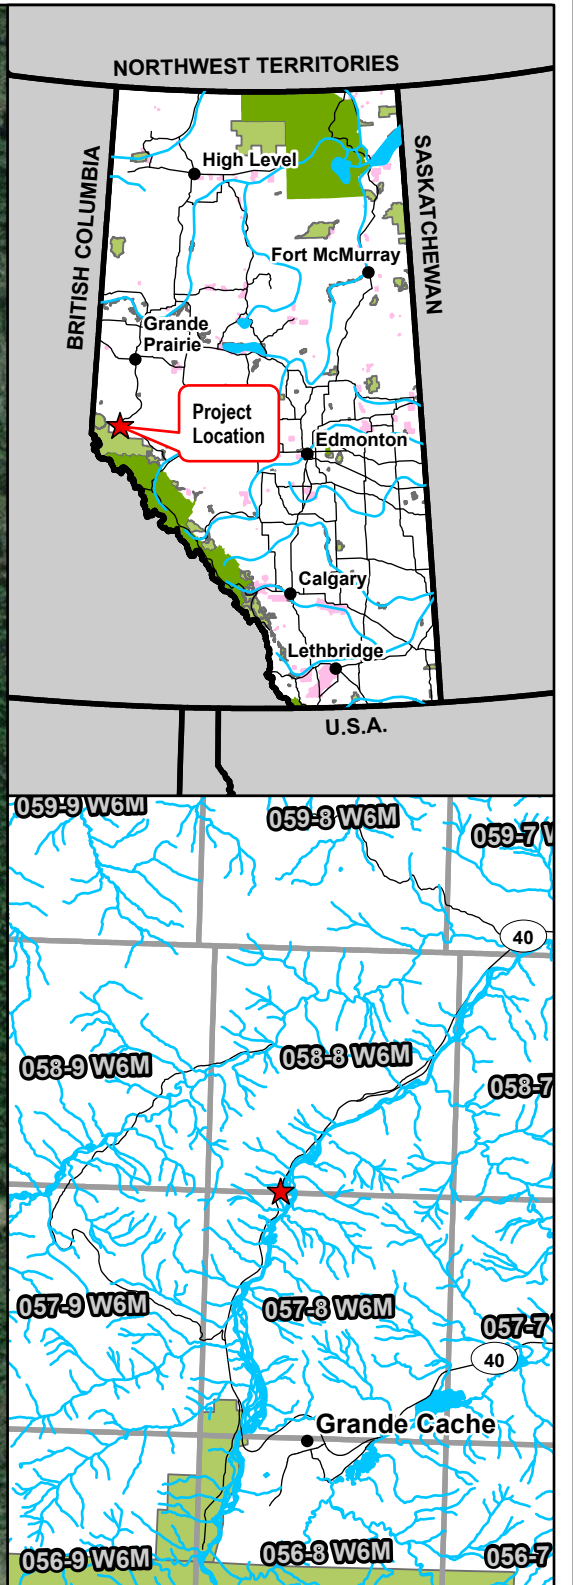
PROJECT	PEACE REGION (GRANDE PRAIRIE DISTRICT-SOUTH) GEOHAZARD RISK MANAGEMENT PROGRAM	
TITLE	Site Plan GP054- Debris Flow Corridor South of McIntyre Mine Hwy 40:36, km 10.9 and 11.2	
SCALE	PROJECT No.	FIG No.
1:3,000	A05116A01	2
