**PEACE REGION  
(GRANDE PRAIRIE DISTRICT – SOUTH) GRMP**

**SITE INSPECTION FORM**

<b>SITE NUMBER AND NAME:</b> GP054 Debris Flow Corridor South of McIntyre Mine		<b>HIGHWAY &amp; KM:</b> 40:36, 8.119 to 12.262	<b>PREVIOUS INSPECTION DATE:</b> June 12, 2023	<b>INSPECTION DATE:</b> <b>June 10, 2024</b>
<b>LEGAL DESCRIPTION:</b>  South NW 29-57-08-W6M North NW 04-58-08-W6M	<b>NAD 83 COORDINATES:</b> UTM    Northing    Easting 11      5981027      358454 11      5984770      360291		<b>RISK ASSESSMENT:</b>  <b>No Recent Occurrence</b> PF: 7 CF: 6 TOTAL: 42 <b>Recent Occurrence</b> PF: 5 CF: 2 TOTAL: 10	
<b>AVERAGE ANNUAL DAILY TRAFFIC (AADT):</b> 760 (north) & 960 (south) (Reference No. 25592, 2023)			<b>CONTRACT MAINTENANCE AREA (CMA):</b> 504

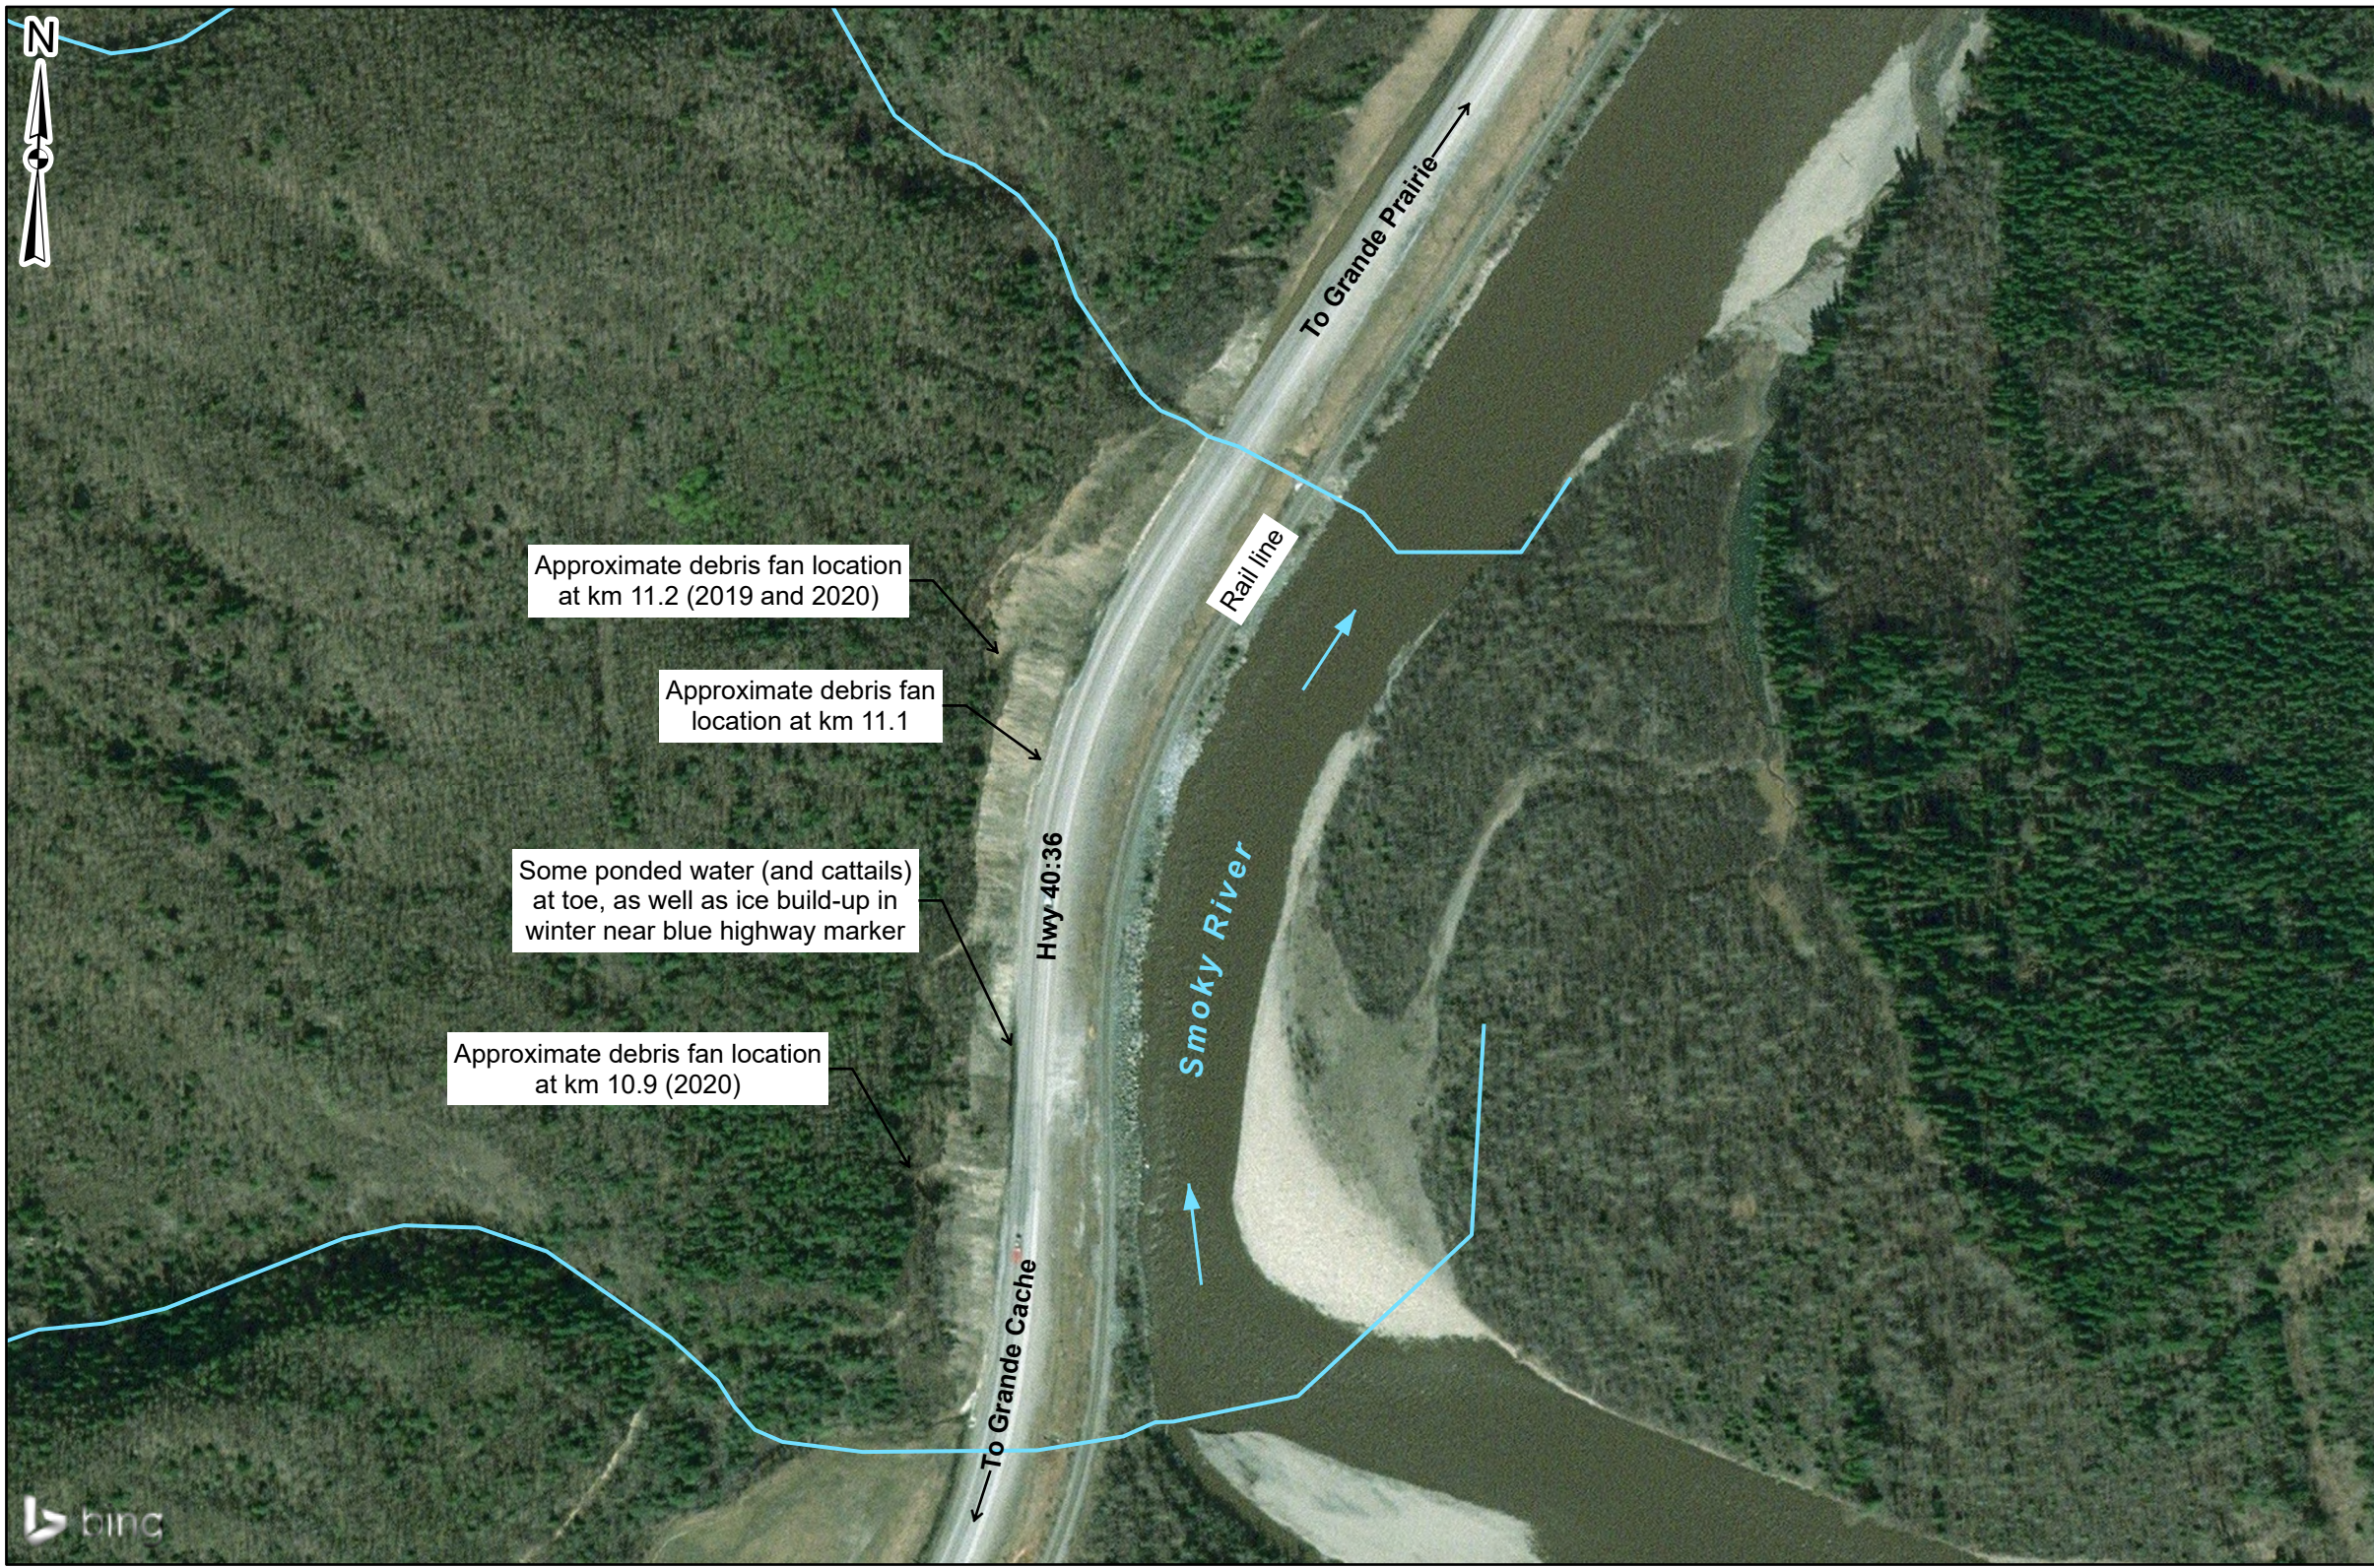
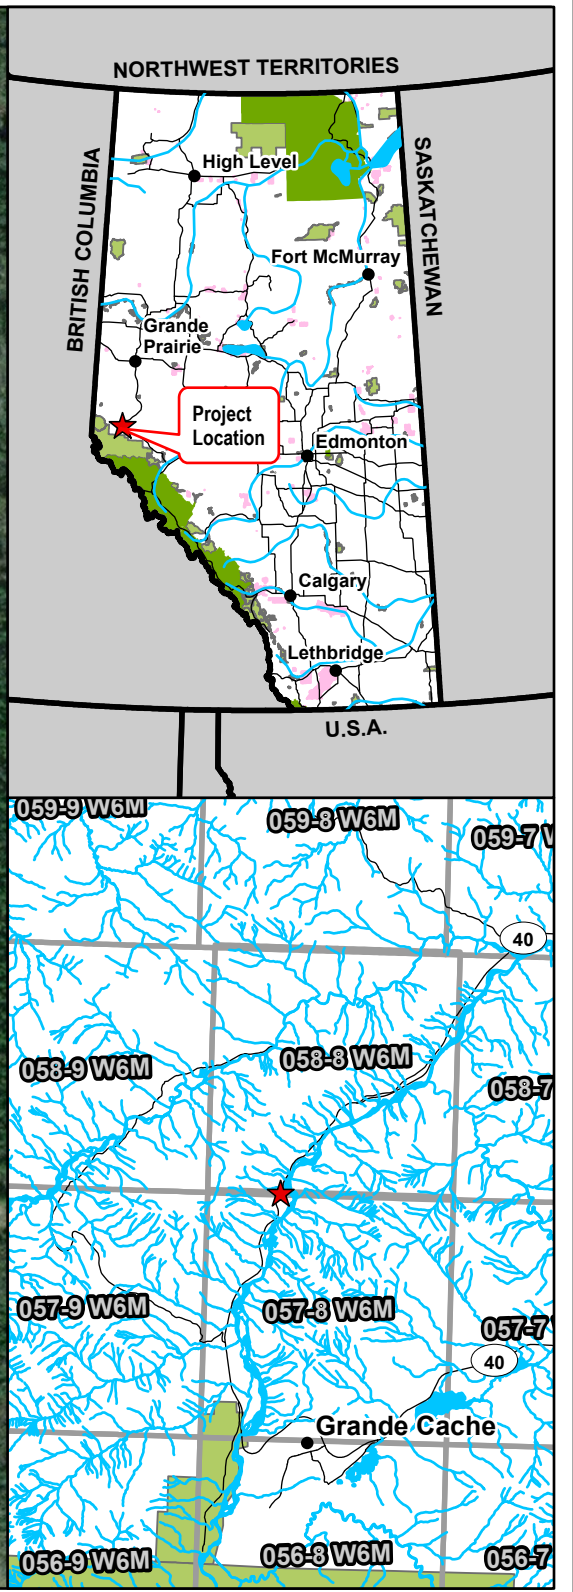
PROJECT PEACE REGION (GRANDE PRAIRIE DISTRICT-SOUTH) GEOHAZARD RISK MANAGEMENT PROGRAM		
TITLE Site Plan GP054- Debris Flow Corridor South of McIntyre Mine Hwy 40:36, km 10.9 and 11.2		
SCALE 1:3,000	PROJECT No. A05116A01	FIG No. 2

Debris flow at approximately km 10.9 (Photos 3 and 4):

- Ponded water in north highway ditch at toe of debris flow.
- Fan is fairly well vegetated, indicating no recent debris flow activity.
- Debris flow material continues to slump slowly towards highway and is approximately 2.5 m from edge of pavement. Backslope failure is approximately 25 m wide. Slope is approximately 5 m to 8 m high.
