Alberta Transportation and Economic Corridors
Main Floor, Provincial Building
9621 96 Avenue
Peace River, Alberta
T8S 1T4

CON0022166 Peace Region (Grande Prairie District – South) GRMP
Hwy 40:36, km 13.700 Debris Flow
Section D – Call-Out Report
Draft

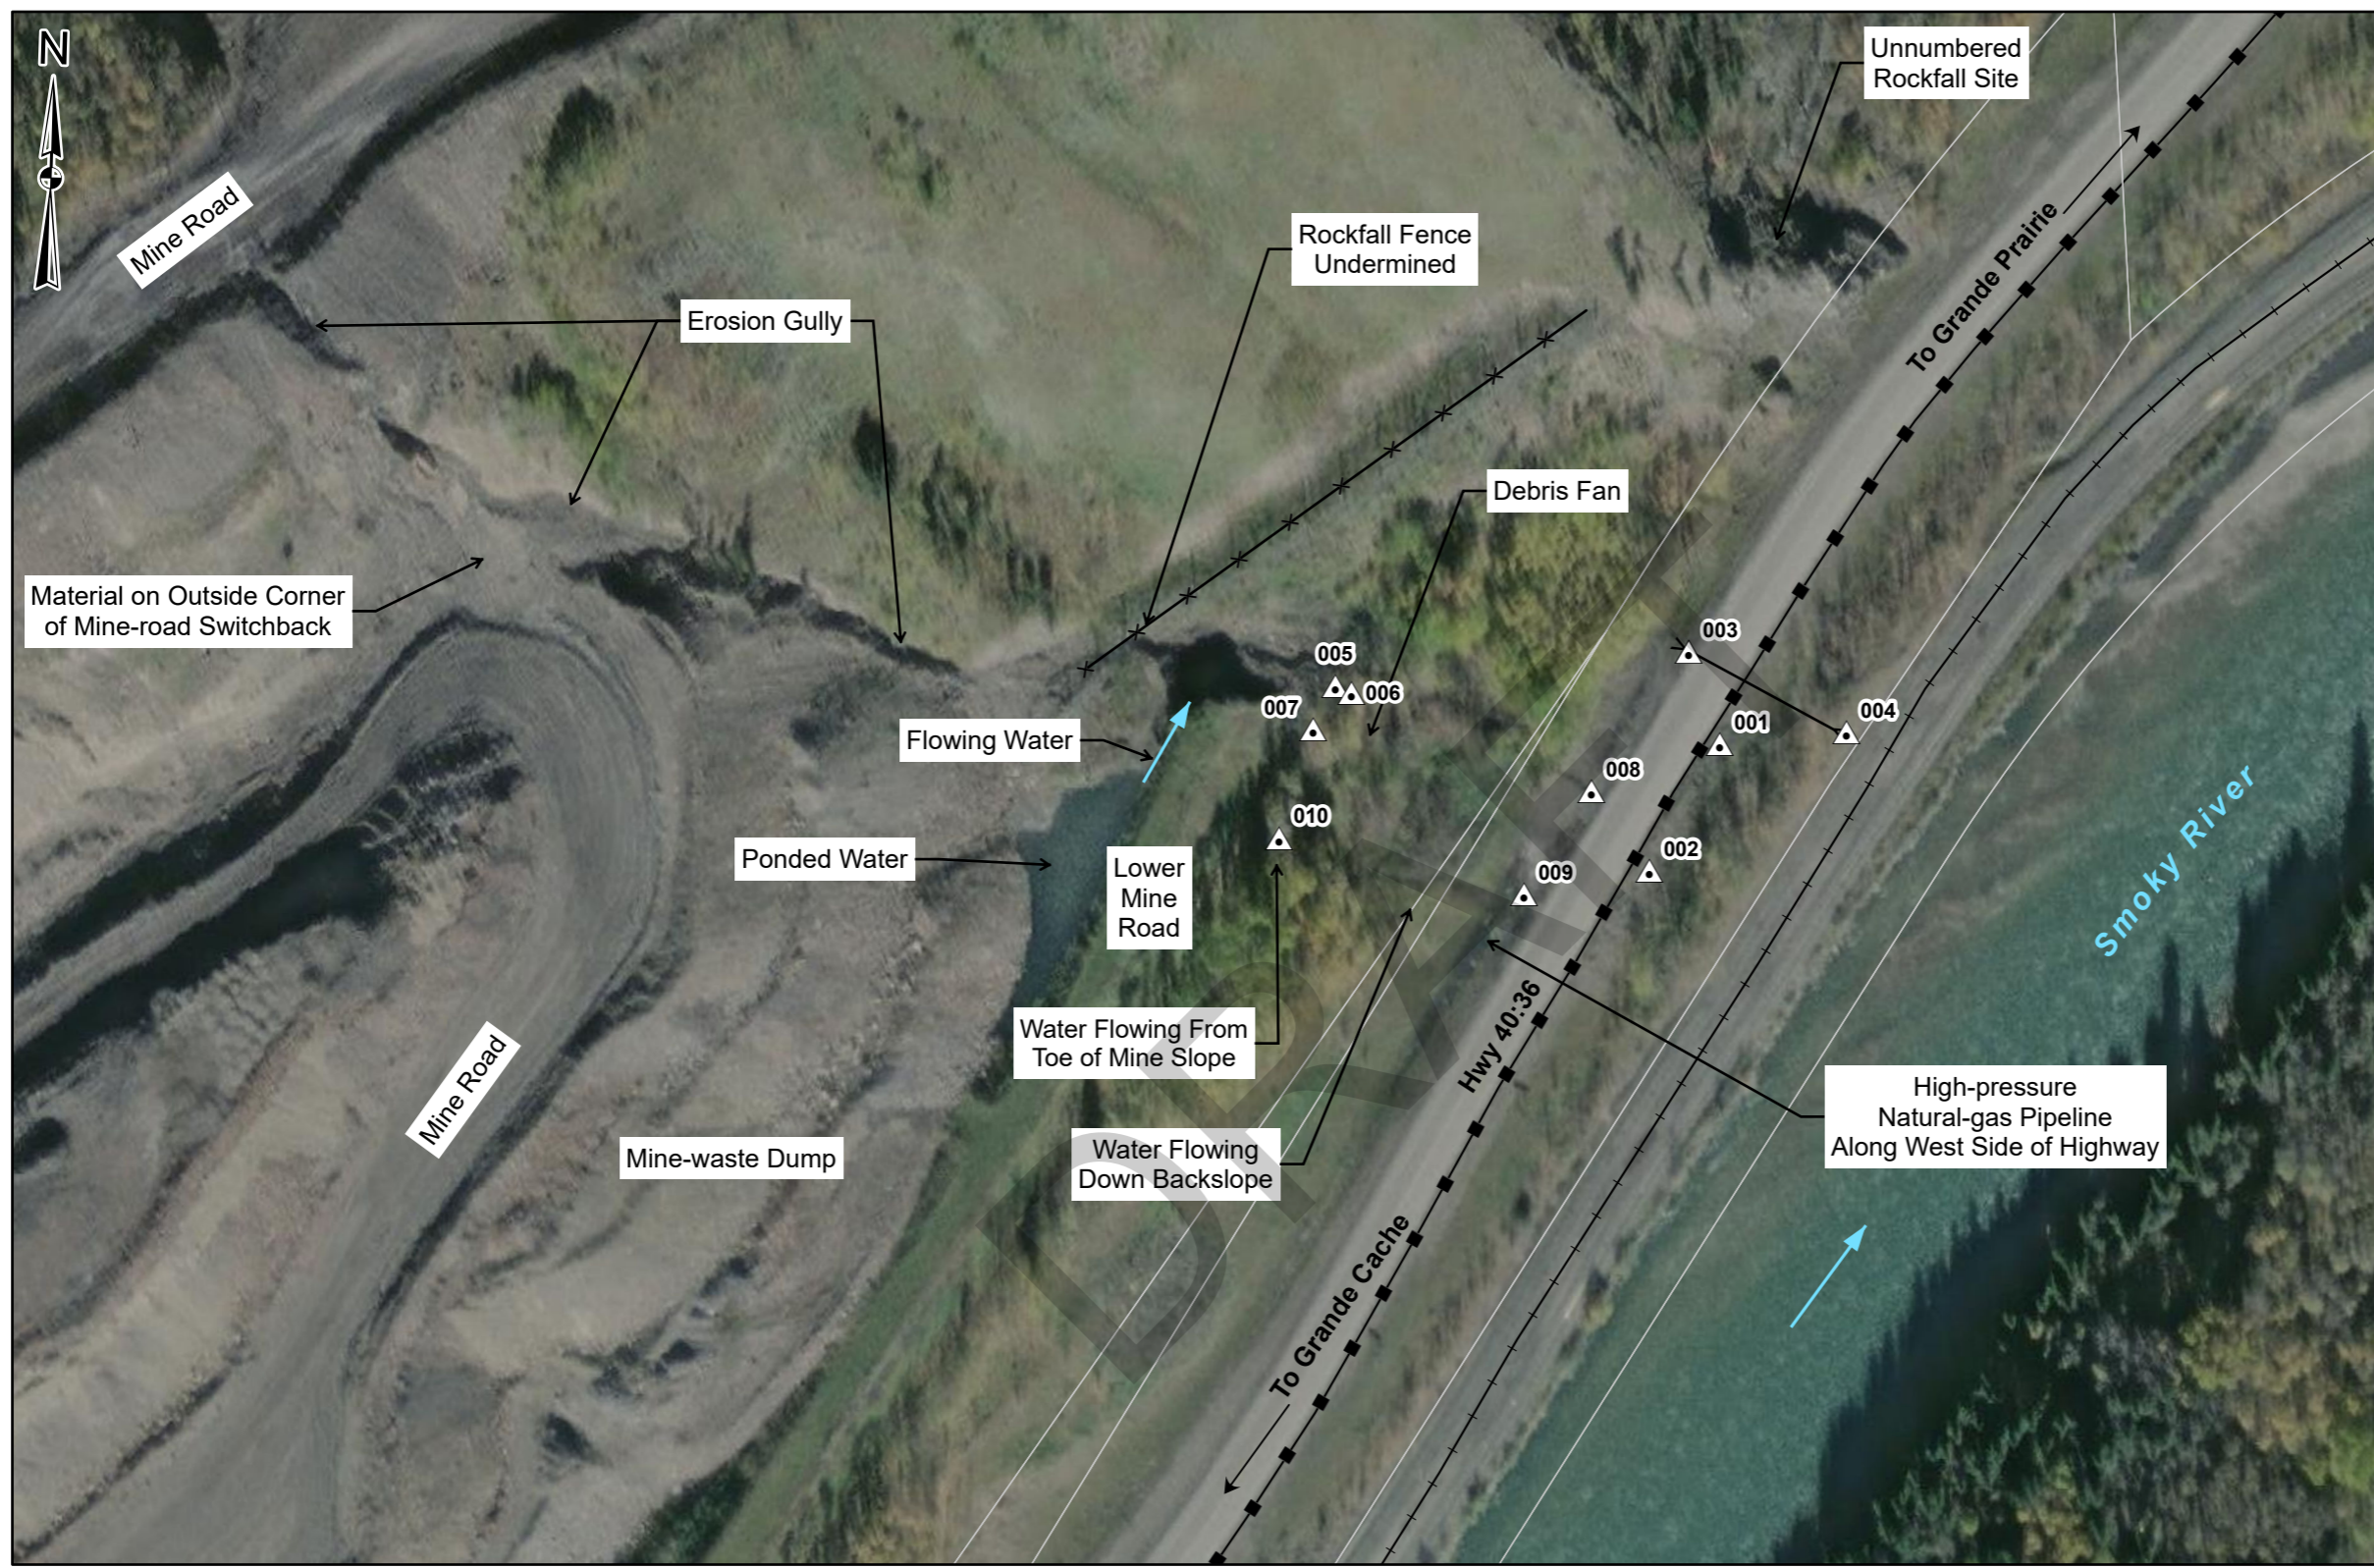
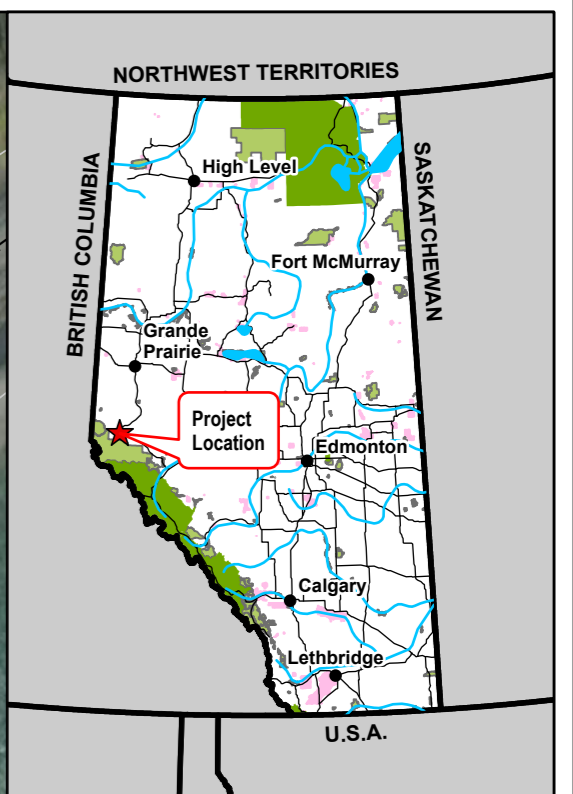
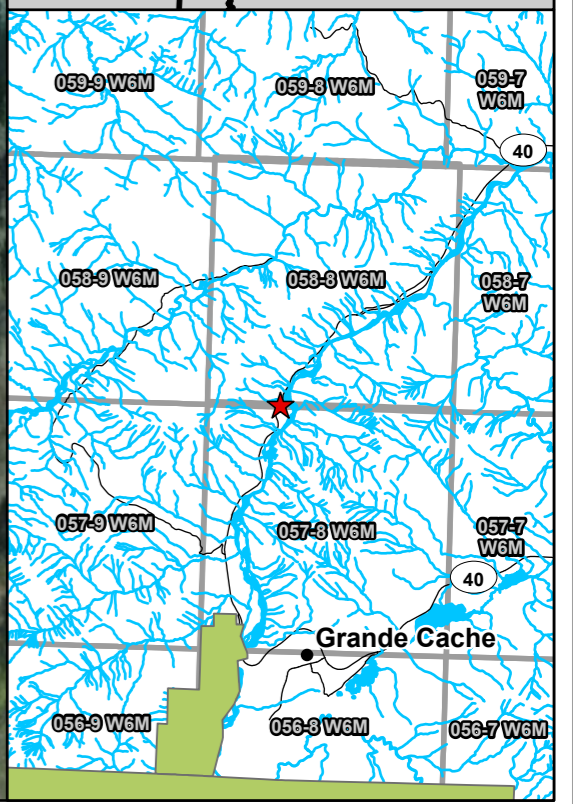
SCALE 1:1,700 PROJECT No. A05116A01 FIG No. 2

TITLE
 Site Plan
 Debris Flow
 Hwy 40:36, km 13.7

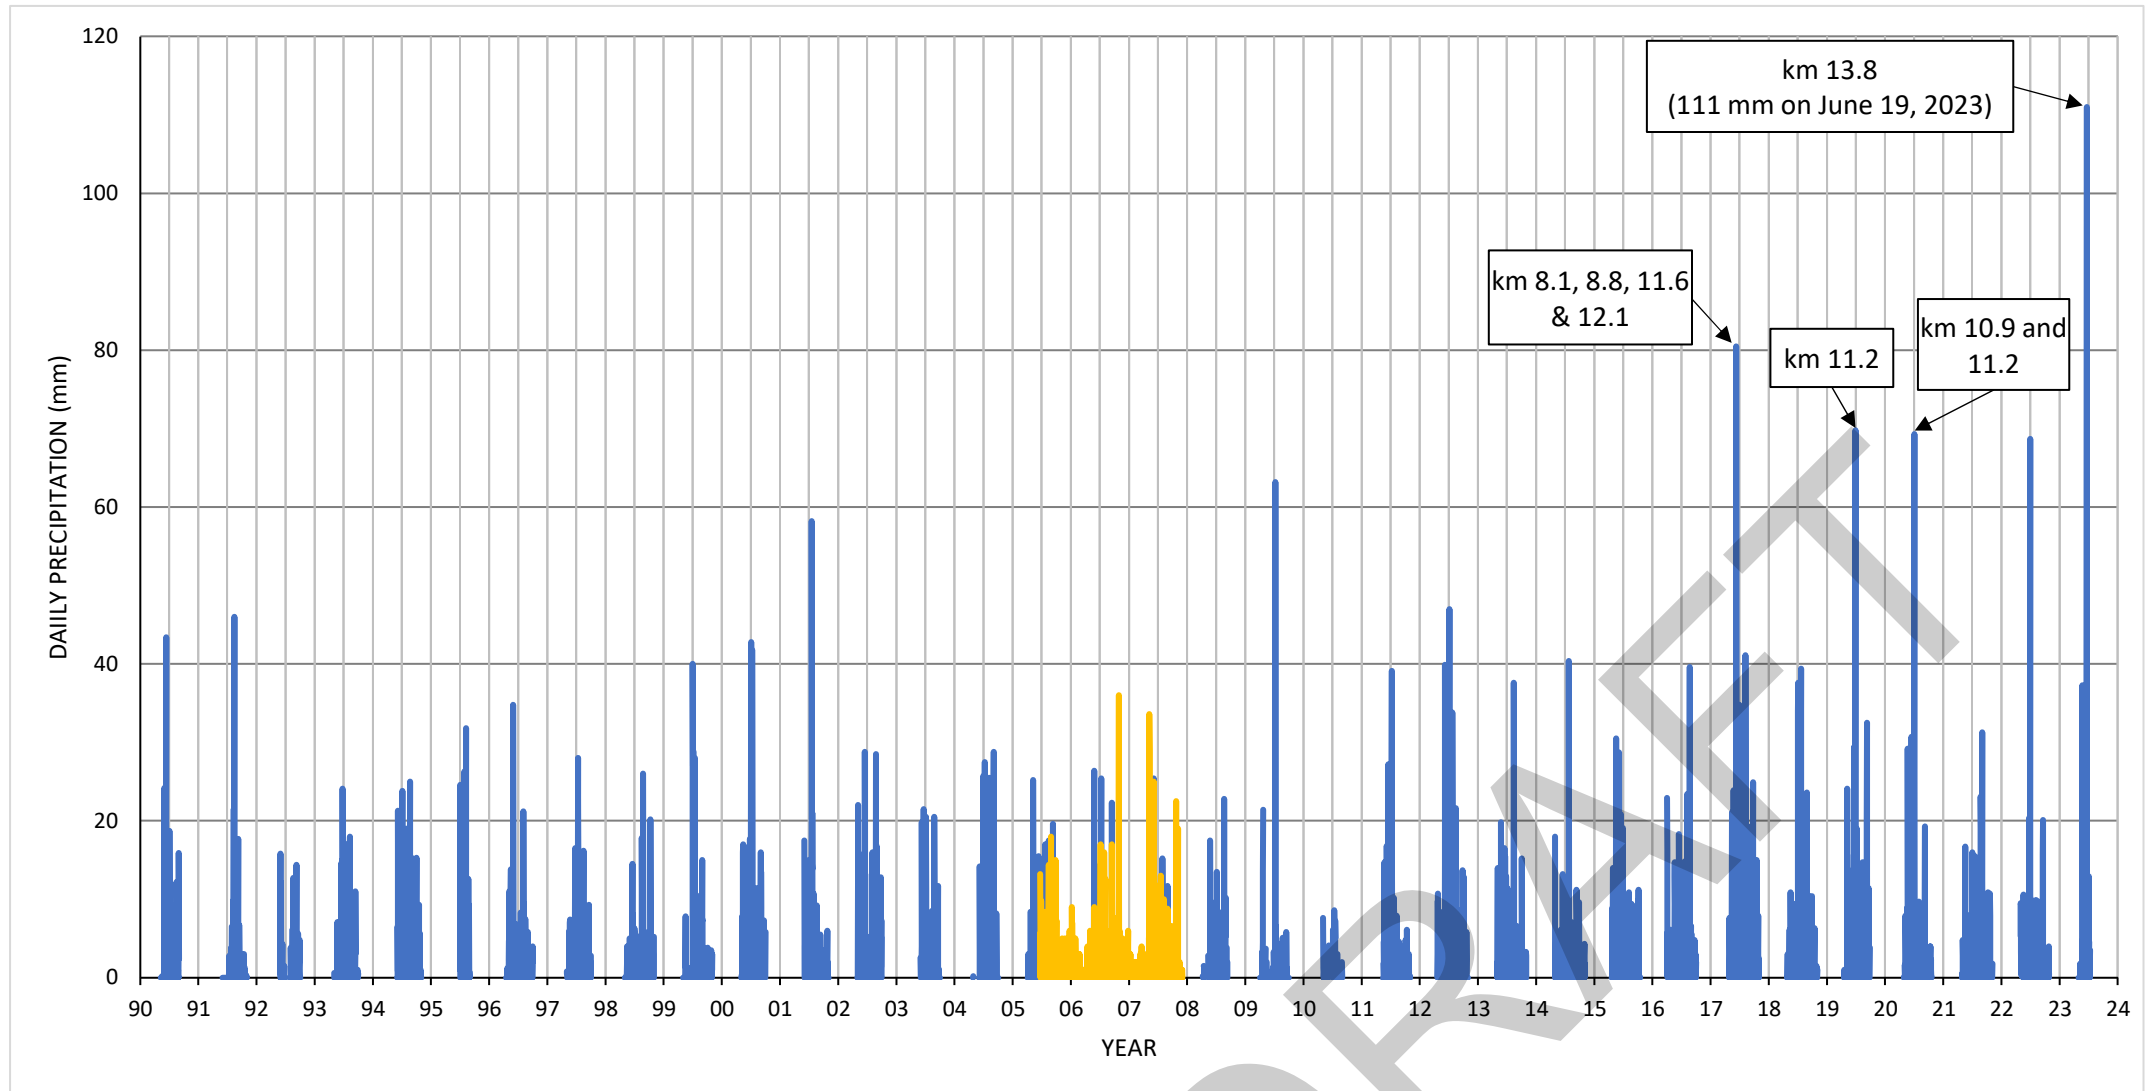
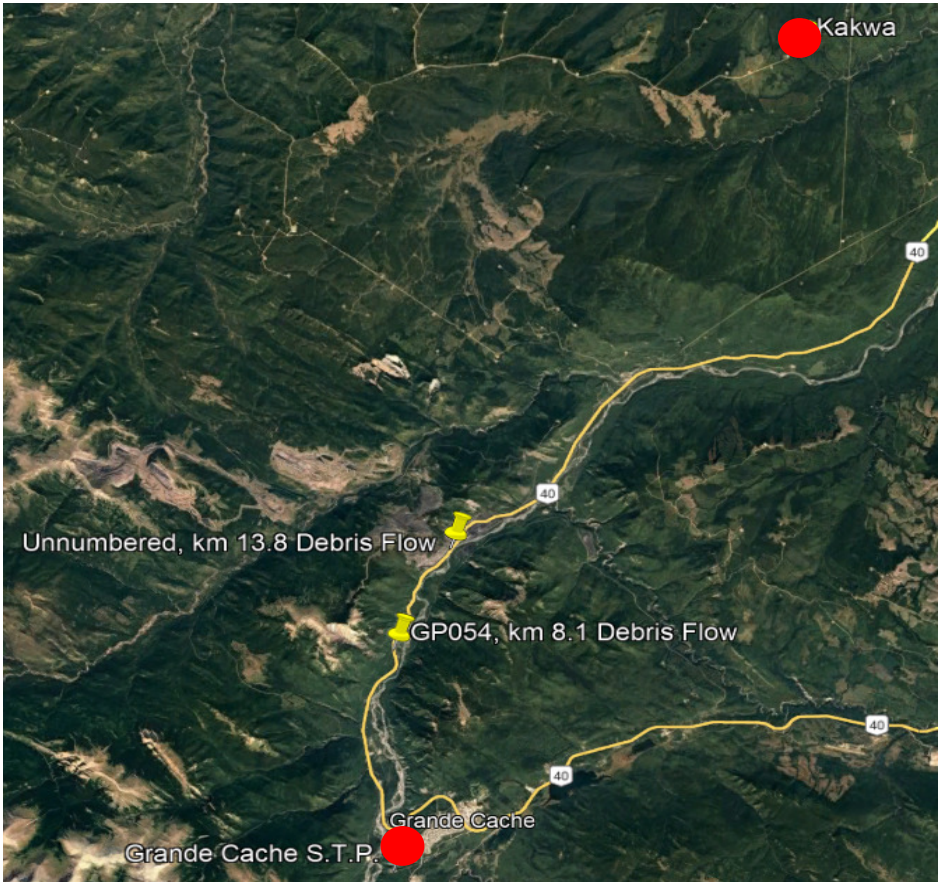
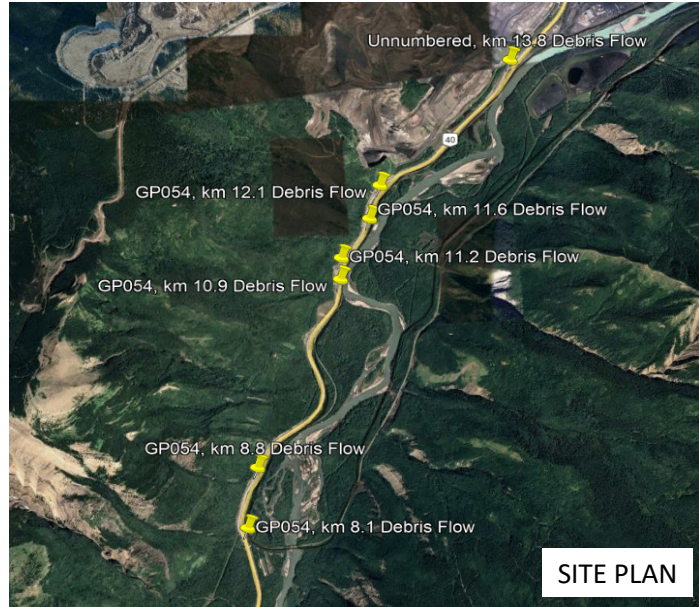
| | | SCALE | PROJECT No. A05116A01 FIG No 3 |

KCB reviewed the available precipitation data for the site from 1967 to 2023. The record is discontinuous before 1990, but the available daily precipitation data from 1990 to 2023 is shown on Figure 3. The data was recorded at the Grande Cache S.T.P. and Kakwa weather stations located approximately 15 km southwest and 26.5 km northeast of the site, respectively (ACIS 2023 and GoC 2023). As previously mentioned in KCB (2022a and 2022b) it is noted that since 1990, the five highest daily precipitation events have occurred since 2017 with daily precipitation between approximately 69 mm to 111 mm. Based on the available data the intensity frequency of heavy precipitation events appears to be increasing in recent years.

A summary of documented debris flows events by kilometer (km) and year are summarized in Table 1. Most of these events appear to correlate to the heavy precipitation years as shown on Figure 3 for the Kakwa weather station.

- Based on Figure 3 the intensity and frequency of heavy precipitation events appears to be increasing in recent years.
