CON0022166 Peace Region (Grande Prairie South) GRMP
Hwy 40:36 rockfall, km 8.395 to 17.161
Call-Out Report

1 INTRODUCTION

As part of the Geohazard Risk Management Program (GRMP) contract for the Grande Prairie South region, Klohn Crippen Berger Ltd. (KCB) was requested by Alberta Transportation (AT) to conduct a call-out inspection for rockfalls along multiple GRMP sites along Hwy 40:36 between km 8.395 to km 17.161. The site is located on the west side of Hwy 40 with the south limit of the call-out area being approximately 8 km north of Grande Cache, Alberta. The call-out area includes the GP049, GP036, an un-numbered site near a rockfall fence erected by a third party, and the newly (in 2022) created GP053 (formerly part of GP008A) GRMP rock slope sites.

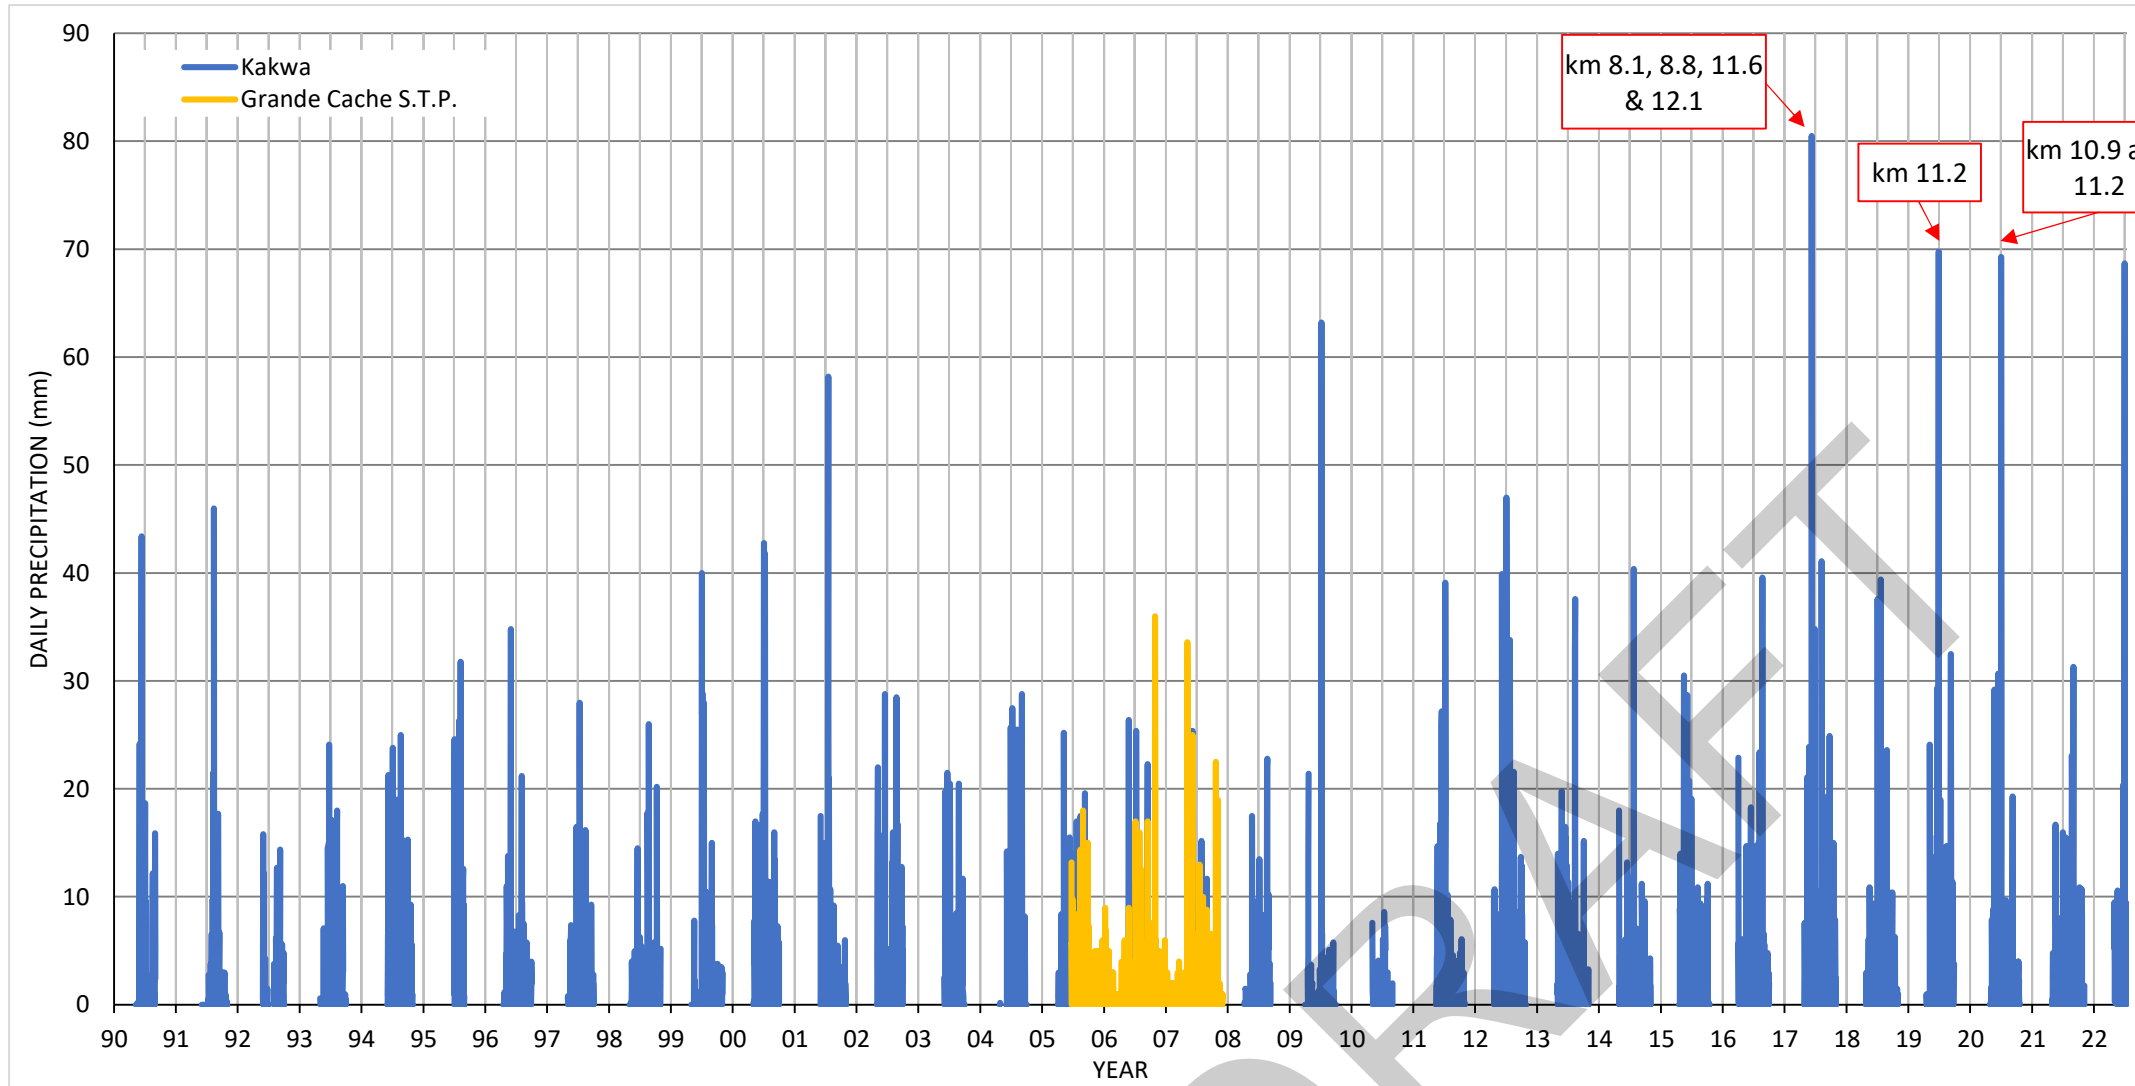
CLIENT		PROJECT	
 		PEACE REGION (GRANDE PRAIRIE DISTRICT - SOUTH) GEOHAZARD RISK MANAGEMENT PROGRAM	
		TITLE	
		Rainfall Data Rockfall Sites Hwy 40:36; km 8.119 to 12.262	
SCALE	PROJECT No.	A05116A01	FIG No. 2

We reviewed weather from nearby weather stations. Our review of precipitation data is presented in Figure 2. Note that since 1990, the four highest daily precipitation events have occurred since 2017 with daily precipitation between approximately 69 mm to 81 mm and these corresponded to rockfall and debris flow events at various locations on Hwy 40:36 as shown on Figure 2. The intensity of daily rainfall events and the frequency of intense rainfall events also appears to have increased.

- Figure 2 indicates that the intensity and frequency of heavy rainfall events appears to be increasing in recent years.
- The rockfall and debris flow events that occurred in 2020 and 2022 appear to be likely to occur again in the future.
- Increased frequency or more intense rainfall may promote additional rockfall hazard and might cause existing problem areas to shed rock blocks sooner than during historical weather conditions. However, increased precipitation may also accelerate weathering of weaker bedrock materials which, upon removal, may undermine more blocks of bedrock creating additional rockfall hazard.

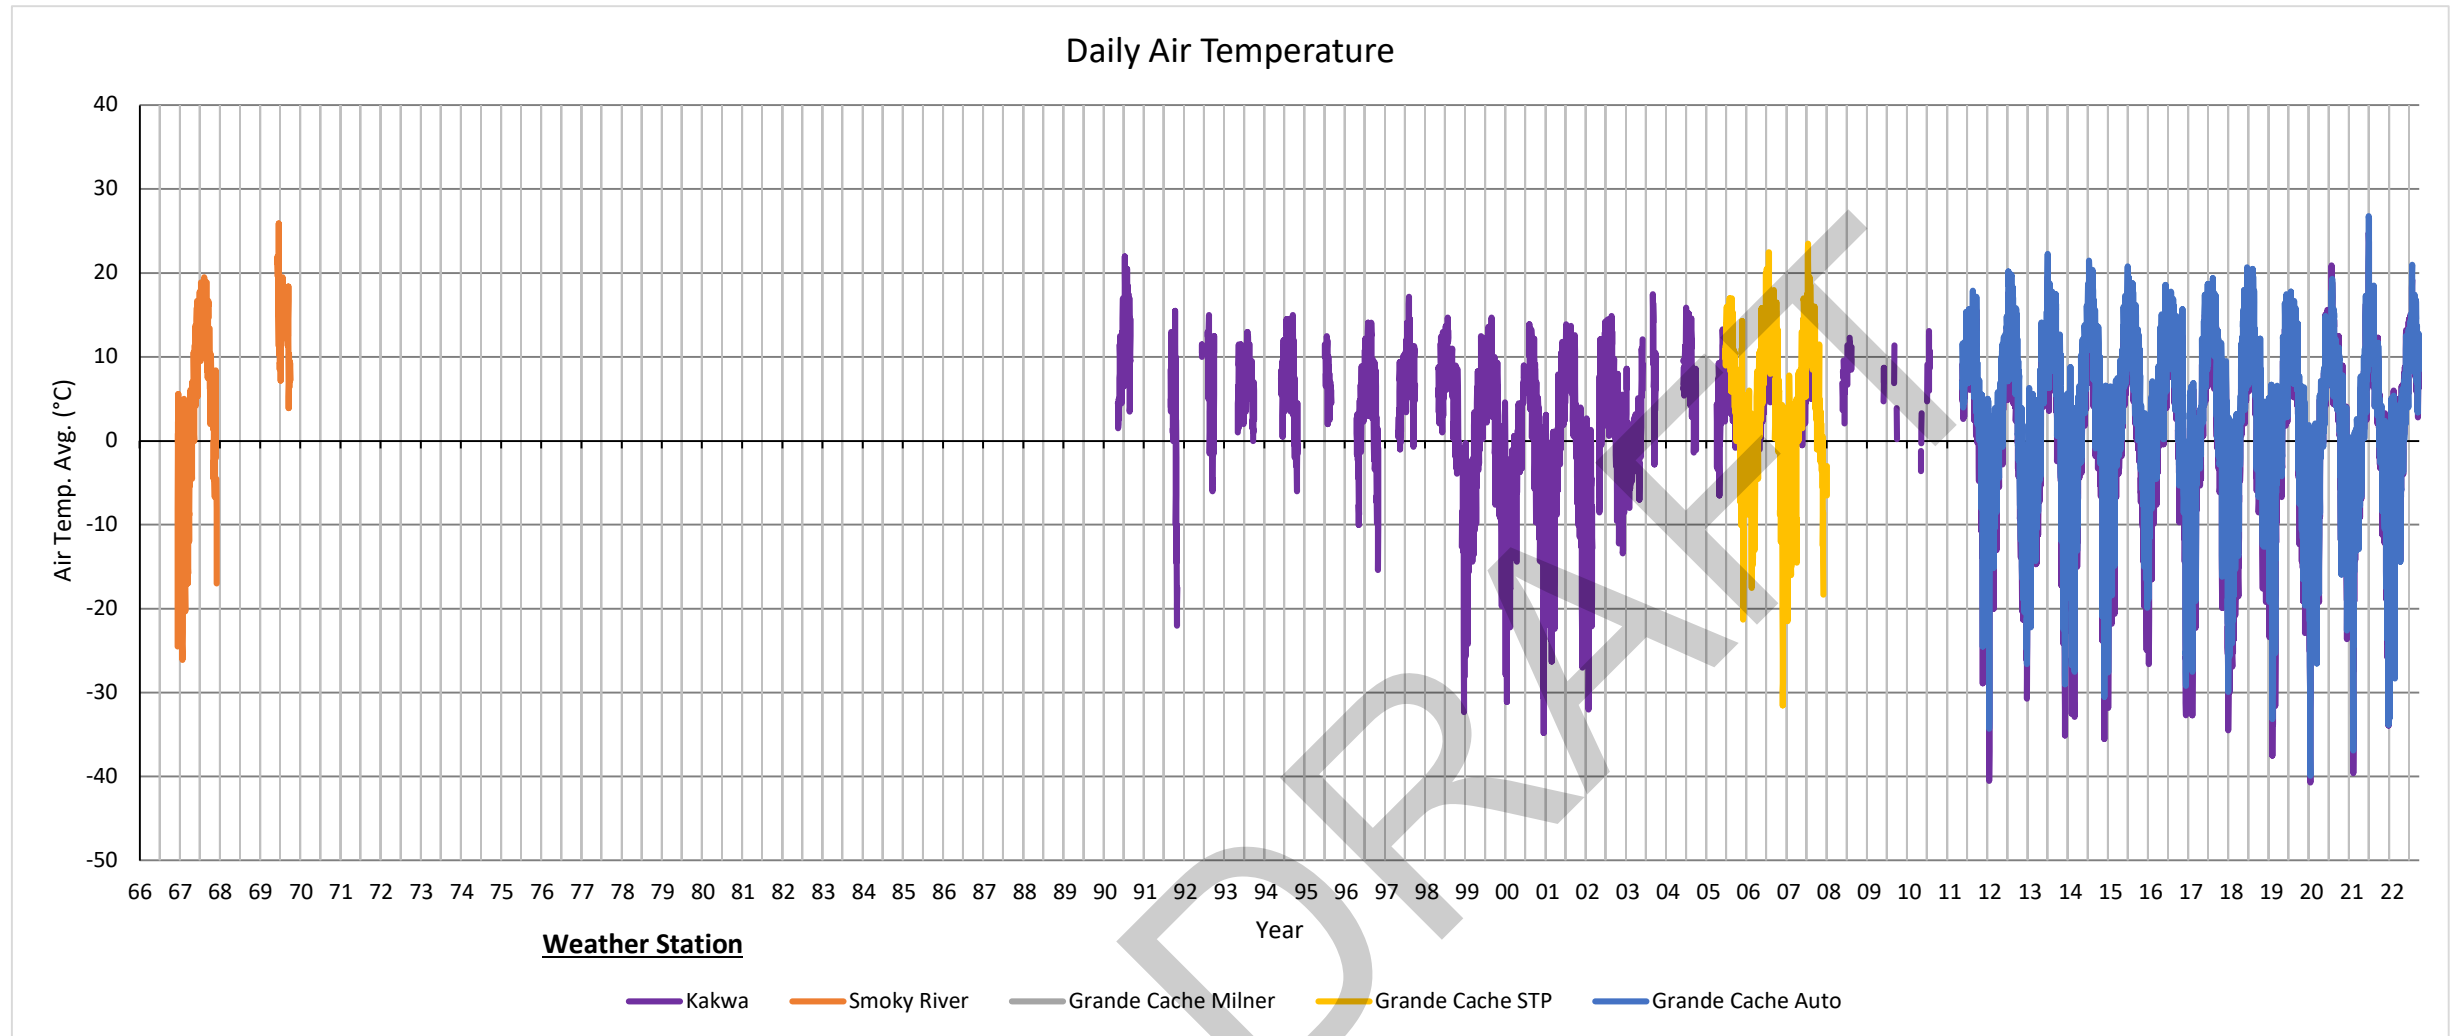
<p>CLIENT</p>	<p>PROJECT</p> <p>PEACE REGION (GRANDE PRAIRIE DISTRICT - SOUTH) GEOHAZARD RISK MANAGEMENT PROGRAM</p>
	<p>TITLE</p> <p style="text-align: center;">Air Temperature Data Rockfall Sites Hwy 40:36; km 8.119 to 12.262</p>
<p>SCALE</p>	<p>PROJECT No. A05116A01 FIG No. 3</p>

Our monthly average air temperature data review is presented in Figure 3. The air temperature data appears to indicate that since 1999 the extreme temperatures appear to have increased (i.e., colder in winter, warmer in summer) but the locations of the available weather stations are on high ground compared to near valley bottom for the subject sites which could result in the available data not being representative of site conditions. AT reports that in recent years (2019 for instance) there have been warmer winters with very little snow compared to previous years. AT has observed water running down slope later in the year than usual, as late as the end of November. AT has observed freezing and thawing conditions in the winter months that historically was not previously experienced in this area of the province.

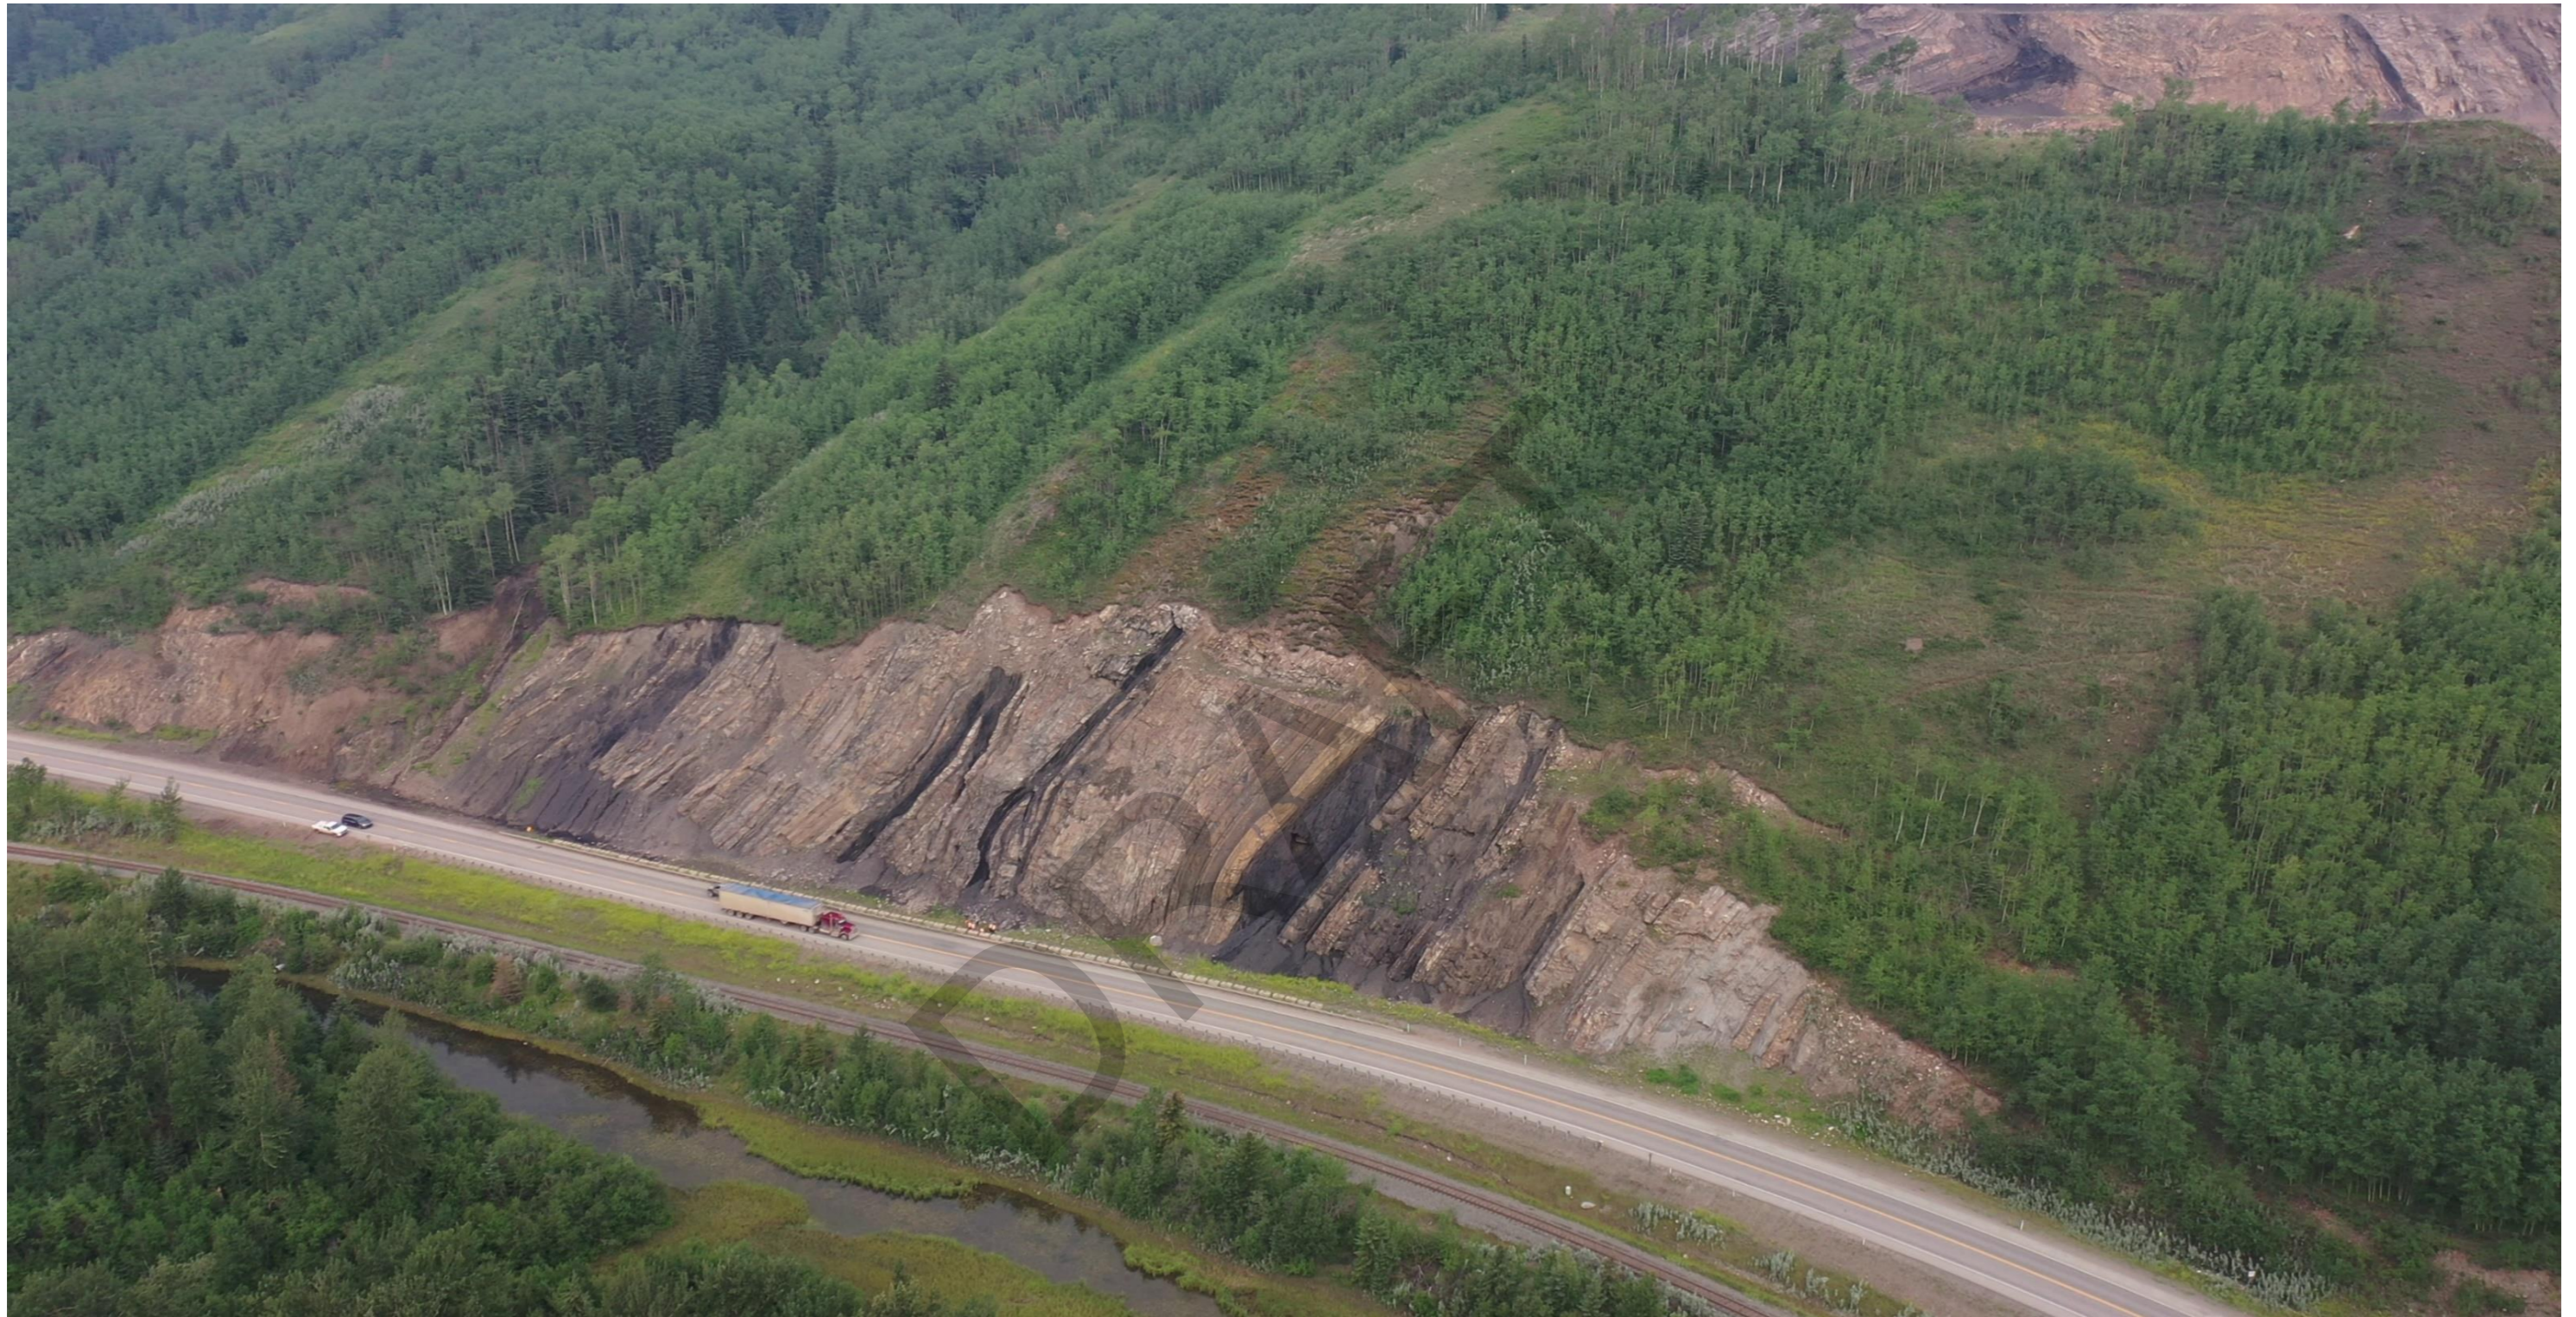
PROJECT		PEACE REGION (GRAND PRAIRIE DISTRICT - SOUTH) GEOHAZARD RISK MANAGEMENT PROGRAM	
TITLE		Site Plan	
		GP036 Rockfall 2.0 km South of McIntyre Mine Hwy 40:36, km 12.061	
SCALE	PROJECT No.	A05116A01	FIG No. 6

- There is a mine road at the crest of the slope as shown in Figure 6 (wooden powerline poles are shown in Photo GP053-I-1).

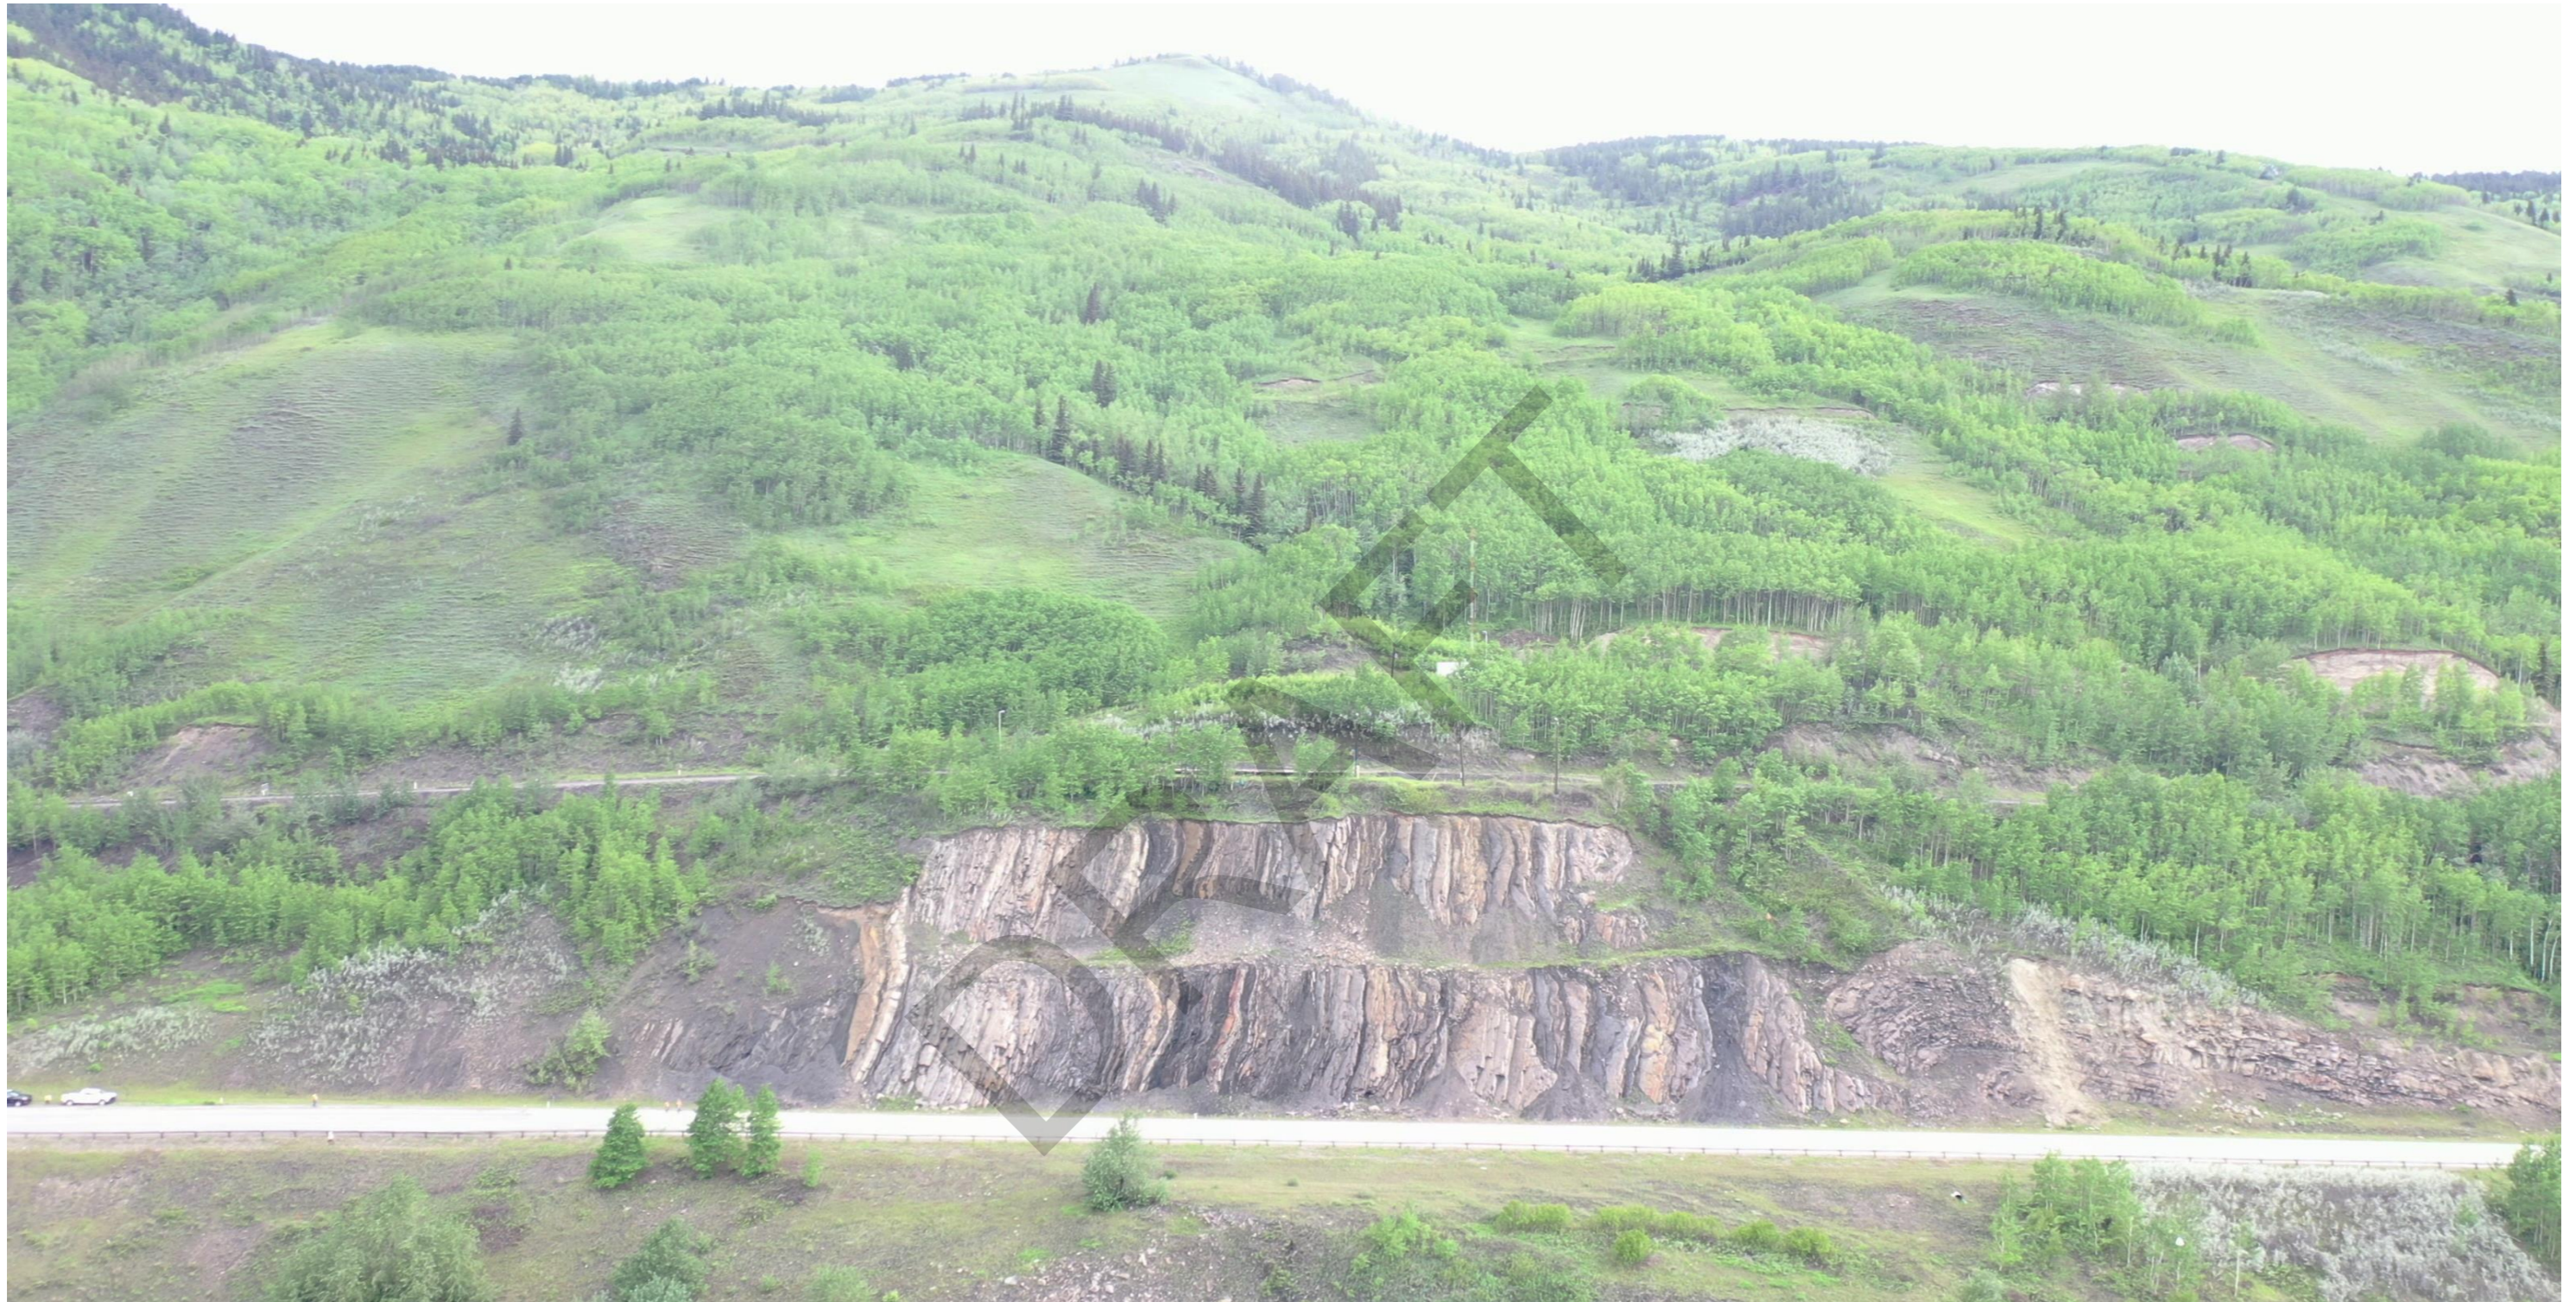
SCALE 	PROJECT No. A05116A01
		FIG No. 7

- The coal seams at this rock slope are eroding faster than the adjacent bedrock seams (Photos GP053-II-4, to -6). The talus cones in the ditch are largest near the coal seams as shown in Figure 7.

- ♦ *The slope should be scaled and the ditch cleaned of rockfall blocks and talus material.*
- A mine access road is located on the hillslope above the GP053-II rock slope. The mine access road is located at the crest of the rock slope in the north quarter of the rock slope (Photo GP053-II-6) and as shown in Figure 7. Soil located the brow of the slope might be fill associated with the mine access road. Mine-road grading and drainage practices might also contribute to rockfall or other debris falling over the crest of the road.
