July 15, 2024

CON0022166 Peace Region (Grande Prairie District – South) GRMP Instrumentation Monitoring Site GP003; H40:38, km 52.134 Cutbank River (South) Roseham Creek Section C – 2024 Spring Readings

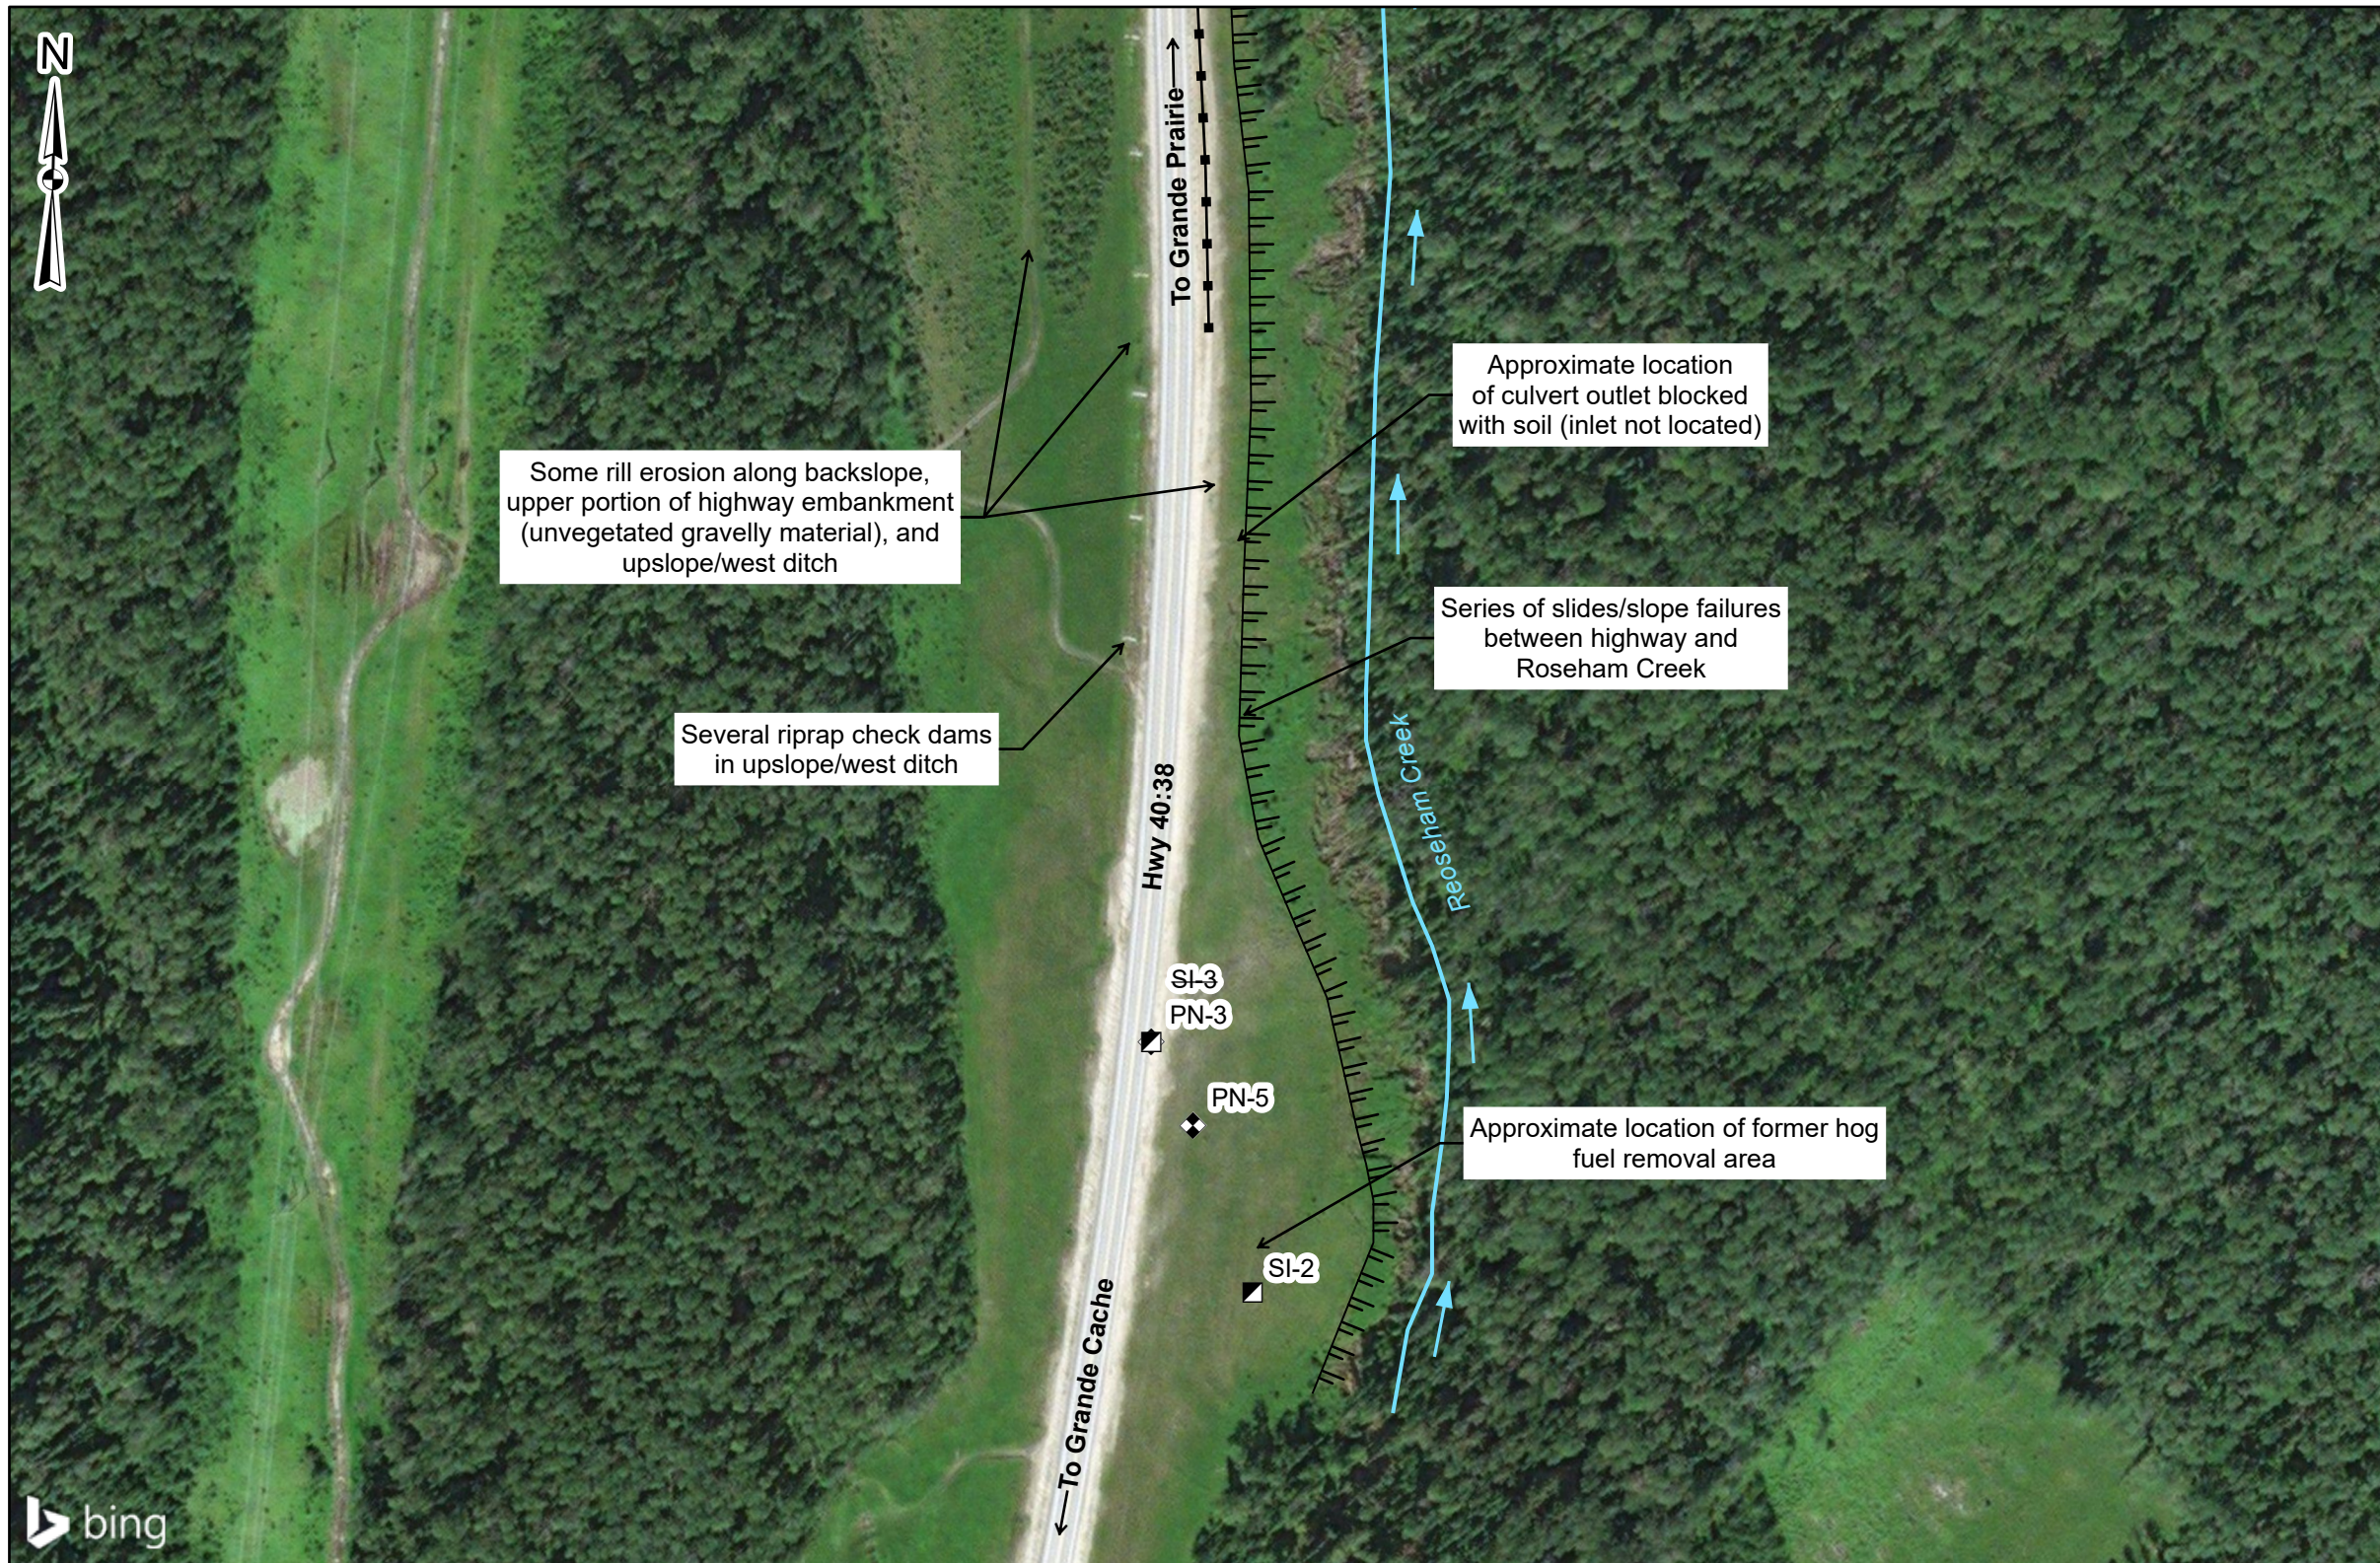
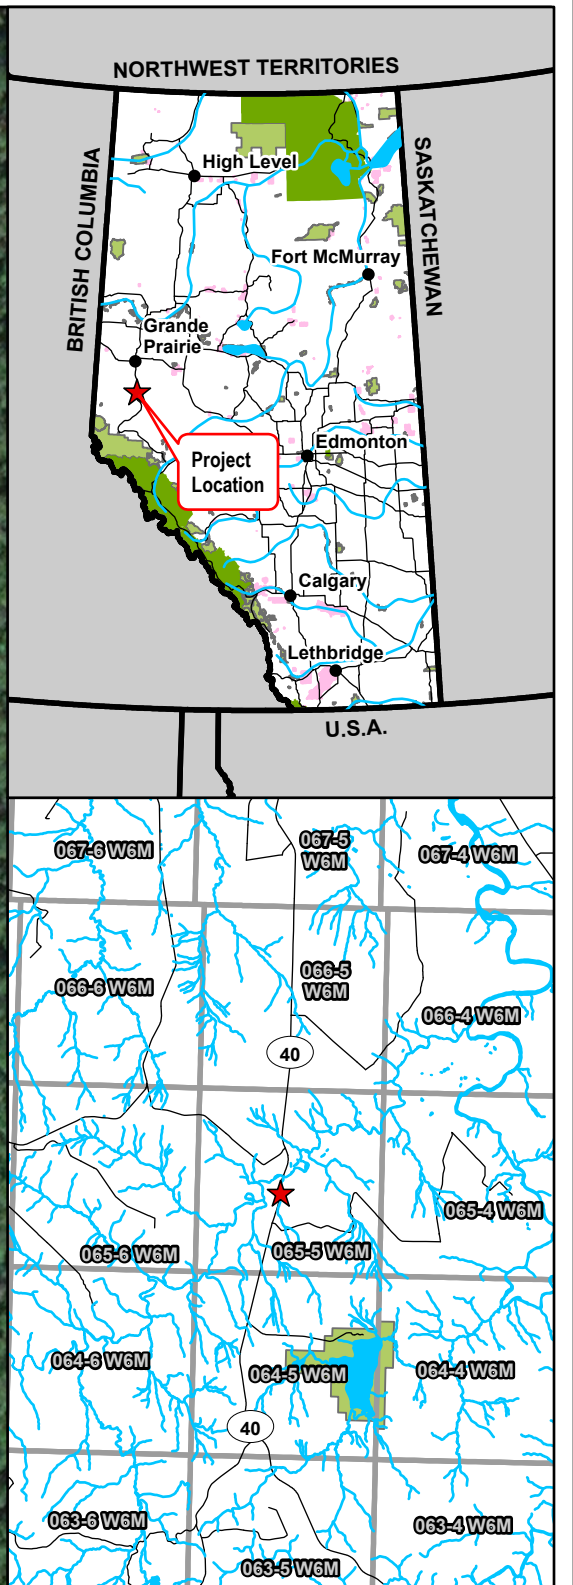
FIGURE

One slope inclinometer (SI) (SI-2) and two pneumatic piezometers (PNs) (PN-3 and PN-5) were read at the GP003 site in the Peace Region (Grande Prairie District – South) (GP South Region) on May 24, 2024, by Tim Hillman, E.I.T. of Klohn Crippen Berger Ltd. (KCB). These instruments were read as part of the GP South Region Geohazard Risk Management Program (GRMP). The site is located on Hwy 40:38, km 52.134, south of the Cutbank River bridge. The approximate site coordinates are 6054593 N, 391085 E (UTM Zone 11, NAD 83). A site plan is presented on Figure 1.

The geohazard at the GP003 site consists of a series of slides/slope failures between Hwy 40:36 and Roseham Creek. Slide movements are exacerbated by creek erosion at the toe of the slope, a high groundwater table, seepage, and low-strength glacio-lacustrine deposits.
