**PEACE REGION – GRANDE PRAIRIE
GEOHAZARD RISK ASSESSMENT
SITE INSPECTION FORM**

SITE NUMBER GP-38	SITE NAME Kakwa R. North Slide at a bridge culvert loc. (2 km north of bridge)	HIGHWAY & KM Hwy 40:42 (2 km north of Kakwa River)	PREVIOUS INSPECTION DATE <i>New Site</i> <i>no inspection previous</i>	INSPECTION DATE May 29, 2014
LEGAL DESCRIPTION -W6M	NAD 83 COORDINATES N 5,442,991 E 118,557	RISK ASSESSMENT PF: 11 CF: 6 TOTAL: 66		
		CURRENT 2014 RISK ASSESSMENT PF: 11 CF: 6 TOTAL: 66

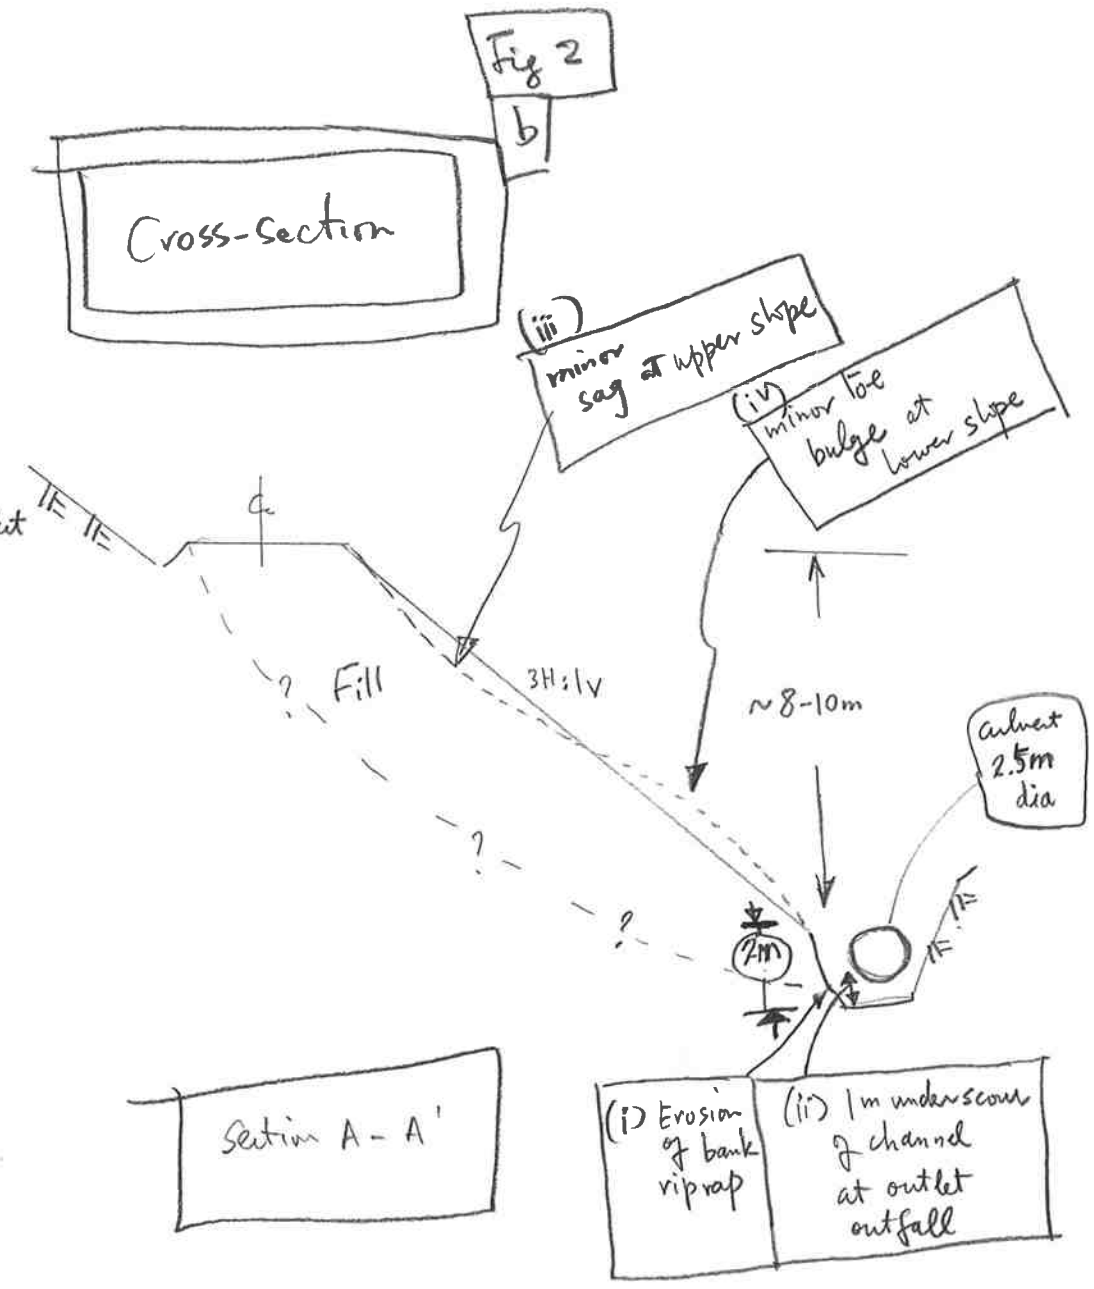
Figure 2 slide detail sketch
Hwy 40:38 Slide at 2.5km North of Kakua Kuer Bridge

note:-
(i) crack pattern	A B C D E F G H is the crack pattern as heads up shown in site photos
(ii)	SI ₁ SI ₂ suggested SI locations
