File: 2008-1002 (call out)

Date: Nov 1, 2010

Re: **Call-out Inspection Report (GP-30a) –Slide Repair**
Hwy 43:12 –Iosegun River West Backslope (Catchwater ditch) slide
Overview Summary of Slide Repair Work (1) Designed by Karl Eng (2) Construction Managed by AMEC

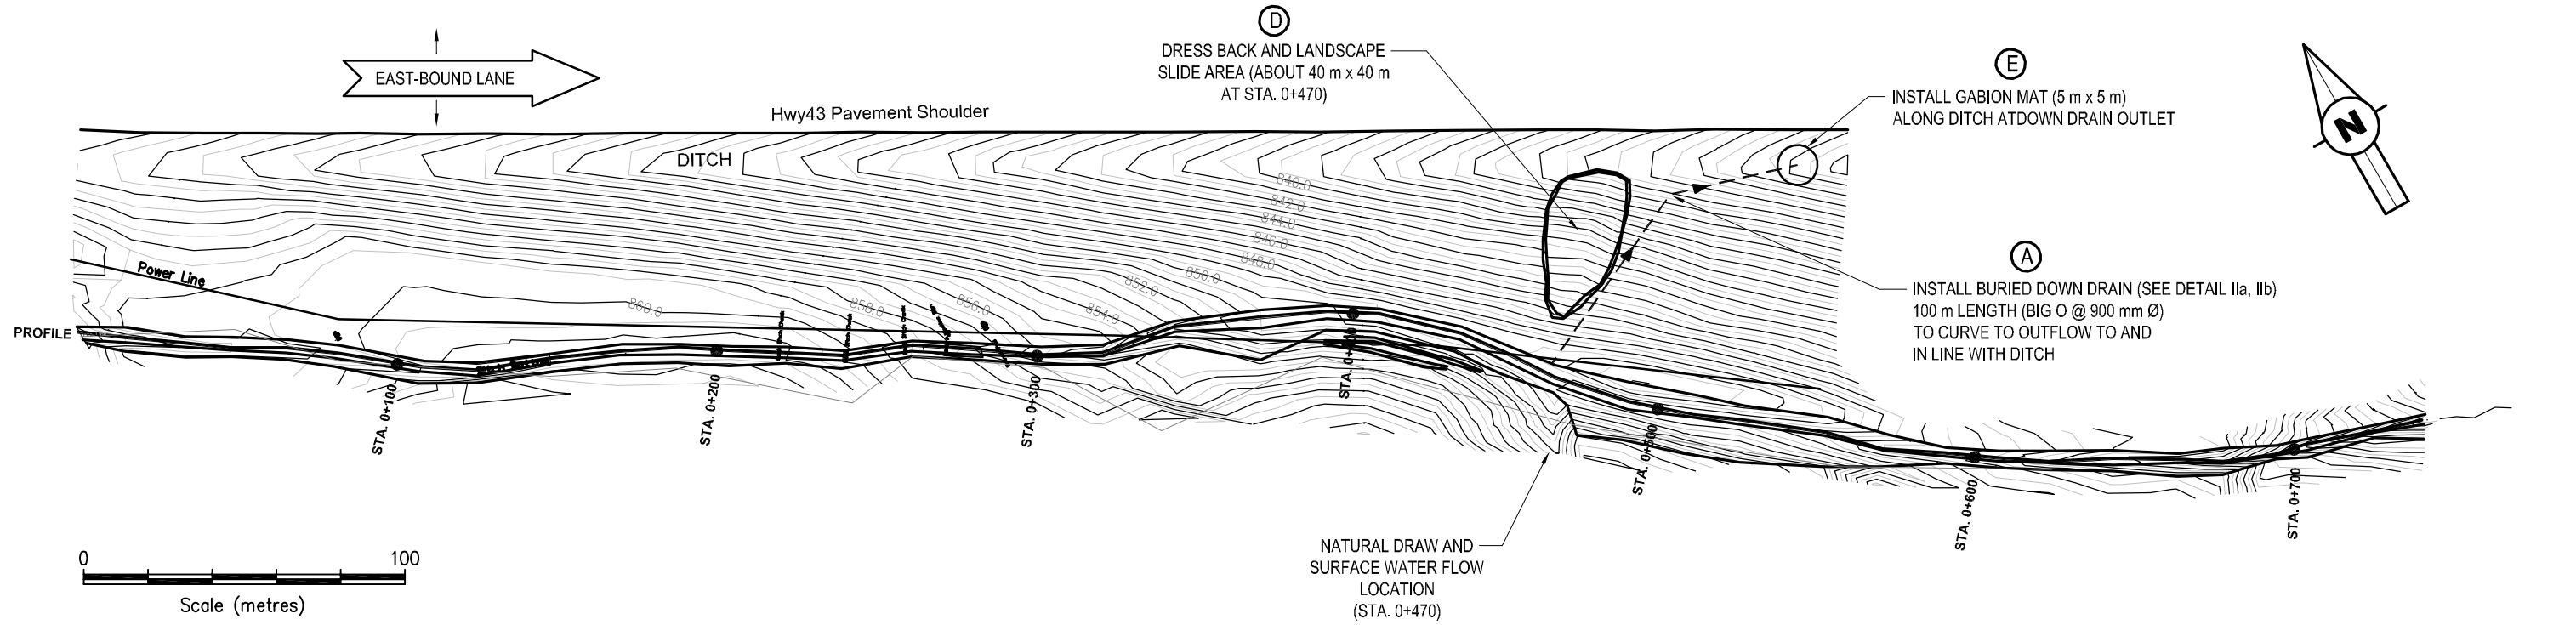
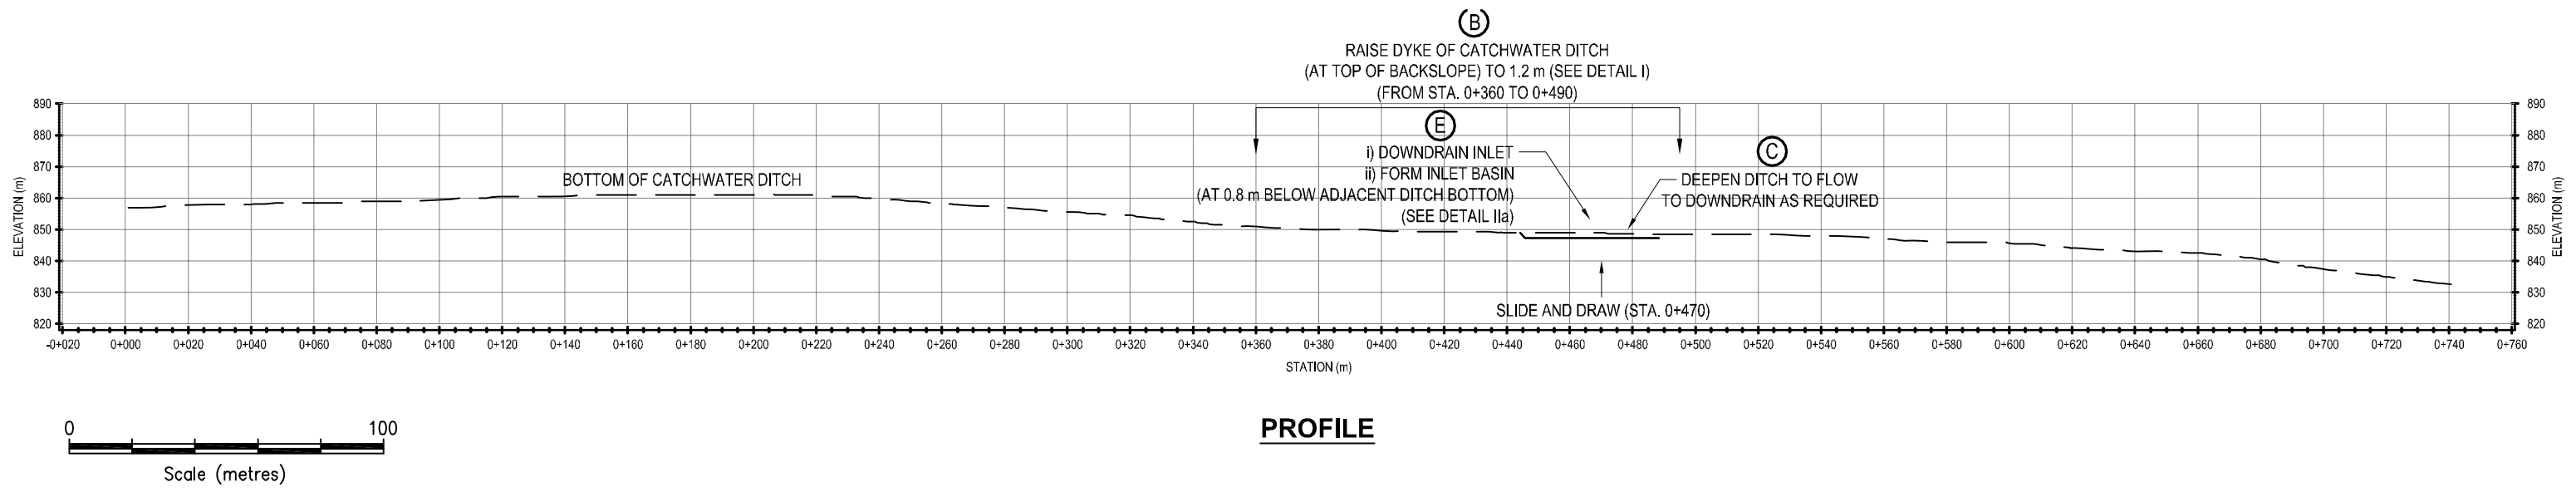
Figure 1a - Plan and Section
Hwy 43:12, Iosegun West Backslope
Slope Slide Repair and Drainage Works (A to E)

- i) Downdrain
- ii) Catchwater Ditching Improvements
- iii) Slope Relandscape
