**ALBERTA TRANSPORTATION
GEOHAZARD ASSESSMENT PROGRAM
PEACE REGION – SWAN HILLS DISTRICT
2020 CALL OUT INSPECTION**

Site Number	Location	Name	Hwy	km
Call Out – GP052	North of Debolt	Puskwaskau River Slide	736:02	27.1
Legal Description		UTM Co-ordinates (NAD 83)		
NW26-74-1-W6		11U N 6,144,288	E 434,543

Date	PF	CF	Total
Previous Inspection:				
Current Inspection:	May 30, 2020	13	5	65
Road AADT:	130	Year:		2019
Inspected By:	Don Proudfoot, Nicole Wilder (Thurber) Ed Szmata, Rishi Adhikari (AT)			
Report Attachments:	<input checked="" type="checkbox"/> Photographs <input checked="" type="checkbox"/> Plans <input type="checkbox"/> Maintenance Items

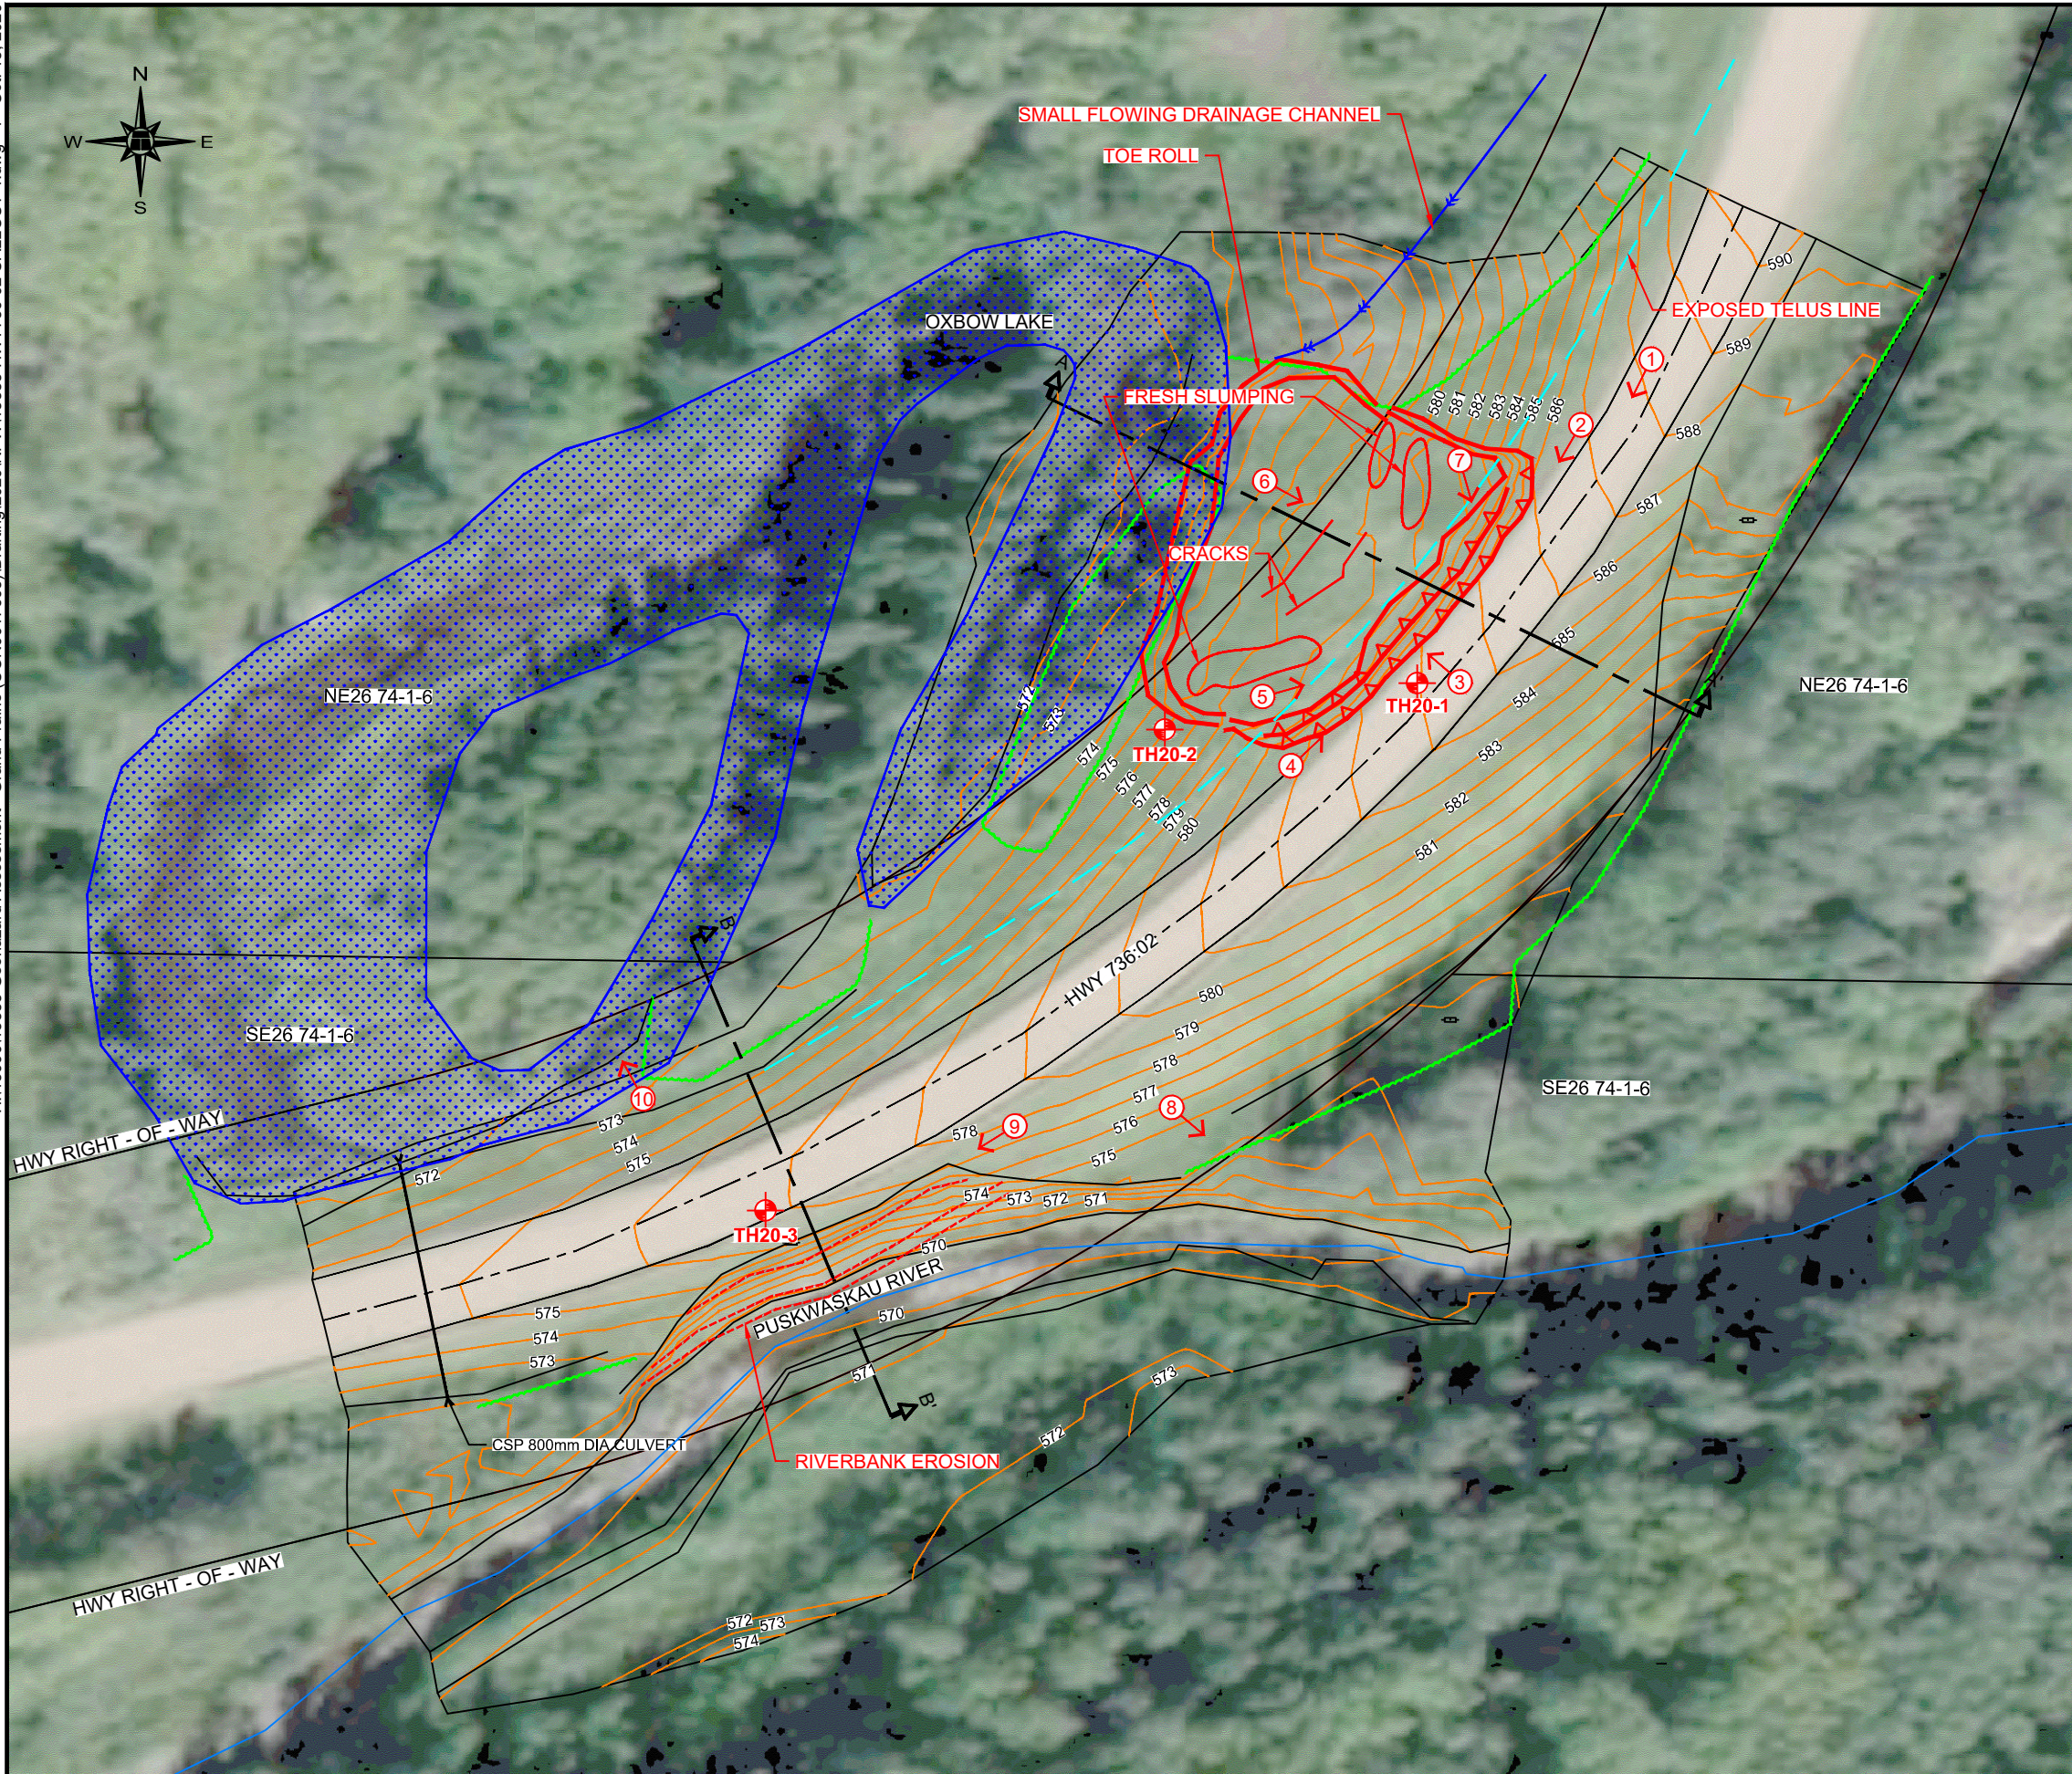
DWG No. 13353 HWY 736:02-CALLOUT-1

Primary Site Issue:	Landslide with a 5 m high backscarp in embankment fill on northwest side of highway which is now cutting into road edge.		
Dimensions:	The slide is about ~20 m long by 40 m wide and there is an overly steepened bank along the Puskwaskau River which has been eroded.		
Date of any remediation:			
Maintenance:			
Observations:	Description	Worse?	
<input checked="" type="checkbox"/> Pavement Distress	The main scarp has retrogressed into the highway and a portion of the southbound lane has slid away.	<input type="checkbox"/>	
<input checked="" type="checkbox"/> Slope Movement	The landslide occurred within the west sideslope of a 13 m high embankment fill, adjacent to an oxbow. The toe roll is present at the base of the slope encroaching into the oxbow, while the backscarp has retrogressed into the highway. On the south side of the highway an overly steep riverbank has been eroded and has sloughed into the river causing it to retrogress towards the highway.	<input type="checkbox"/>

There was damage to the highway as the backscarp had retrogressed into the highway and there was relatively fresh sloughing and moist/wet soil within the slide mass, which was marked with many small tension cracks and tears further downslope within the slide mass, along with free ponding of water in a couple low lying tears.

The riverbank next to the Puskwaskau river on the other (south) side of the highway is very steep. The river appears to eroding/undercutting the bank which causes the overhang to slough into the river and this process continues to retrogress towards the highway. At the time of the inspection the erosion was approximately 6 m away from the highway; however, there was a leaning power pole that will likely be compromised soon.

Potential repair options for the west landslide area are as follows:

Option 1:

Sub-excavate the failed slide mass down to intact foundation soil and rebuild the slope with imported pit run gravel with layers of geogrid. The excavation for the gravel wedge would likely need to extend to about the east shoulder of the highway, requiring a depressed detour on the east slope, however this should be confirmed by the slope stability assessment. The new fill material should be placed and compacted in thin horizontal lifts, benched into the intact slope surface, utilizing a gravel shear key (if required) to stabilize the slide area. Some of the more suitable excavated clay material could be used to provide a clay cap overtop the gravel as the finished slope surface to shed runoff, with any excess removed from site. A subdrain should be installed along the base of the slide excavation to drain any subsurface water that may enter the new fill zone.
