November 6, 2023

**ALBERTA TRANSPORTATION AND ECONOMIC CORRIDORS GRMP (CON0022164)
PEACE REGION (PEACE RIVER DISTRICT)
INSTRUMENTATION MONITORING RESULTS – FALL 2023**

SECTION C

SITE PH009: OLD HWY 2:02 SHOP SLIDE

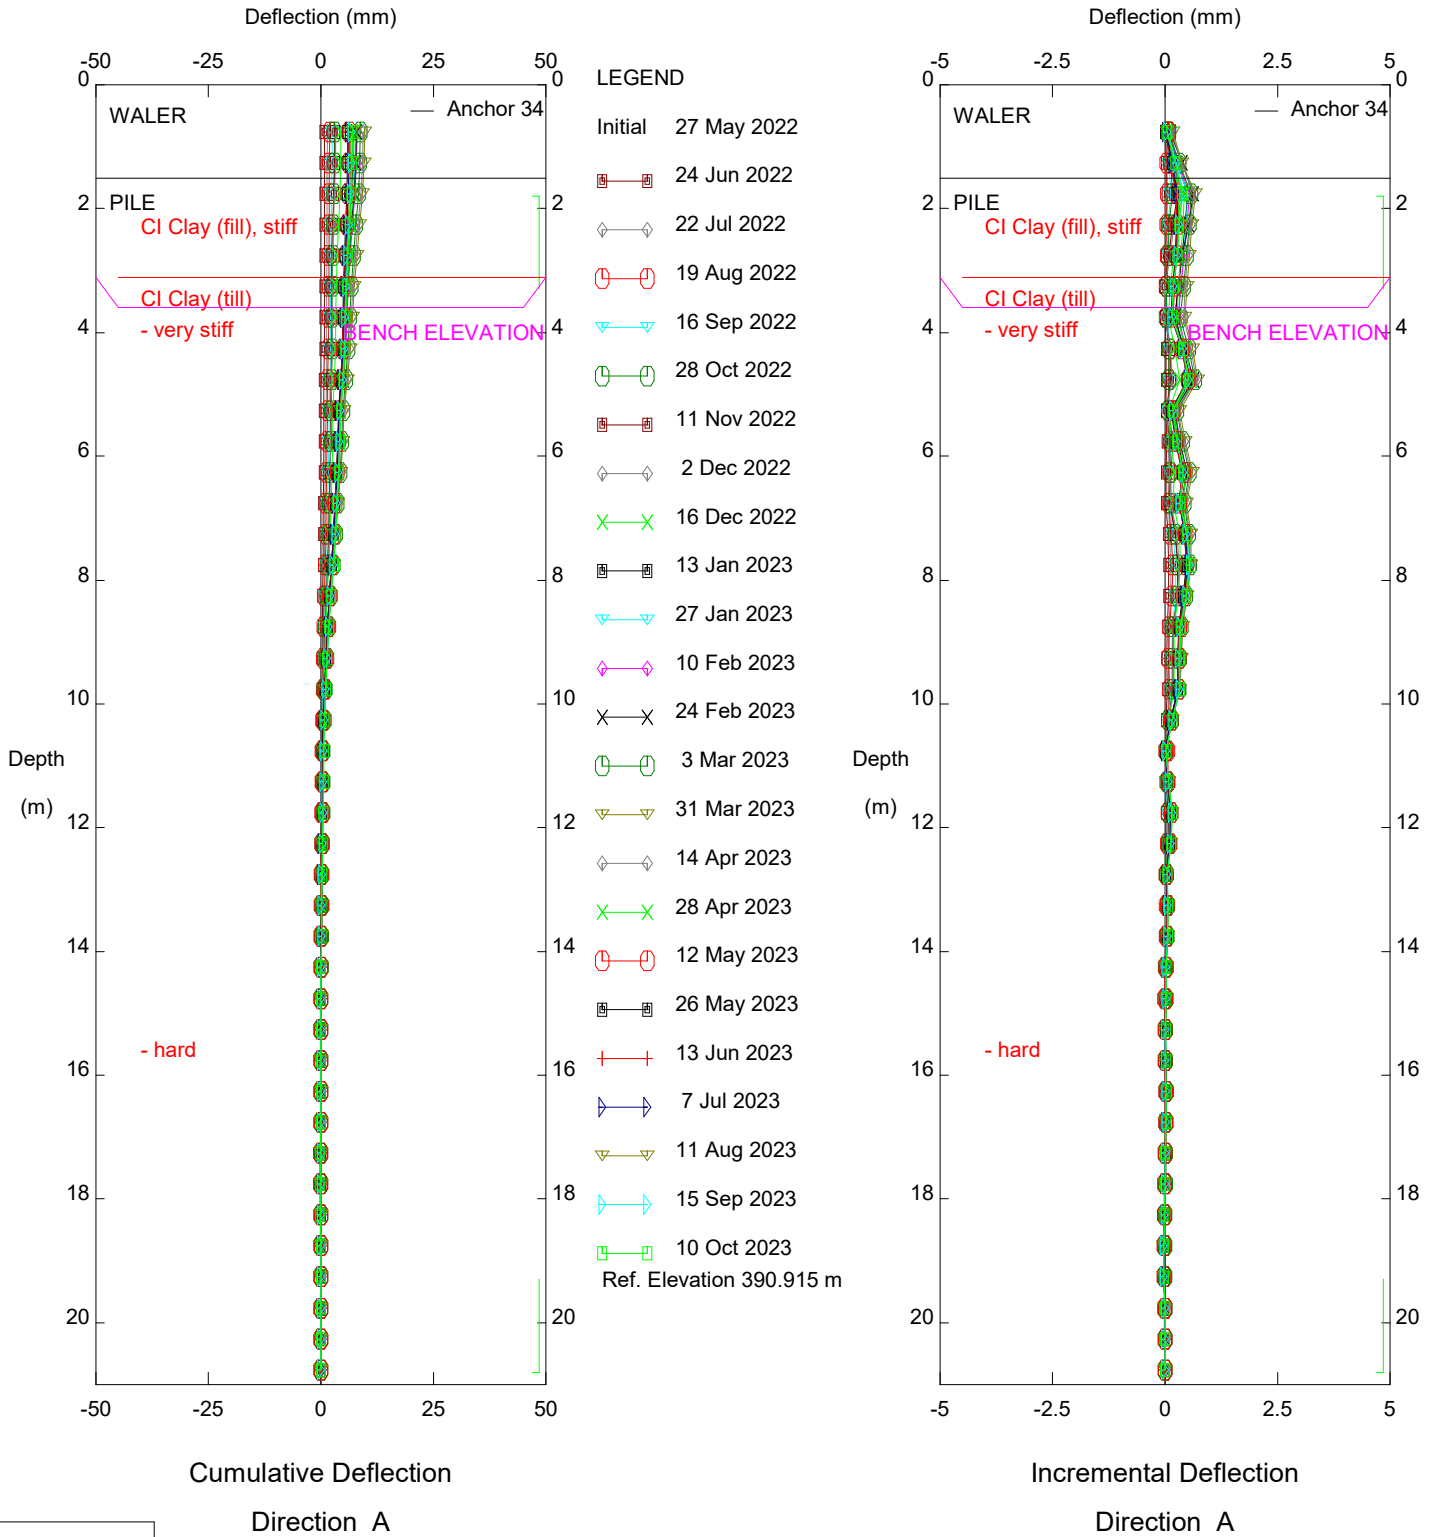
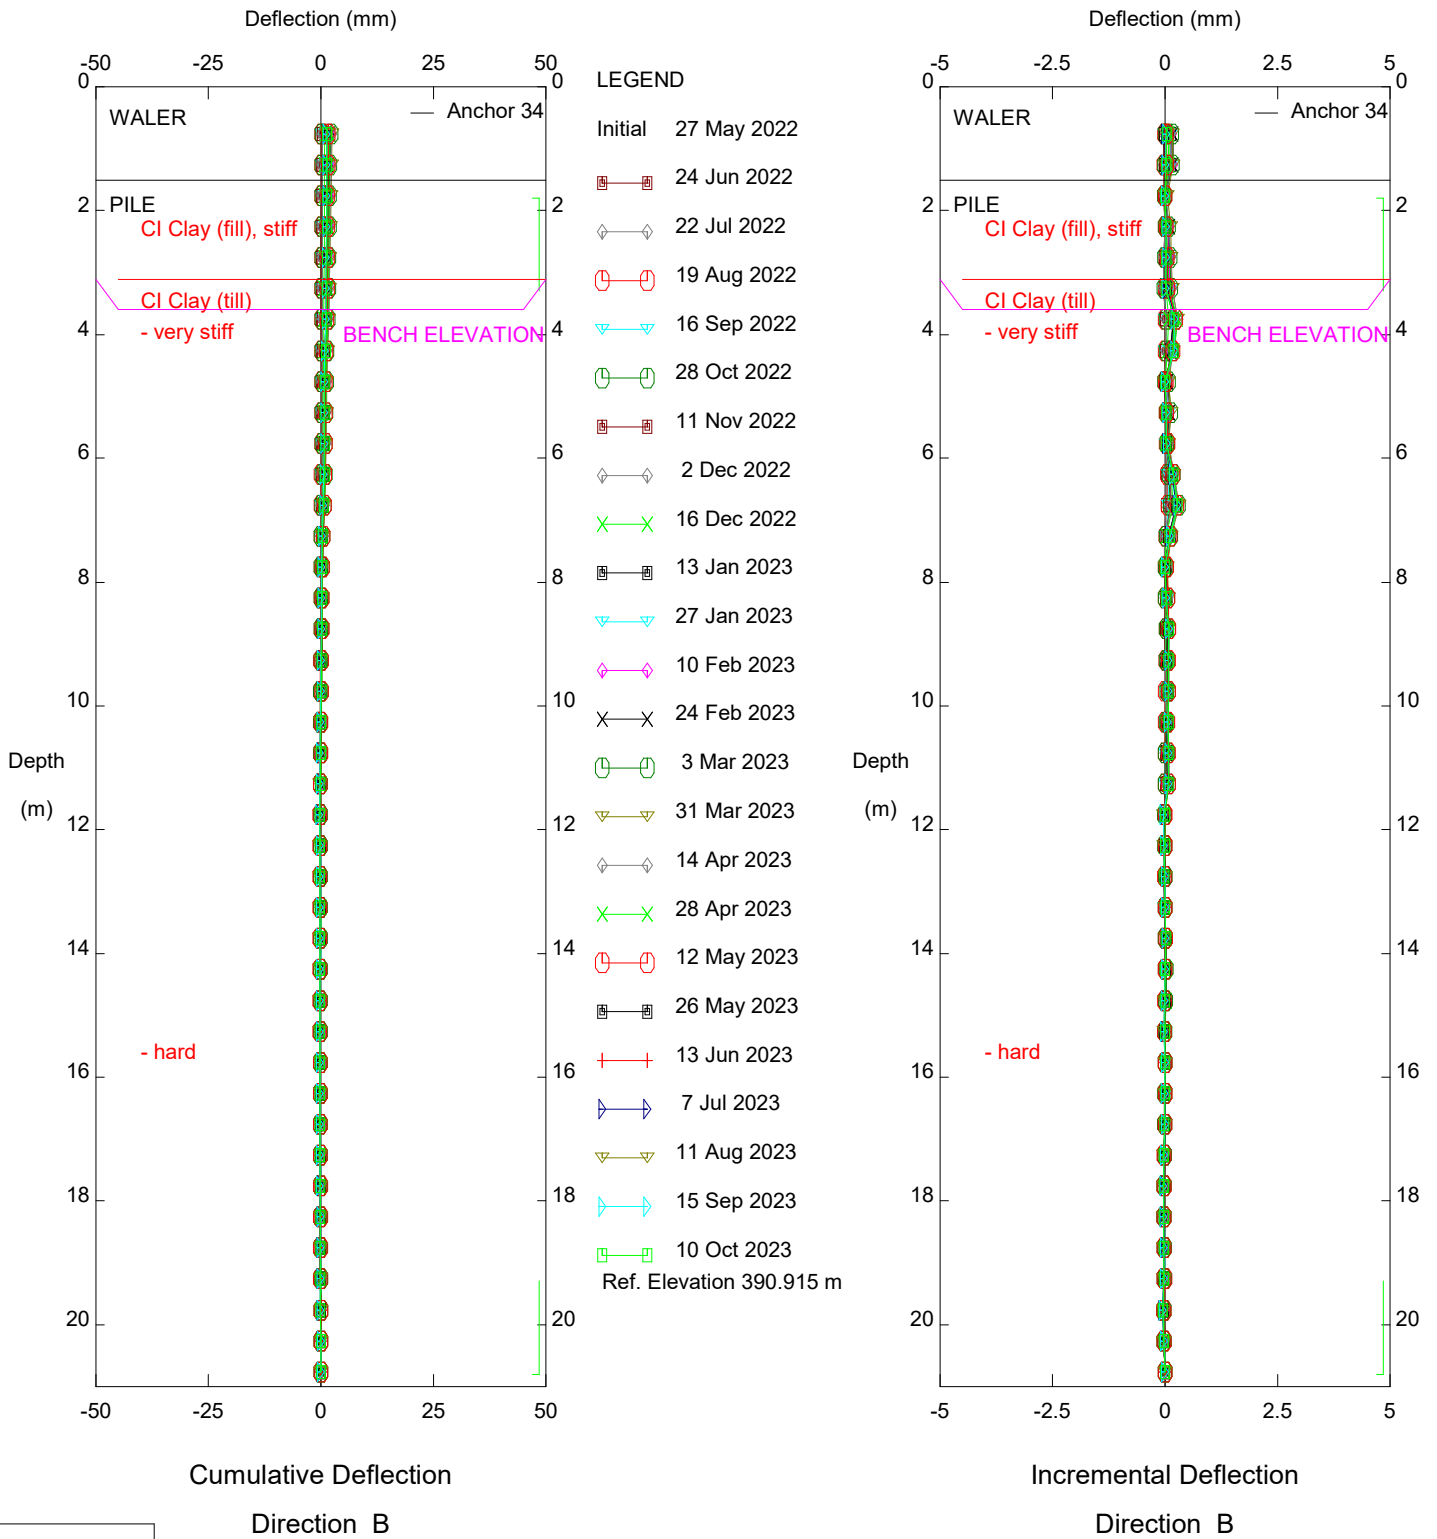
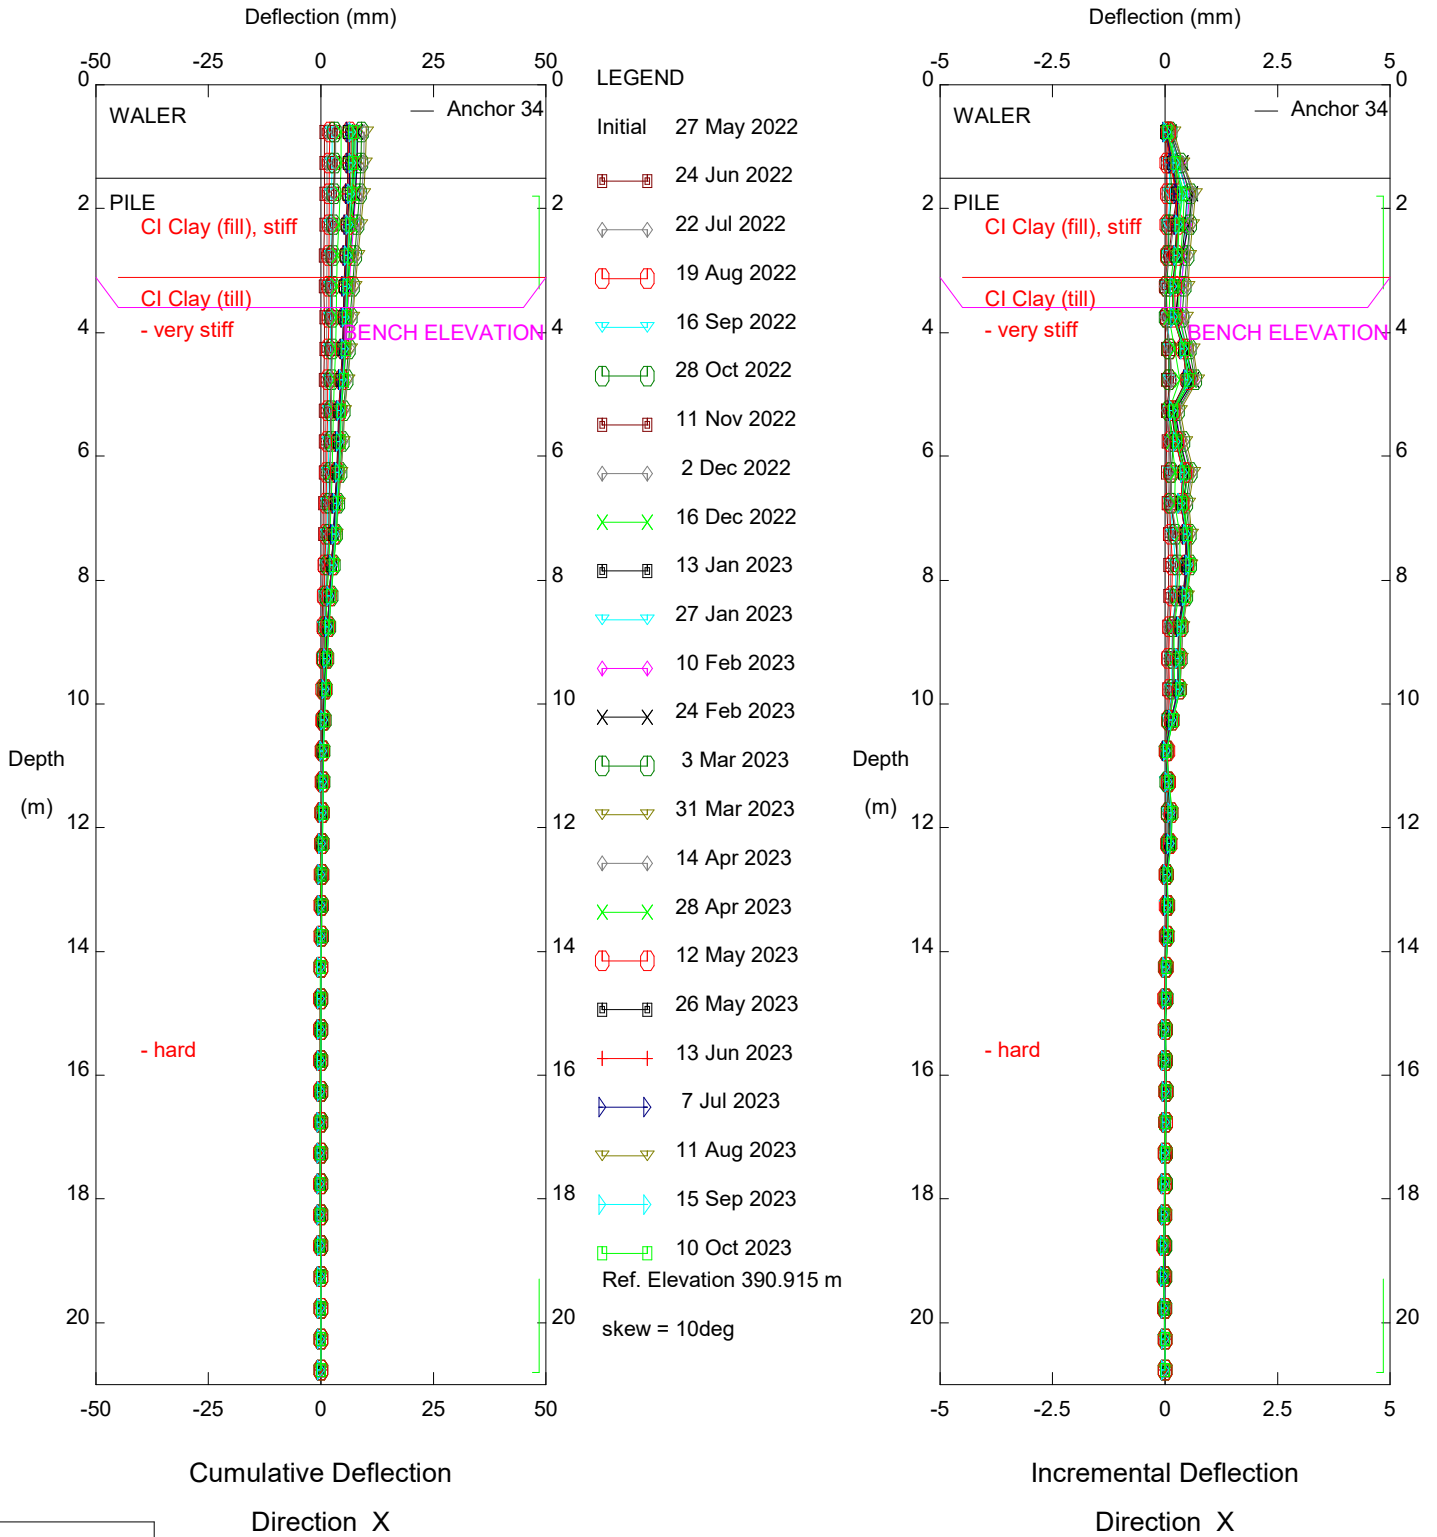
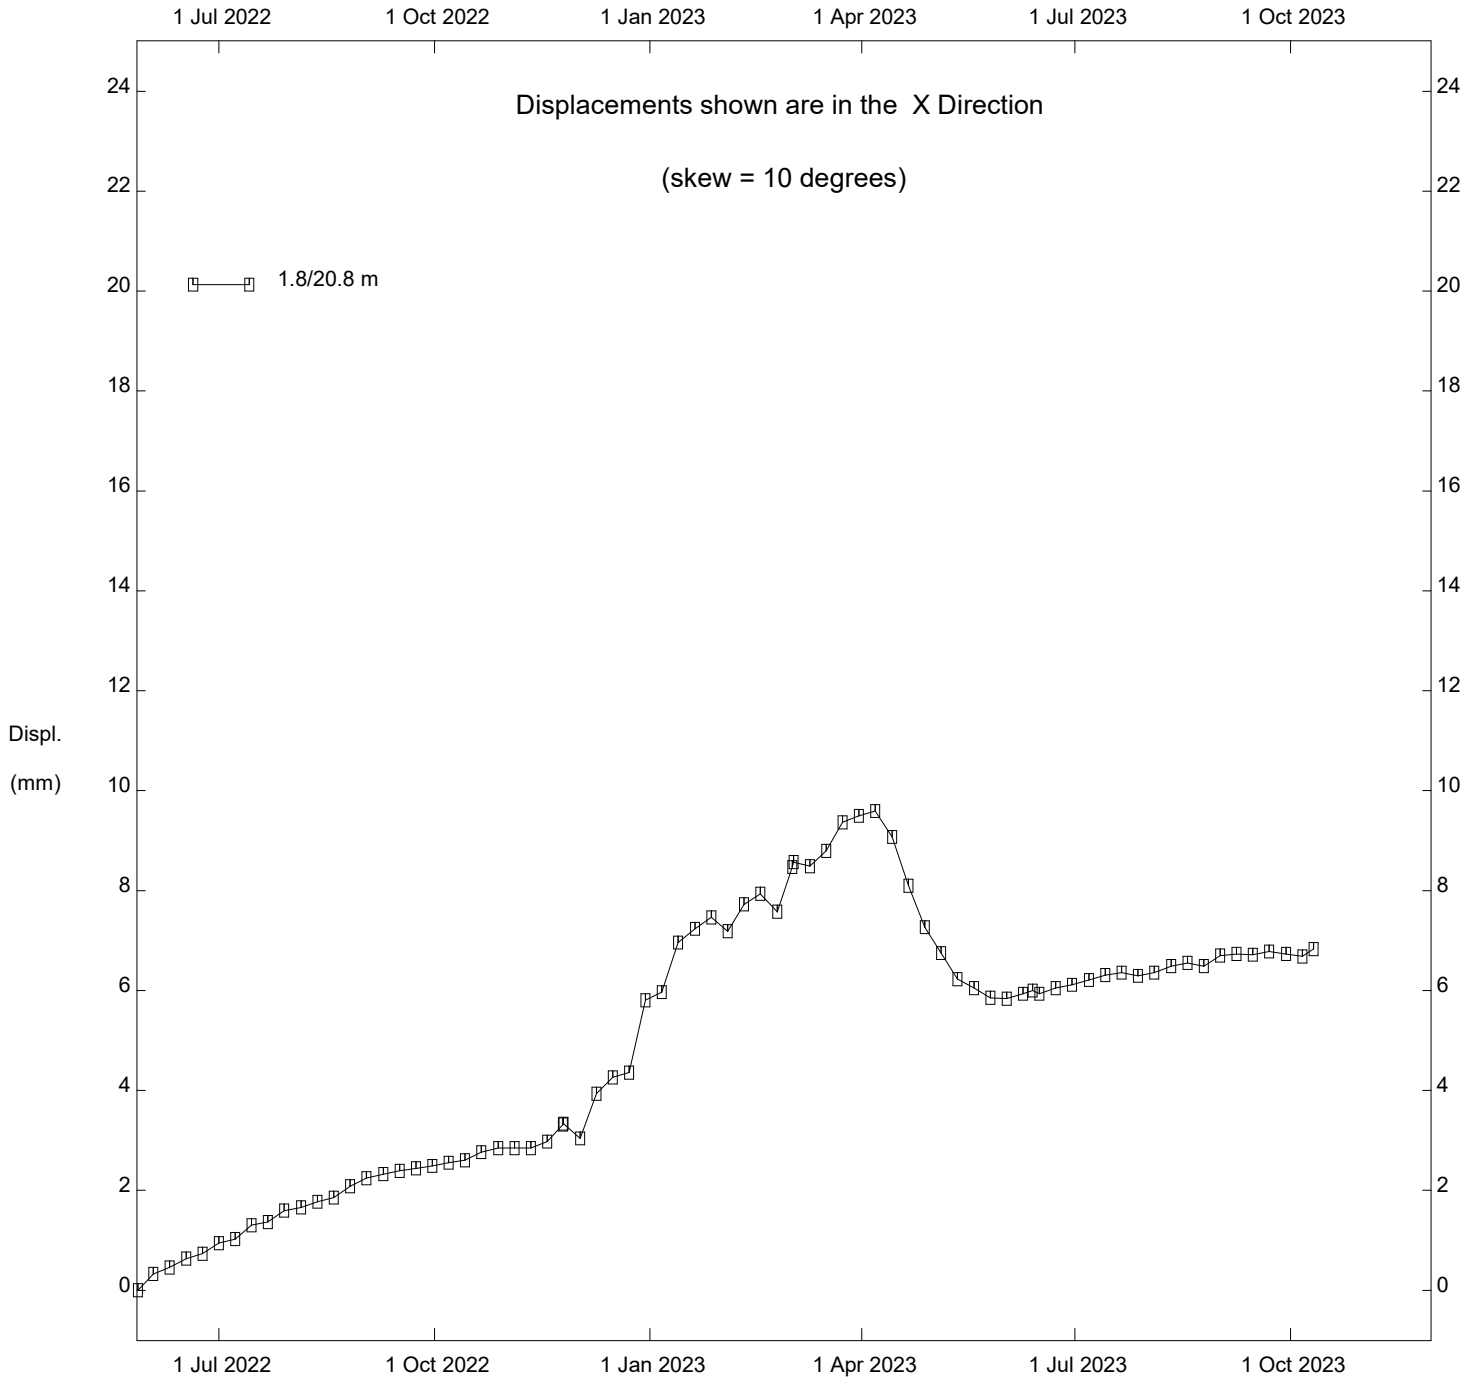
Shop Slide Type 1 Wall Section, Inclinator SAA-P34

The strain gauges in P34 show their maximum positive (tension) strain (130.2 microstrain) on the upslope pile face at 9.3 m depth, with a corresponding trend of negative (compression) strain (-206.1 microstrain) on the downslope pile face at the same depth. This seems to correspond to the observed deflection of the pile in the downslope direction noted in the SAA above 9 m depth.

Pile head deflections measured by the SAA are within an acceptable range. More deflection is noted in the cantilever section of the wall (SAA-P113) which would be expected. The additional deflection in SAA-P34 may be due to the deeper amount of cut as compared to the slope below SAA-P77. The March-April 2023 drop in deflection corresponds with a drop in the loads carried by some of the anchors (A34, A51, and A67 and to a lesser extent at A19) which could indicate a post-winter shifting of the slope. Interestingly, there was not a drop off in the load carried by Anchor A77 despite the drop in the pile head deflection. This will require additional readings and analysis to interpret and will be considered as part of the ongoing development of threshold criteria for this pile wall.

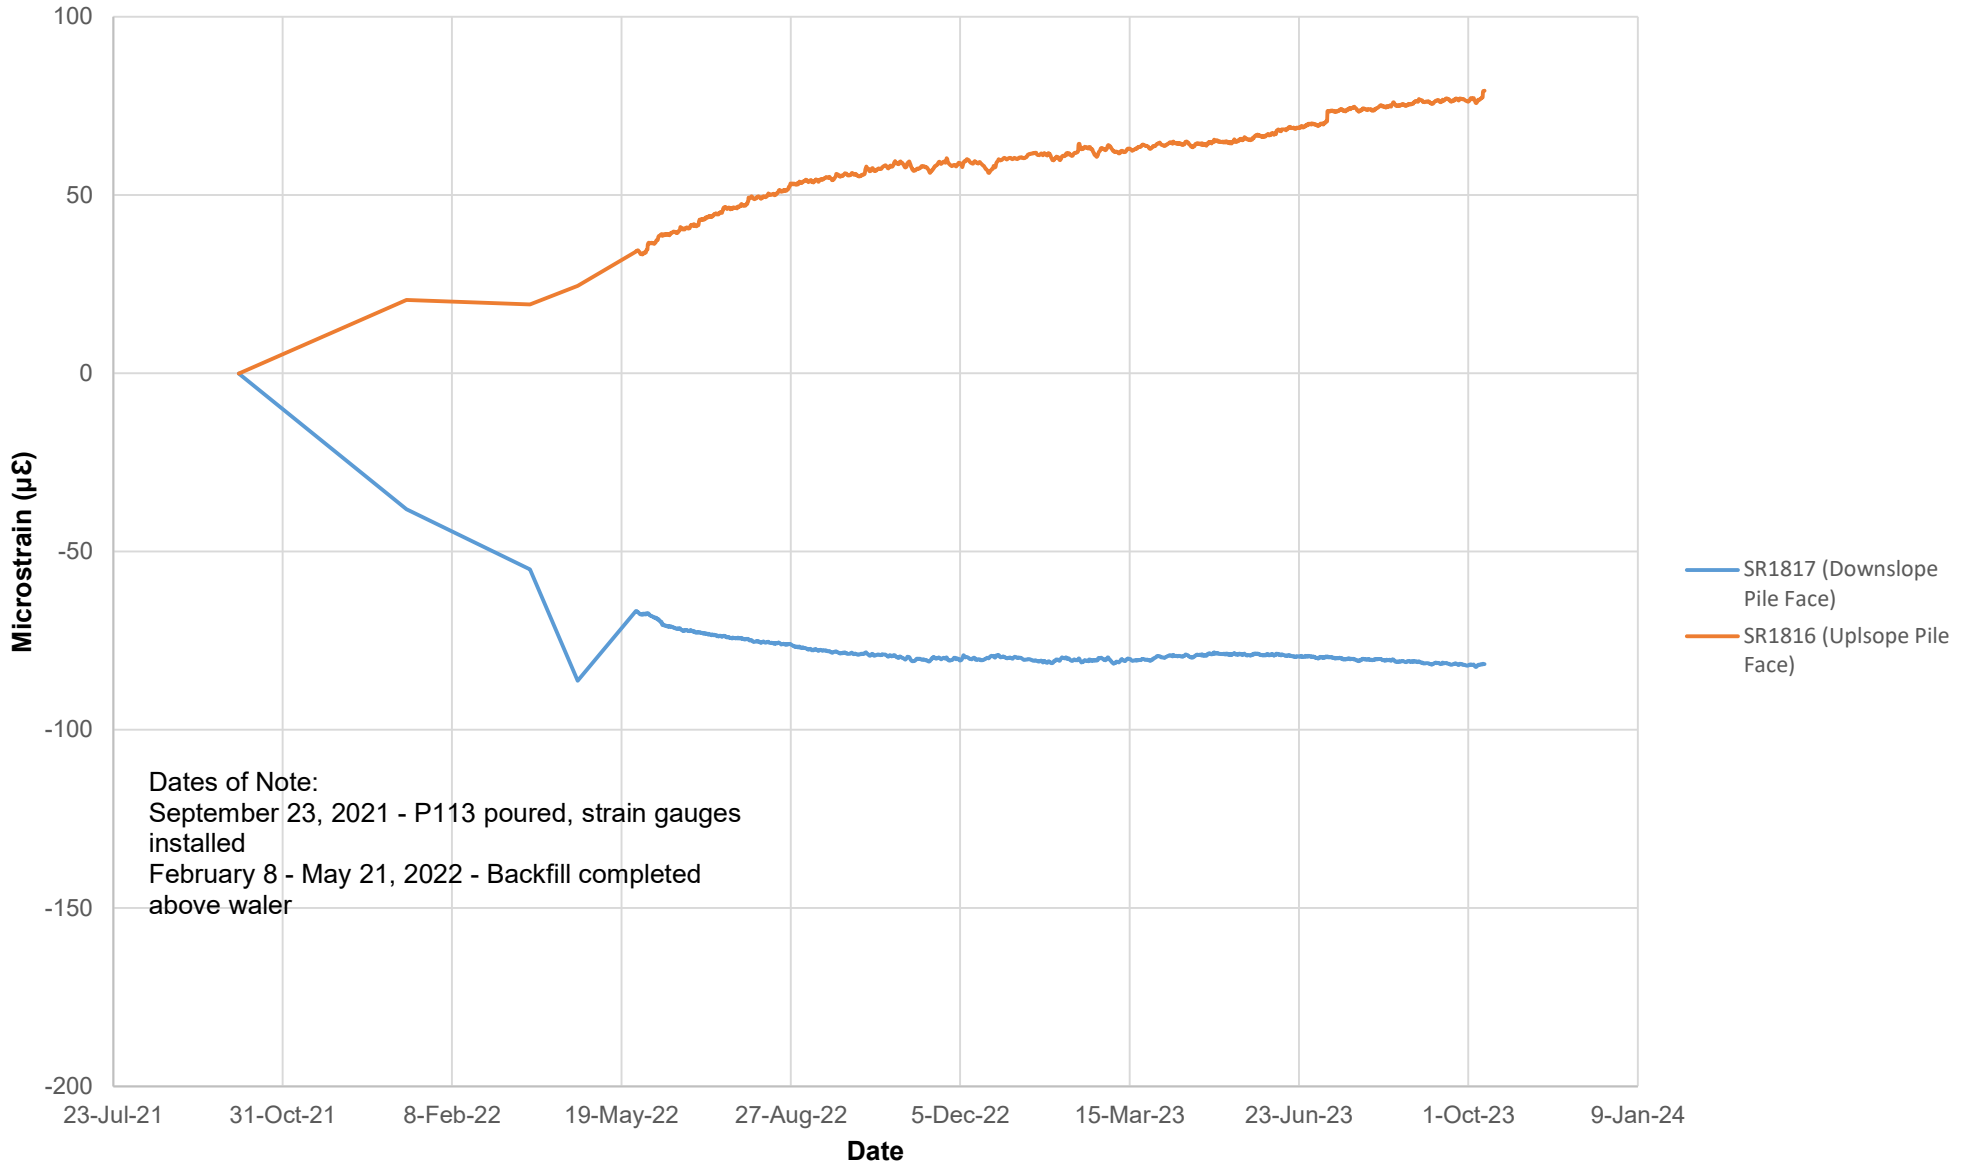
**FIGURE PH009-11: PEACE RIVER SHOP SLIDE
P113 MAXIMUM STRAIN VS TIME (19.0 m DEPTH)**

The maximum negative strain for P113, of -123.0 microstrain, was measured on the downslope side at 19.0 m depth. The depth of the main slip surface of the deep-seated landslide at this location, as indicated by former SI05-3, was at 17.5 m below original ground prior to wall construction. The strain gauges are plotted on Figures PH009-1 through PH009-12 in Appendix A.
