THURBER ENGINEERING LTD.

July 14, 2023

**ALBERTA TRANSPORTATION AND ECONOMIC CORRIDORS GRMP (CON0022164)
PEACE REGION (PEACE RIVER DISTRICT)
INSTRUMENTATION MONITORING RESULTS – SPRING 2023**

SITE PH009: OLD HWY 2:02 SHOP SLIDE

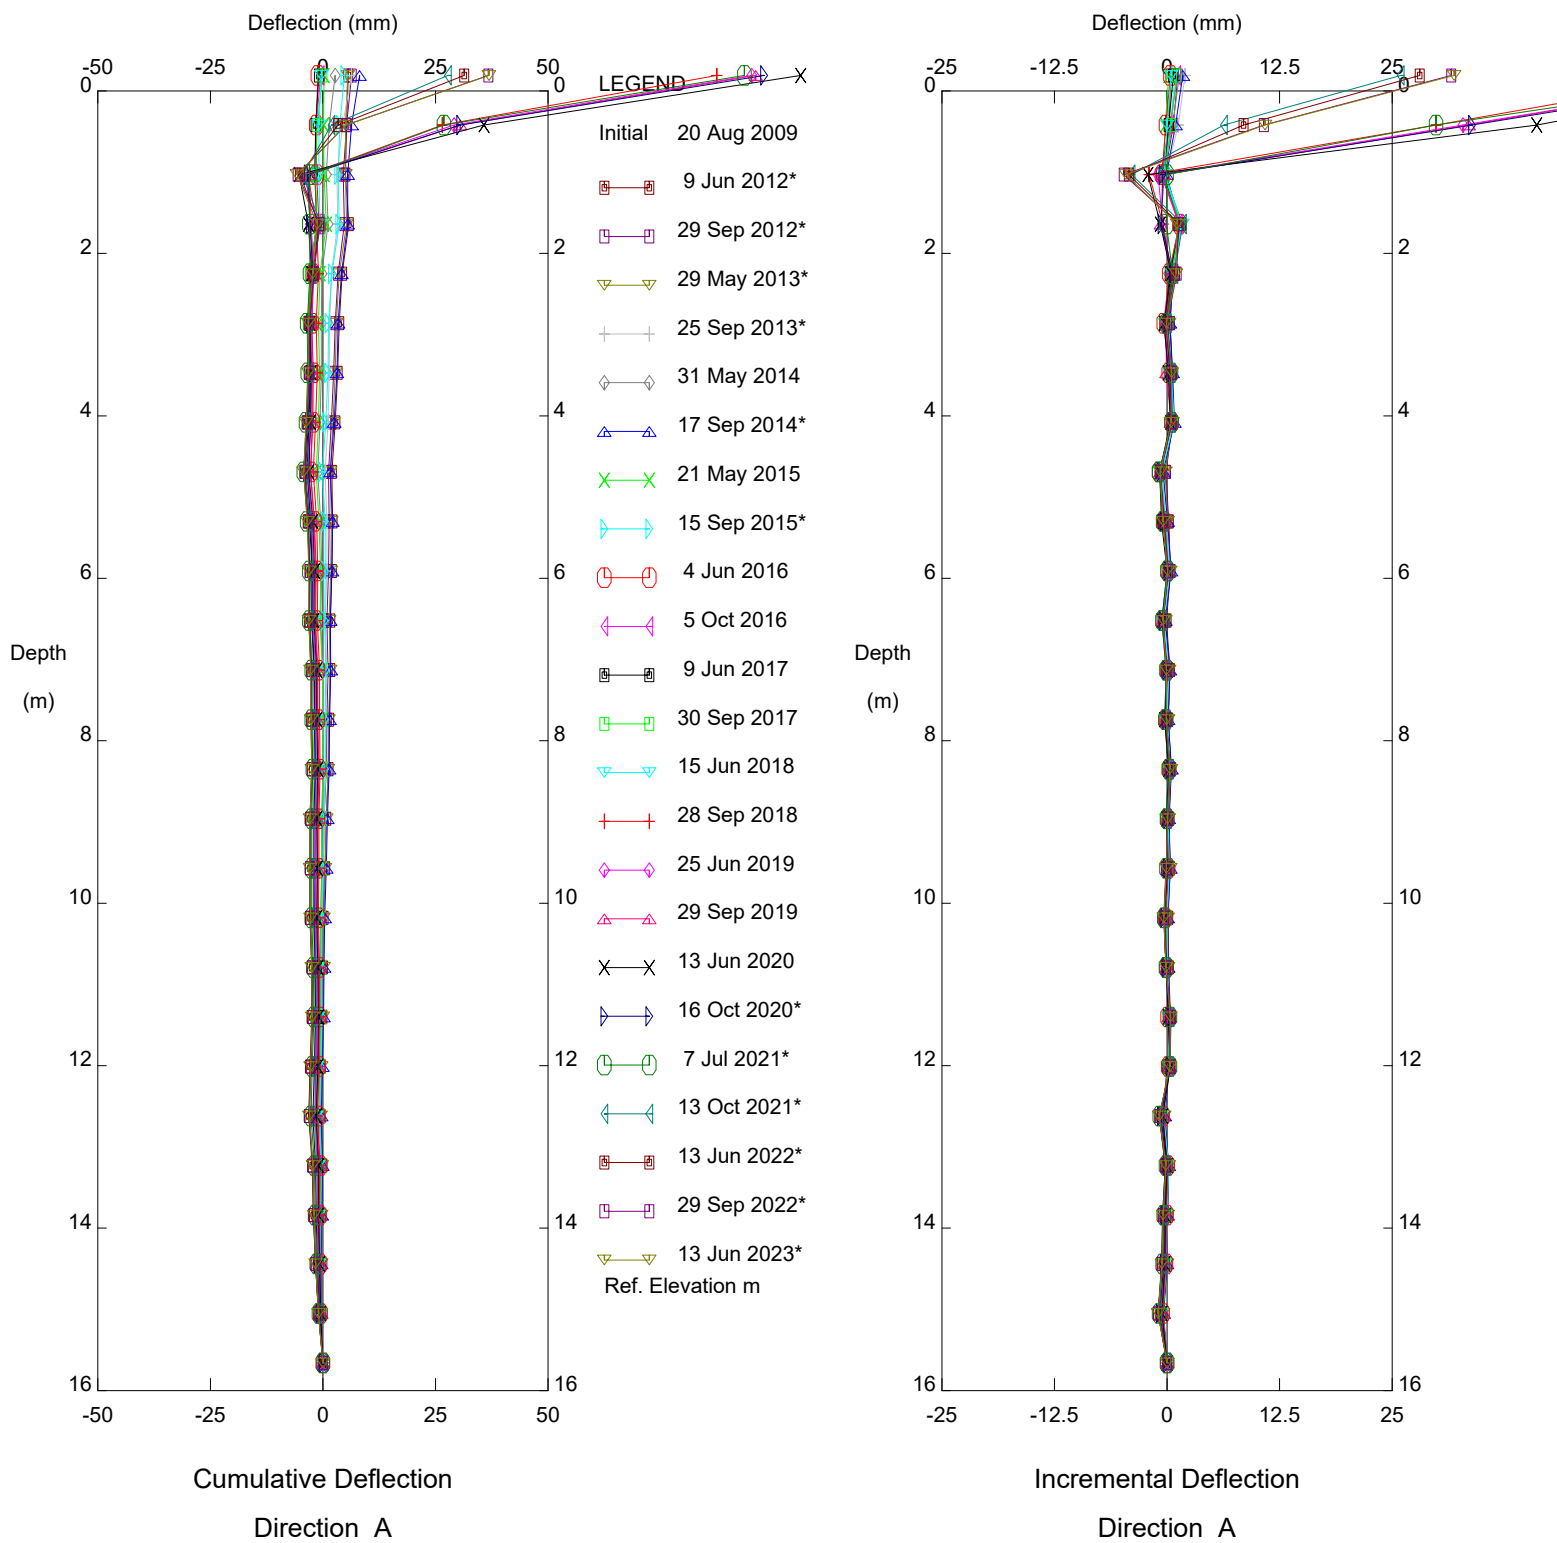
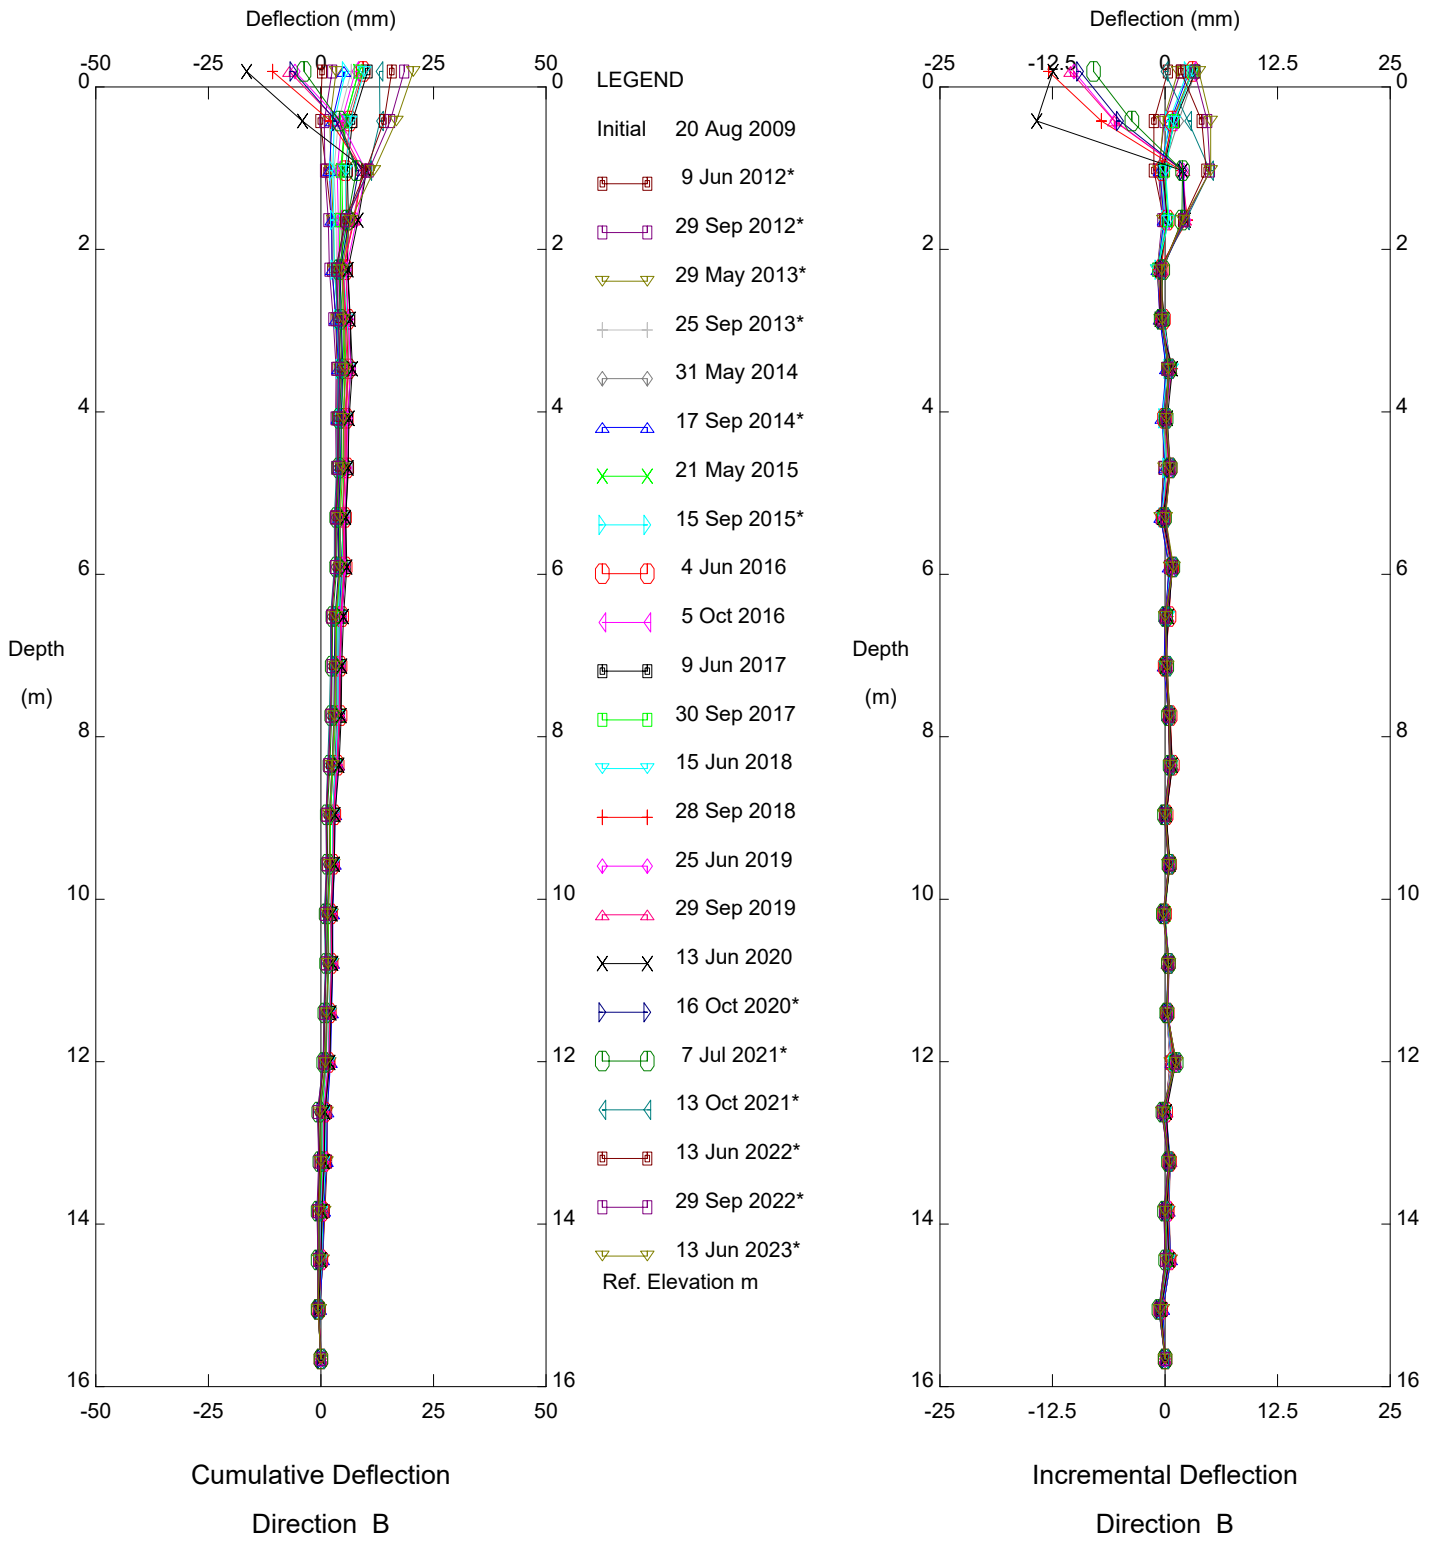
PH009 Old Hwy 2:02 Shop Slide, Inclinometer SI09-3

Slope inclinometer SI05-1 showed no discernible movement over 0.0 m to 3.0 m depth since the fall of 2022 readings. SI09-3 continued to show no discernible movement. SI09-4 showed rates of movement of 0.2 mm/yr and 0.4 mm/yr over 8.6 m to 10.5 m depth and 11.7 m to 13.5 m depth, respectively, since the fall of 2022 readings. These movement zones were first observed in 2021 during construction and displacement has been increasing slightly with each subsequent set of readings. The upper portion of SI09-4 was bent during grading and related shortening of the instrument during construction. SI11-01 showed a rate of movement of 4.1 mm/yr over 13.9 m to 16.3 m depth. SI11-01 showed a maximum rate of movement of 34.3 mm/yr over this zone in June 14, 2022, near the end of construction, however the movement rate has decreased for two consecutive readings cycles. SI19-5 showed no discernible movement over 8.2 m to 11.2 m depth and a rate of movement of 0.2 mm/yr over 17.9 m to 19.7 m depth. The overall movement in SI19-5 has slowed significantly since slope offloading and the completion of construction.

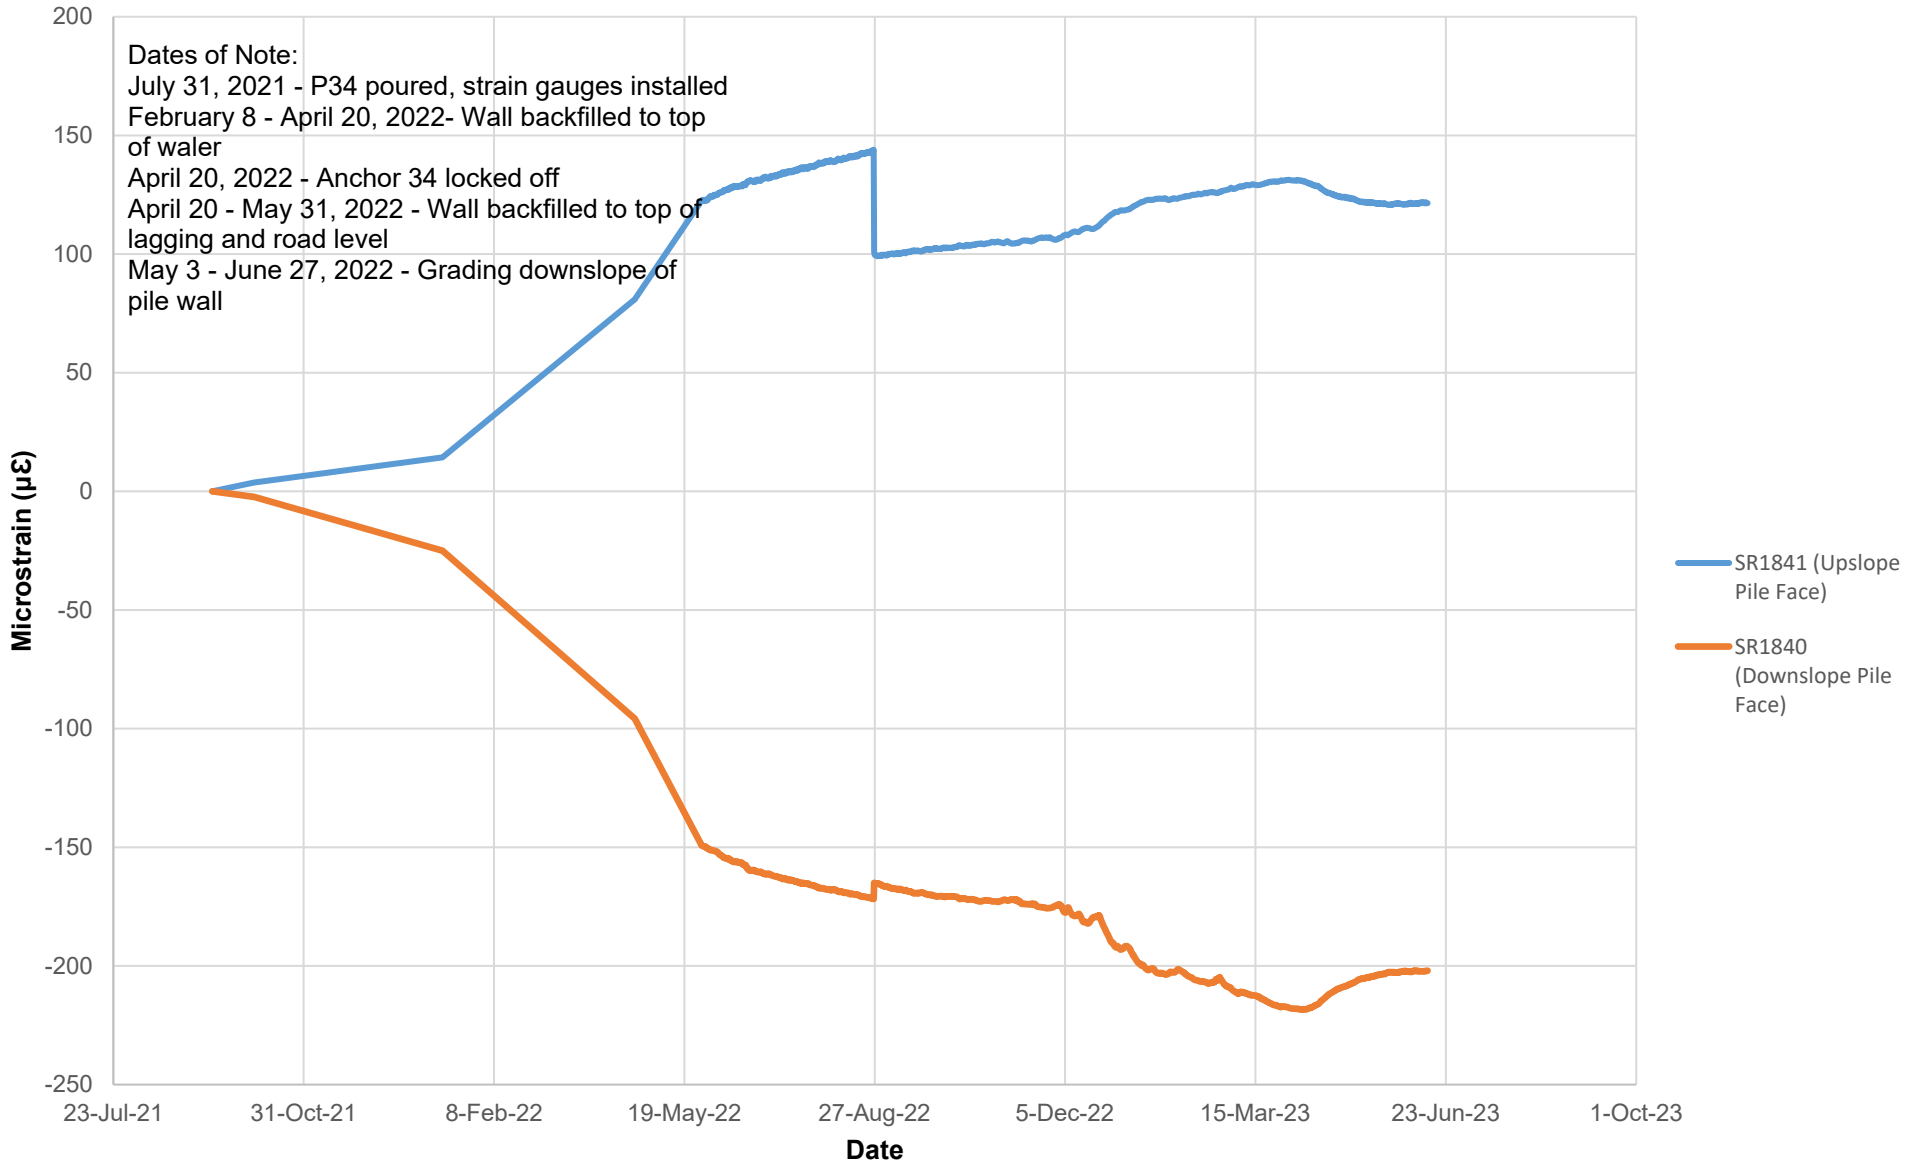
**FIGURE PH009-3: PEACE RIVER SHOP SLIDE
P34 MAXIMUM STRAIN VS TIME (9.3 m DEPTH)**

The strain gauges in P34 show their maximum positive (tension) strain (121.4 microstrain) on the upslope pile face at around 9 m depth, with a corresponding trend of negative (compression) strain (-202.1 microstrain) on the downslope pile face at the same depth. This seems to correspond to the observed deflection of the pile in the downslope direction noted in the SAA above 9 m depth. The strain gauges on the downslope side of P77 indicate a maximum negative strain of -135.7 microstrain at a depth of 7.1 m. P77 does not show as clear of a trend of strain in the upslope pile strain gauges compared to P34. The upslope strain gauges for P113 show a noticeable increase in positive strain at 15 m depth on the upslope face of the pile, which may indicate an inflection point where the pile is bending. The strain gauges are plotted on Figures PH009-1 through PH009-9 in Appendix A.
