**ALBERTA TRANSPORTATION AND  
ECONOMIC CORRIDORS GRMP  
PEACE REGION – (PEACE RIVER DISTRICT)  
INSTRUMENTATION MONITORING - FALL 2024**

Site Number	Location	Name	Hwy	km
PH045	Hwy 35:08 C1 26.2	Meikle Pile Wall	35:08	Km 26.2
<b>Legal Description:</b>		<b>UTM Co-ordinates</b>		
6-7-94-22 W5		11U E 467580.75	N	6333080.85

<b>Current Monitoring:</b>	23-Sep-2024	<b>Previous Monitoring</b>	24-May-2024
<b>Instruments Read By:</b>	Mr. Niraj Regmi, G.I.T., and Mr. Nixson Mationg, Thurber

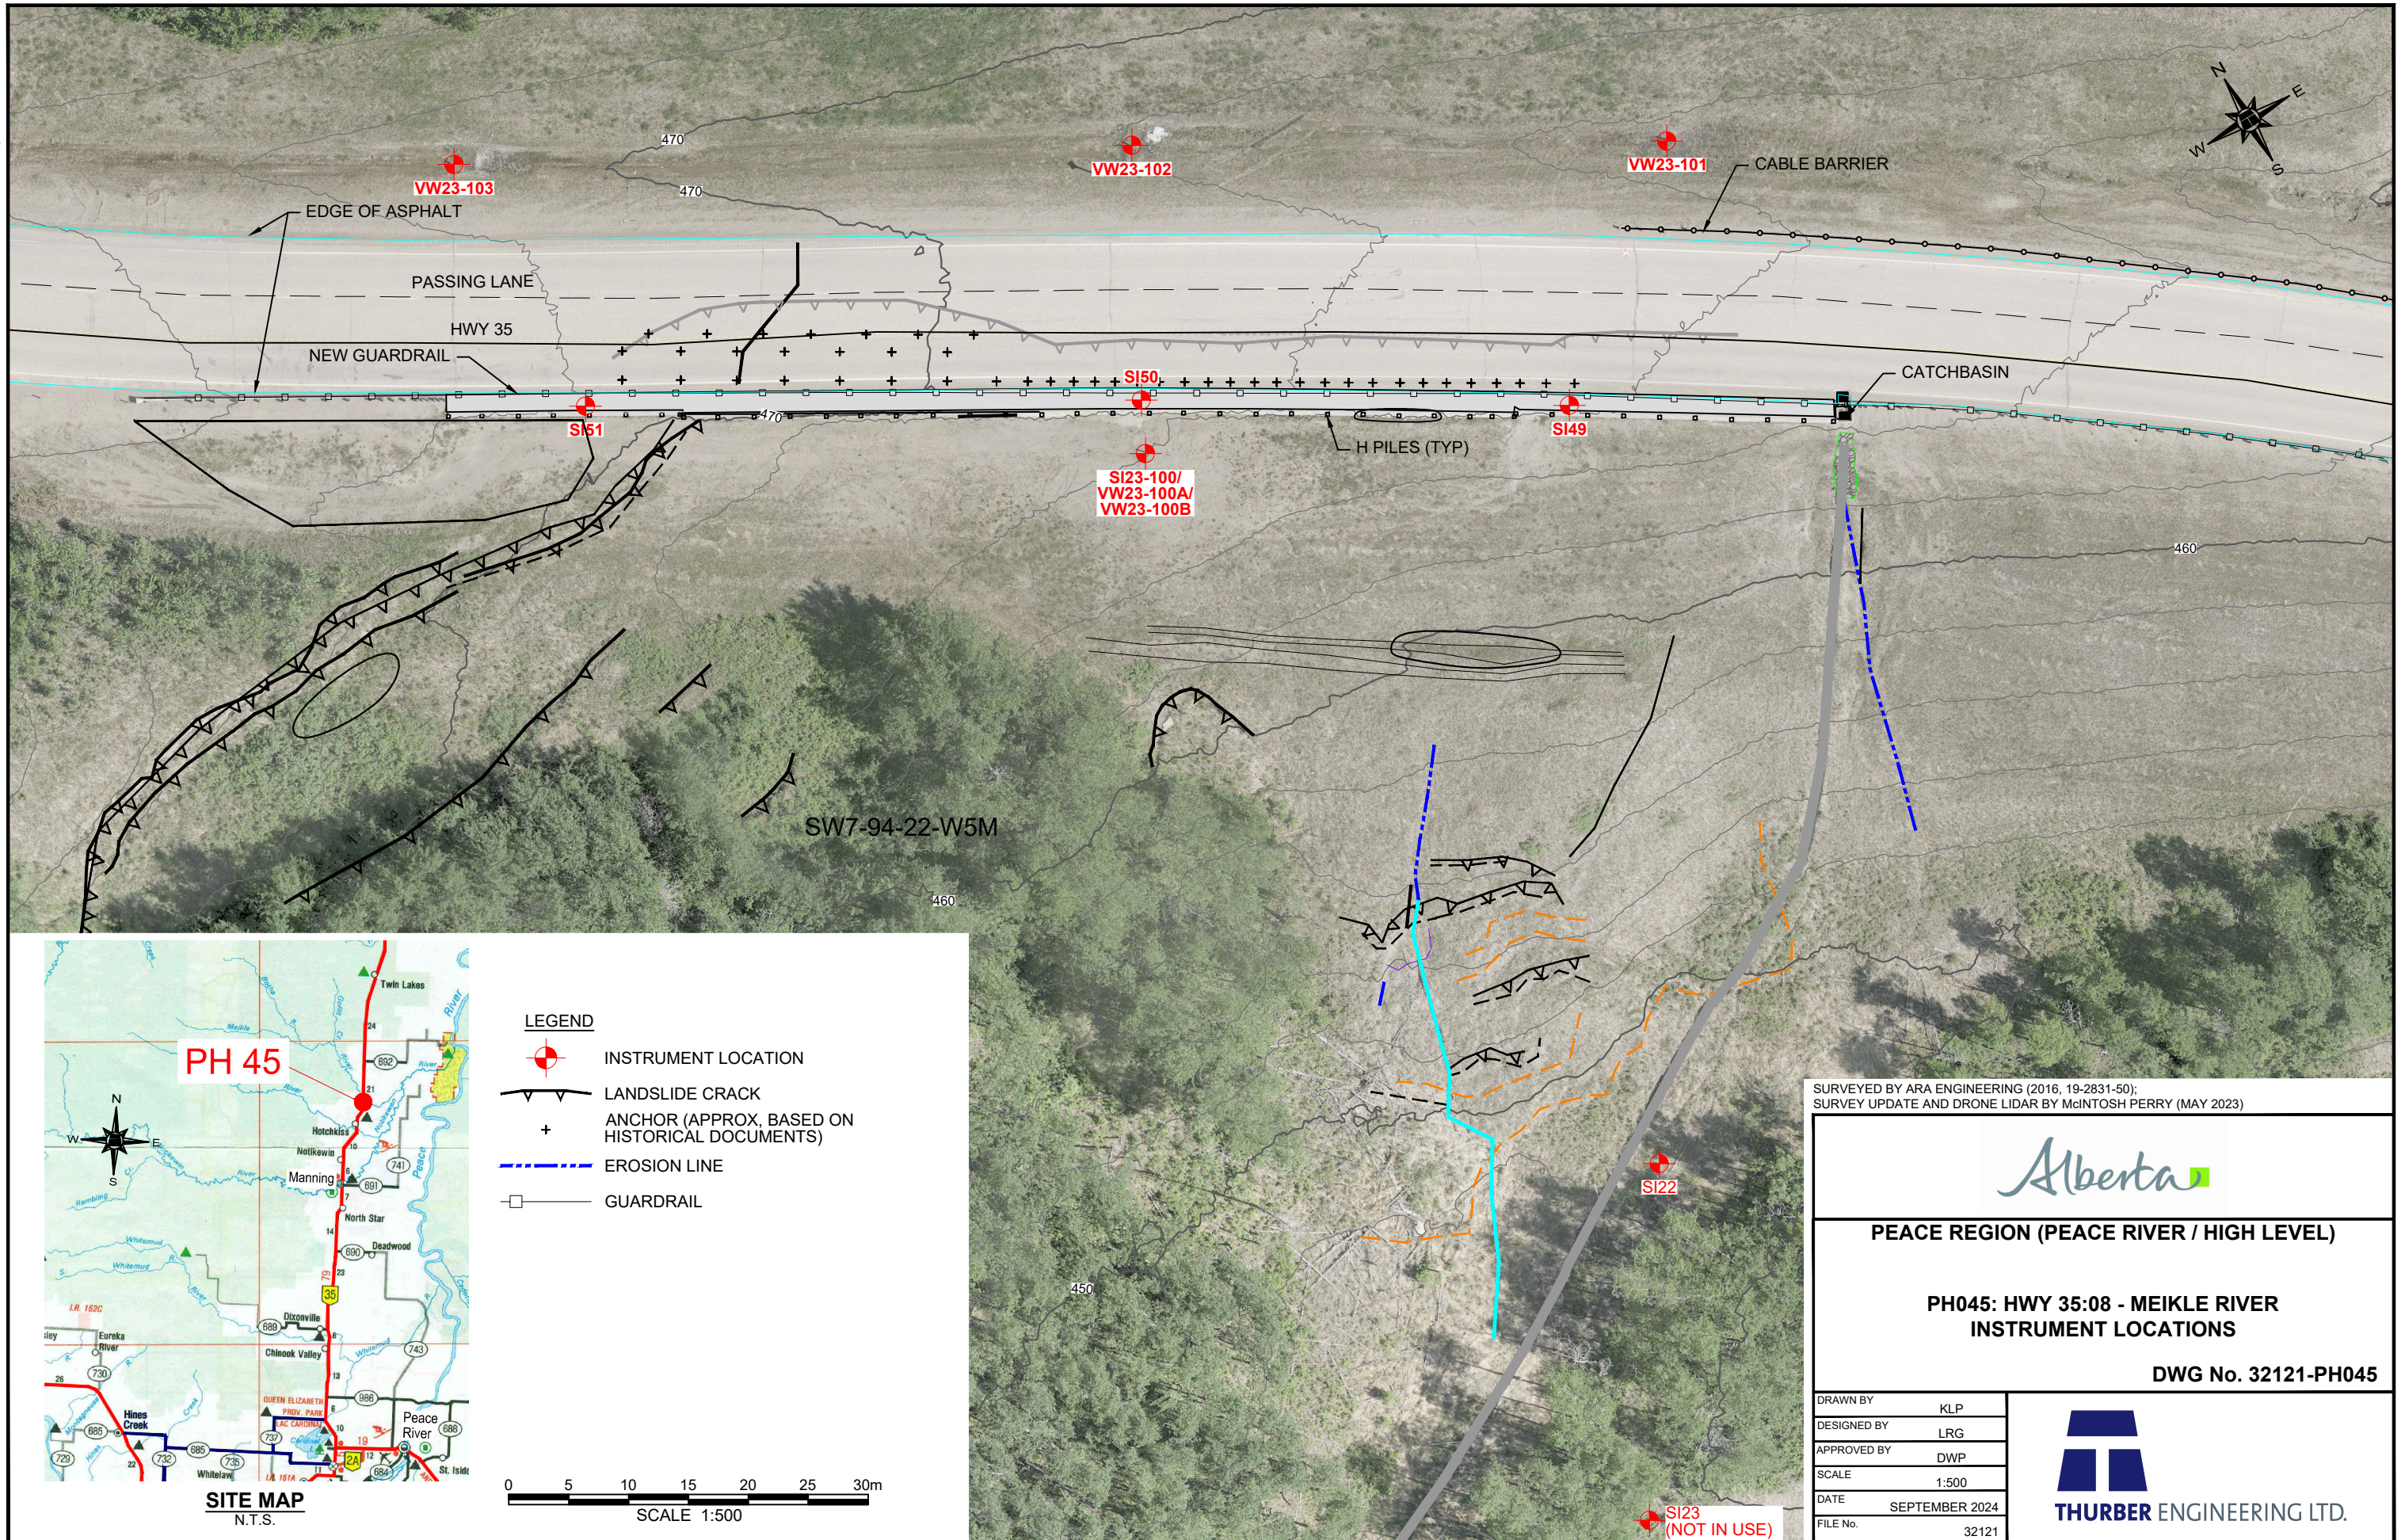
* SI-51 probe comes to surface not in grooves, may be damaged at 2 feet depth. Top of casing damaged
*SI-51 Probe did not go past 65 ft, SI was read from 2 ft to 64 ft
** SI-50 - top of SI slightly damaged
