| Site Number | Location | Name | Hwy | km |
|---|---|---|---|---|
| PH045 | Hwy 35:08 C1 26.2 | Meikle Pile Wall | 35:08 | Km 26.2 |

**ALBERTA TRANSPORTATION AND ECONOMIC CORRIDORS GRMP (CON0022164)
PEACE REGION (PEACE RIVER DISTRICT)
INSTRUMENTATION MONITORING RESULTS**

SPRING 2024

SITE PH045: HWY 35:08, MEIKLE RIVER (km 26.2 PILE WALL)

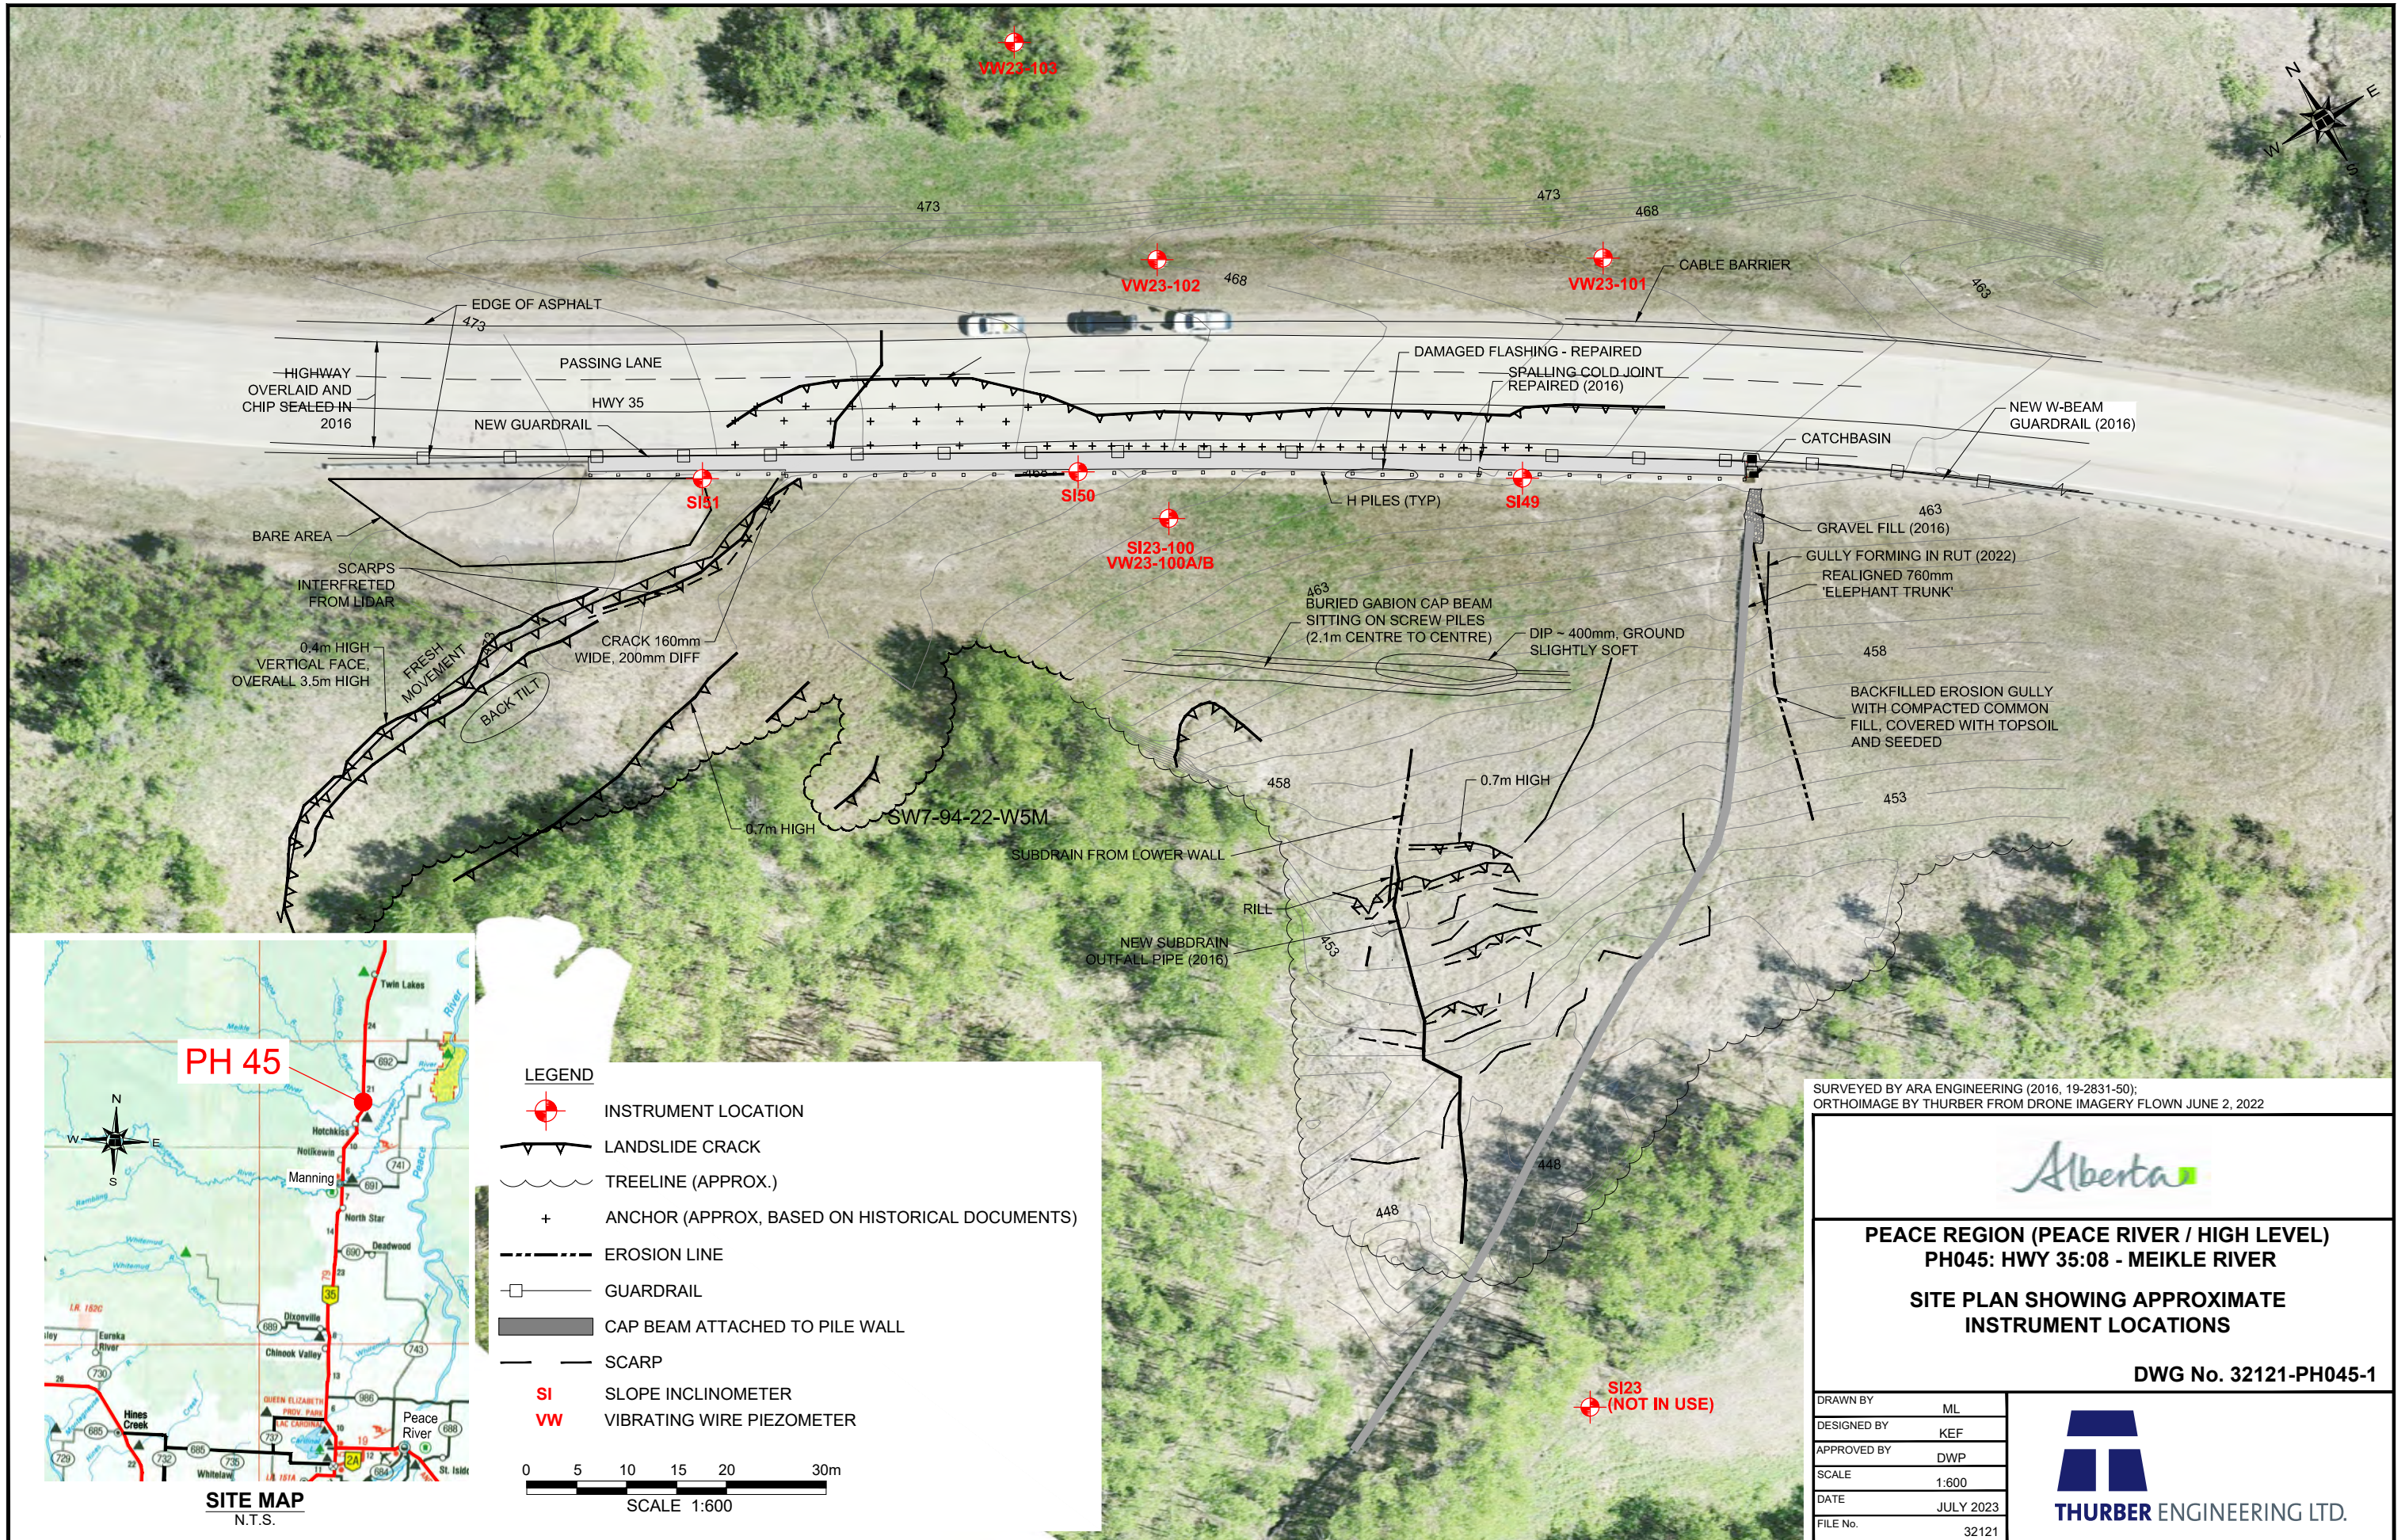
SITE MAP
N.T.S.

* SI-51 probe comes to surface not in grooves, may be damaged at 2 feet depth. Top of casing damaged
*SI-51 Probe did not go past 65 ft, SI was read from 2 ft to 64 ft
** SI-50 - top of SI slightly damaged
