**PEACE REGION (PEACE RIVER/HIGH LEVEL)
PH077-1 & PH077-2 EAST SIDE OF HINES CREEK BRIDGE
HWY 682:02, km 12.6-12.7**

PH077-1: EAST SIDE OF HINES CREEK BRIDGE
 HWY 682:02, km 12.6~12.7
 2018 INSPECTION PLAN - SITE 1

**PH077-2: EAST SIDE OF HINES CREEK BRIDGE
HWY 682:02, km 12.6~12.7
2018 INSPECTION PLAN - SITE 2**

**WATERCOURSE CULVERT
ON HWY 682, 17 km W OF FAIRVIEW
GENERAL LAYOUT**

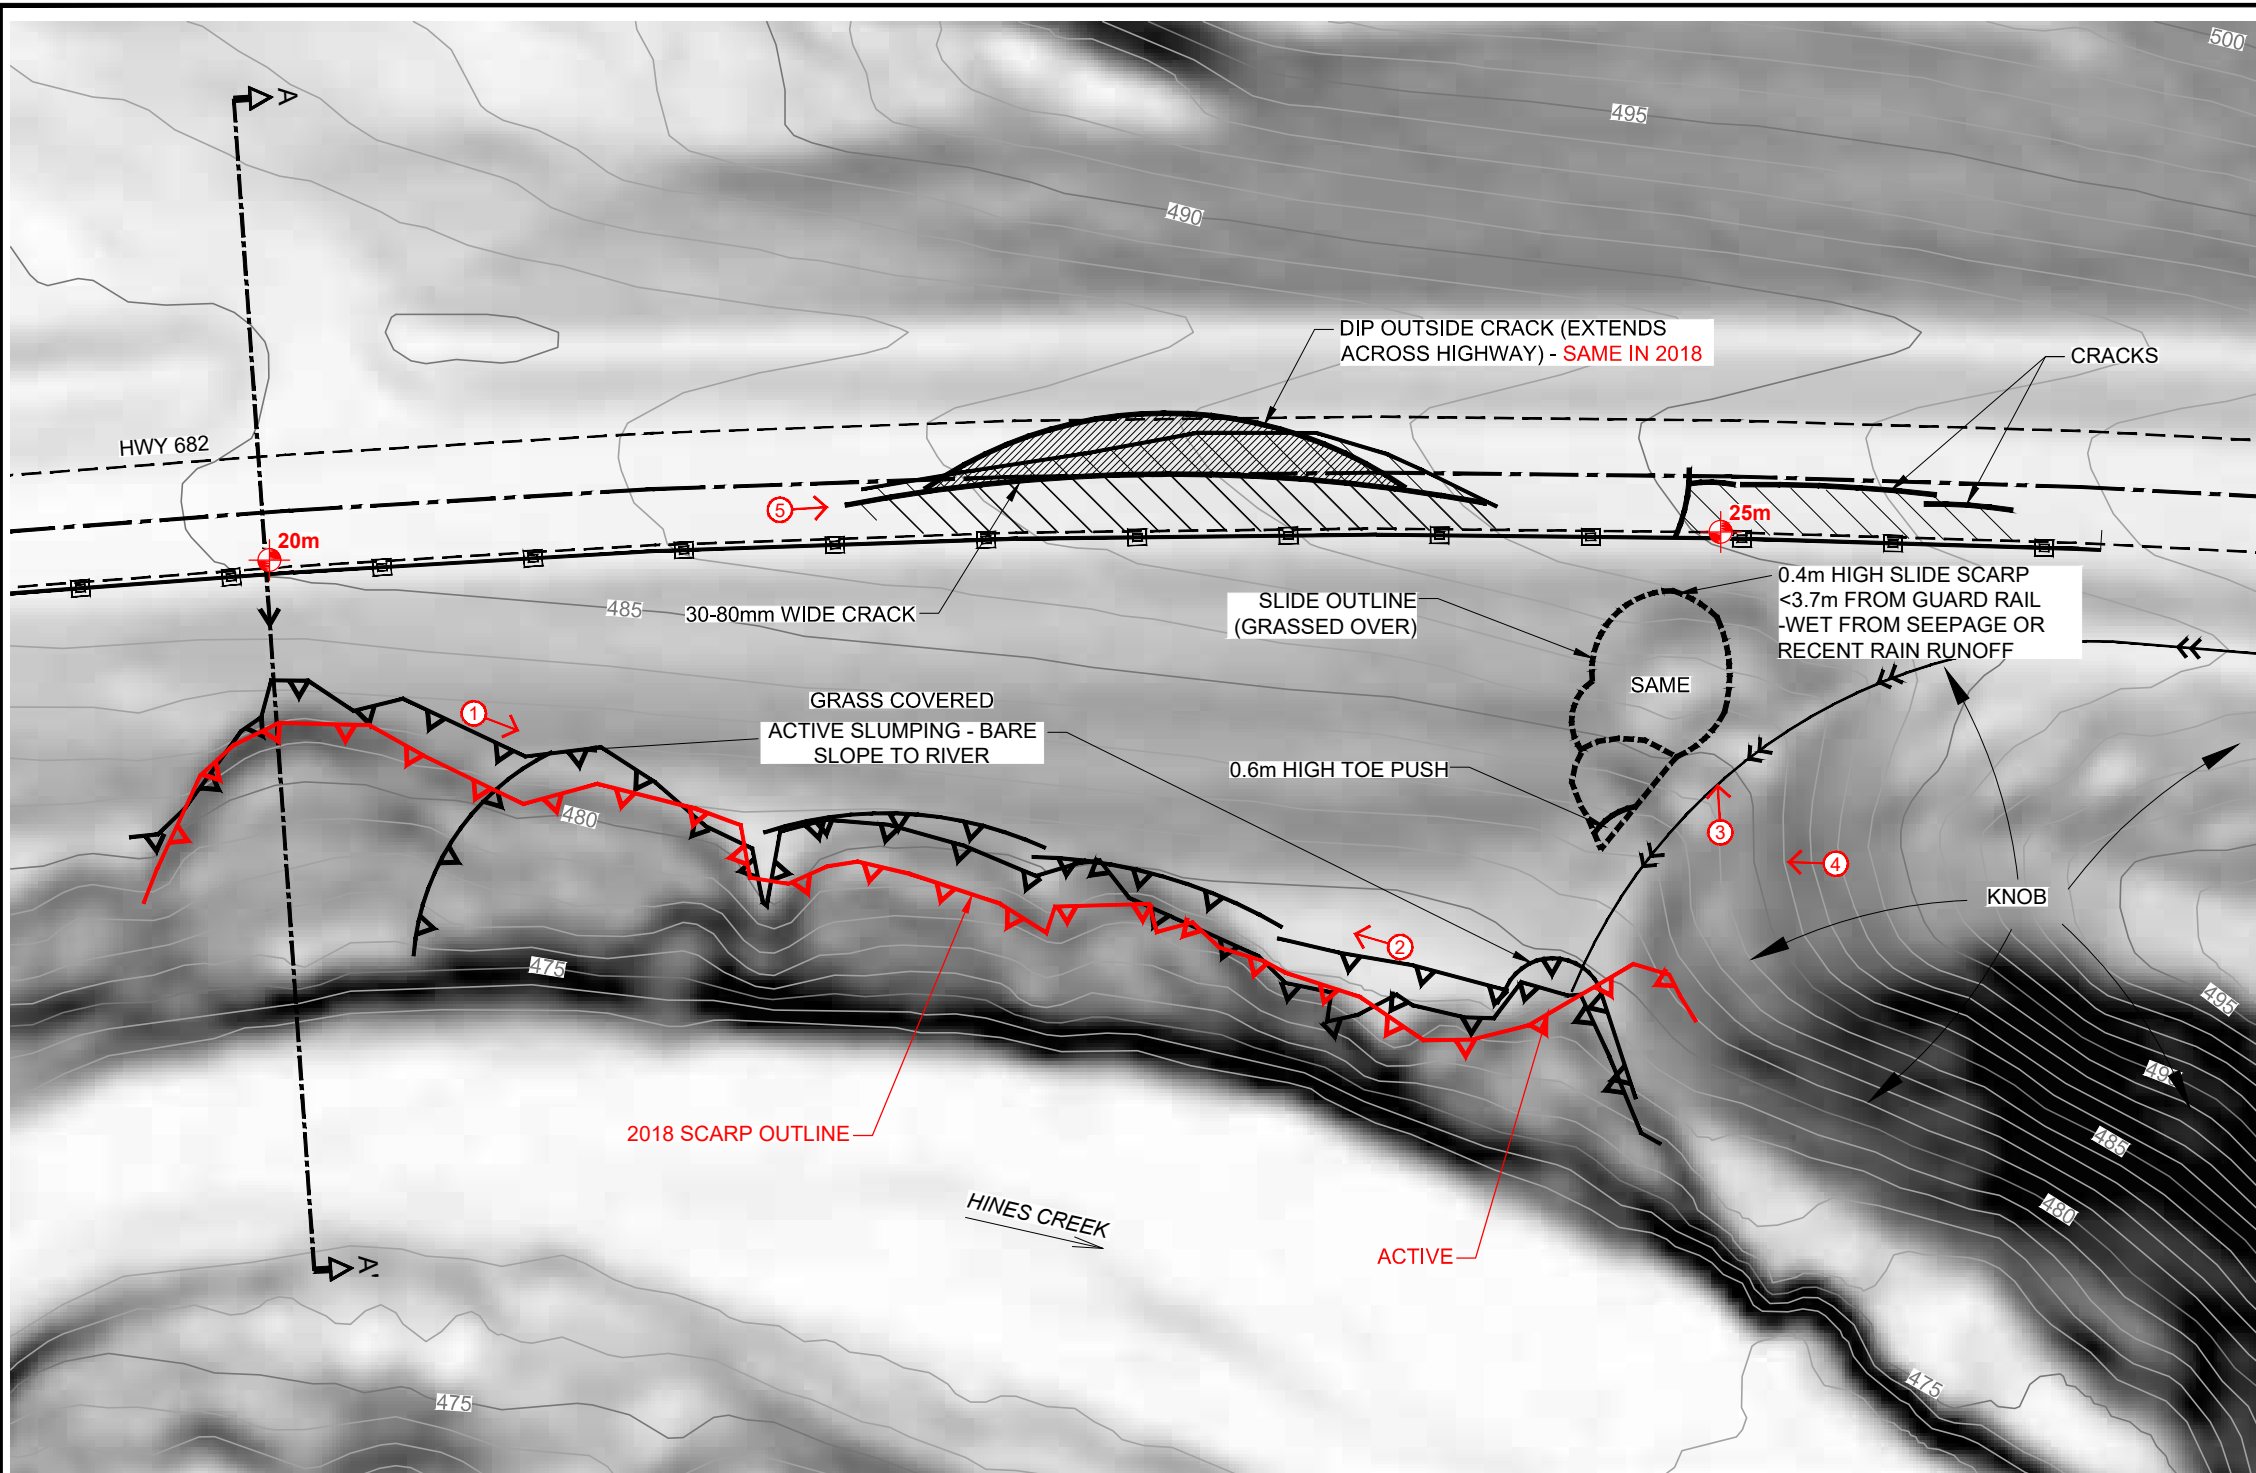
DWG No. 13351-PH077-1-1

1. MAY 16, 2018 OBSERVATIONS SHOWN IN RED.

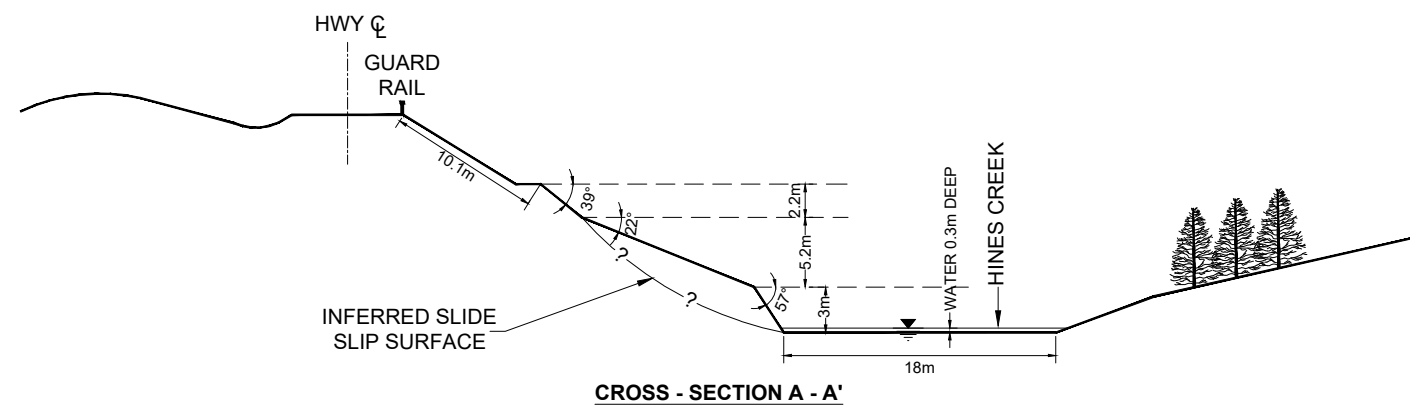
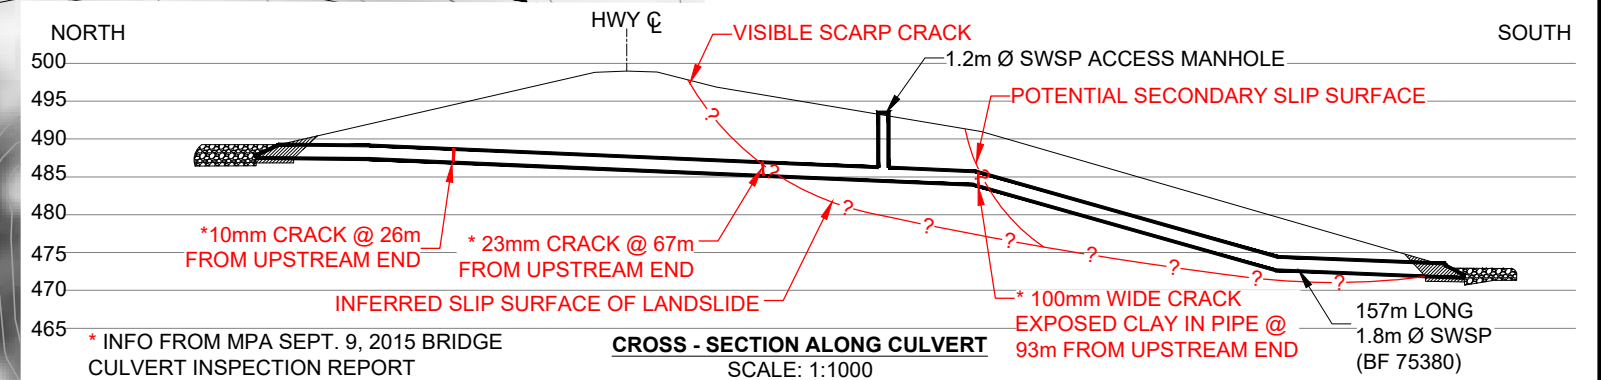
DWG No. 13351-PH077-2-1

- NOTES**
1. GABIONS LACKING INTERMEDIATE BAFFLES AND LIDS NOT ADEQUATELY TIED.
 2. MAY 16, 2018 OBSERVATIONS SHOWN IN RED.
