THURBER ENGINEERING LTD.

File No.: 32121

**GEOHAZARD RISK MANAGEMENT PROGRAM (CON0022164)
PEACE REGION (PEACE RIVER DISTRICT
SECTION D CALL-OUT REPORT
THE BIG EDDIE, BRICK'S HILL: HWY 684:02 km 8.86 to 8.98**

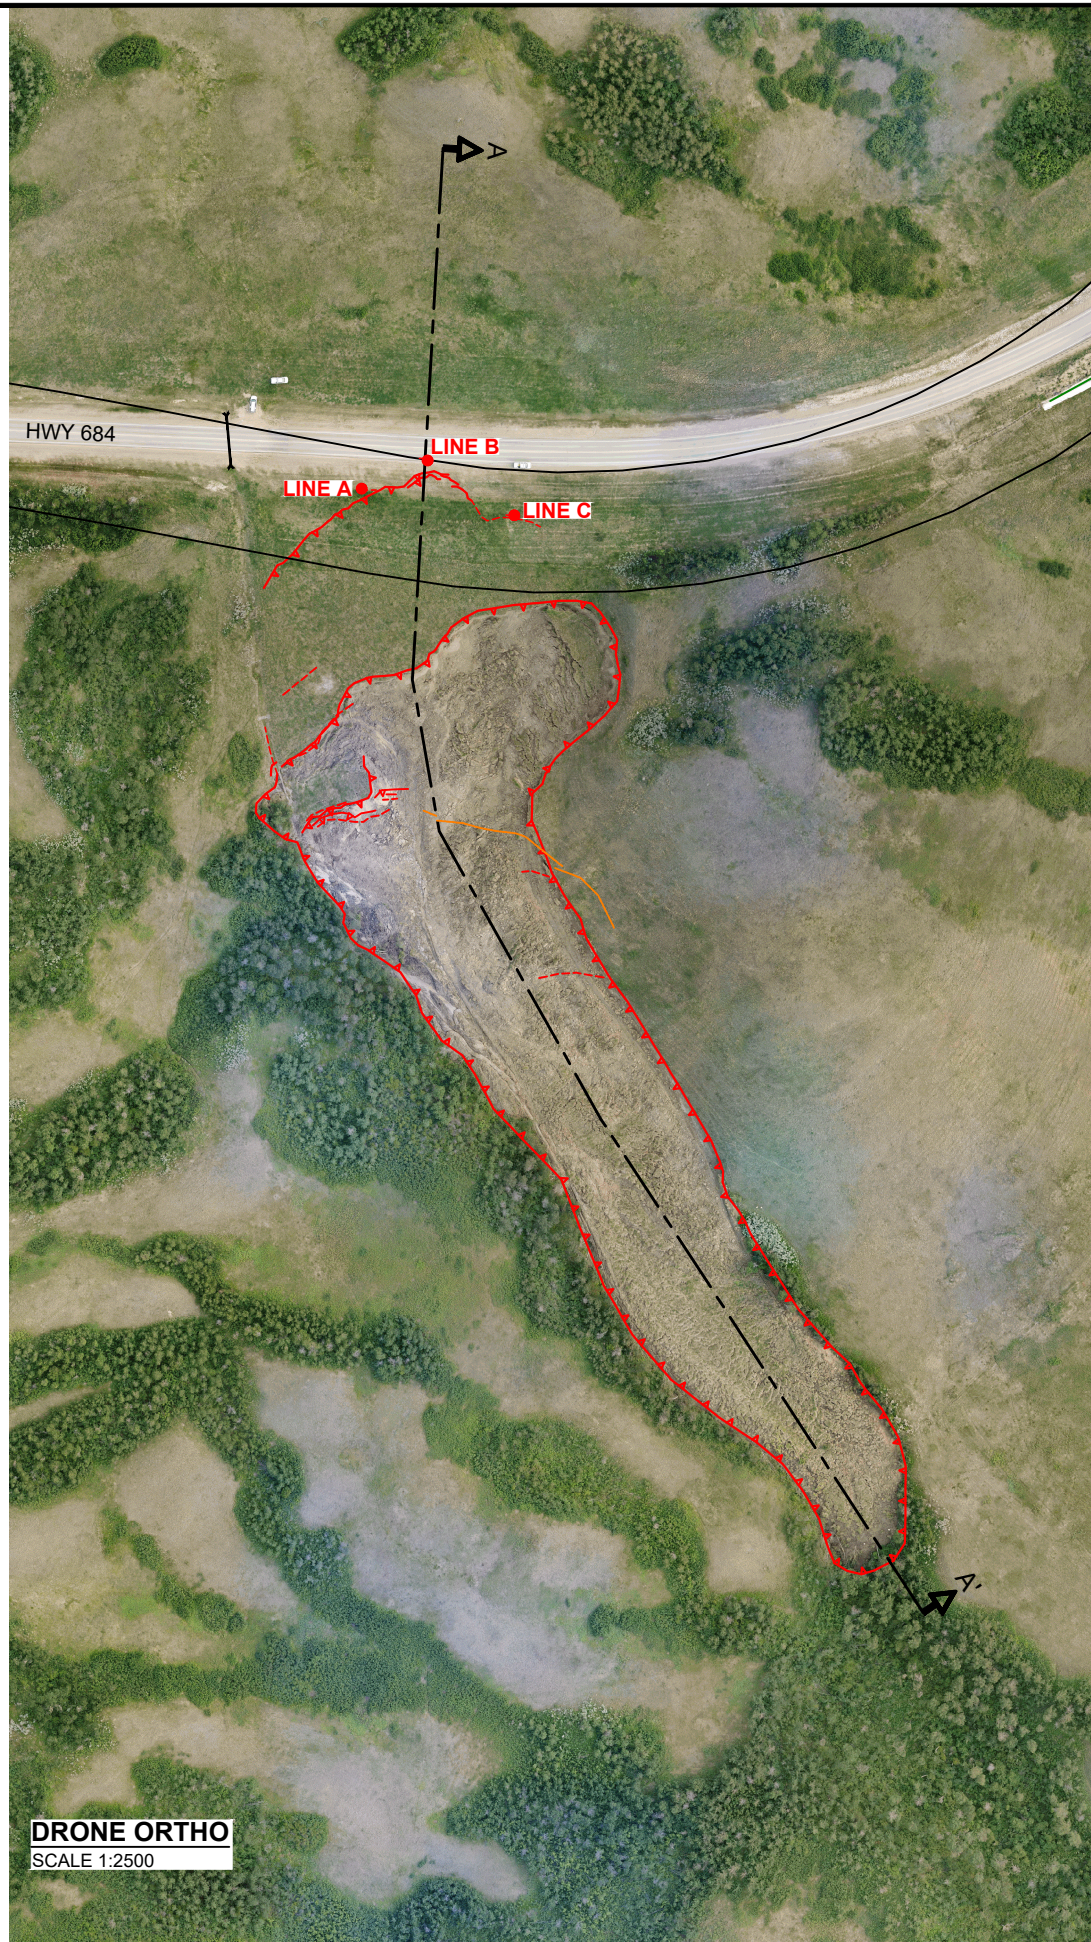
DRONE ORTHO
SCALE 1:2500

Although there had not been distress noted at this location since the 1980s, Google Earth imagery from May 10, 2023, shows cracks starting to form in the lower half of the fill slope. These cracks, shown in Figure 1.1, have been approximately transferred on to the Drawings.

CRACK
-

CRACK SEEN ON GOOGLE EARTH
MAY 10, 2023, SATELLITE IMAGE
-

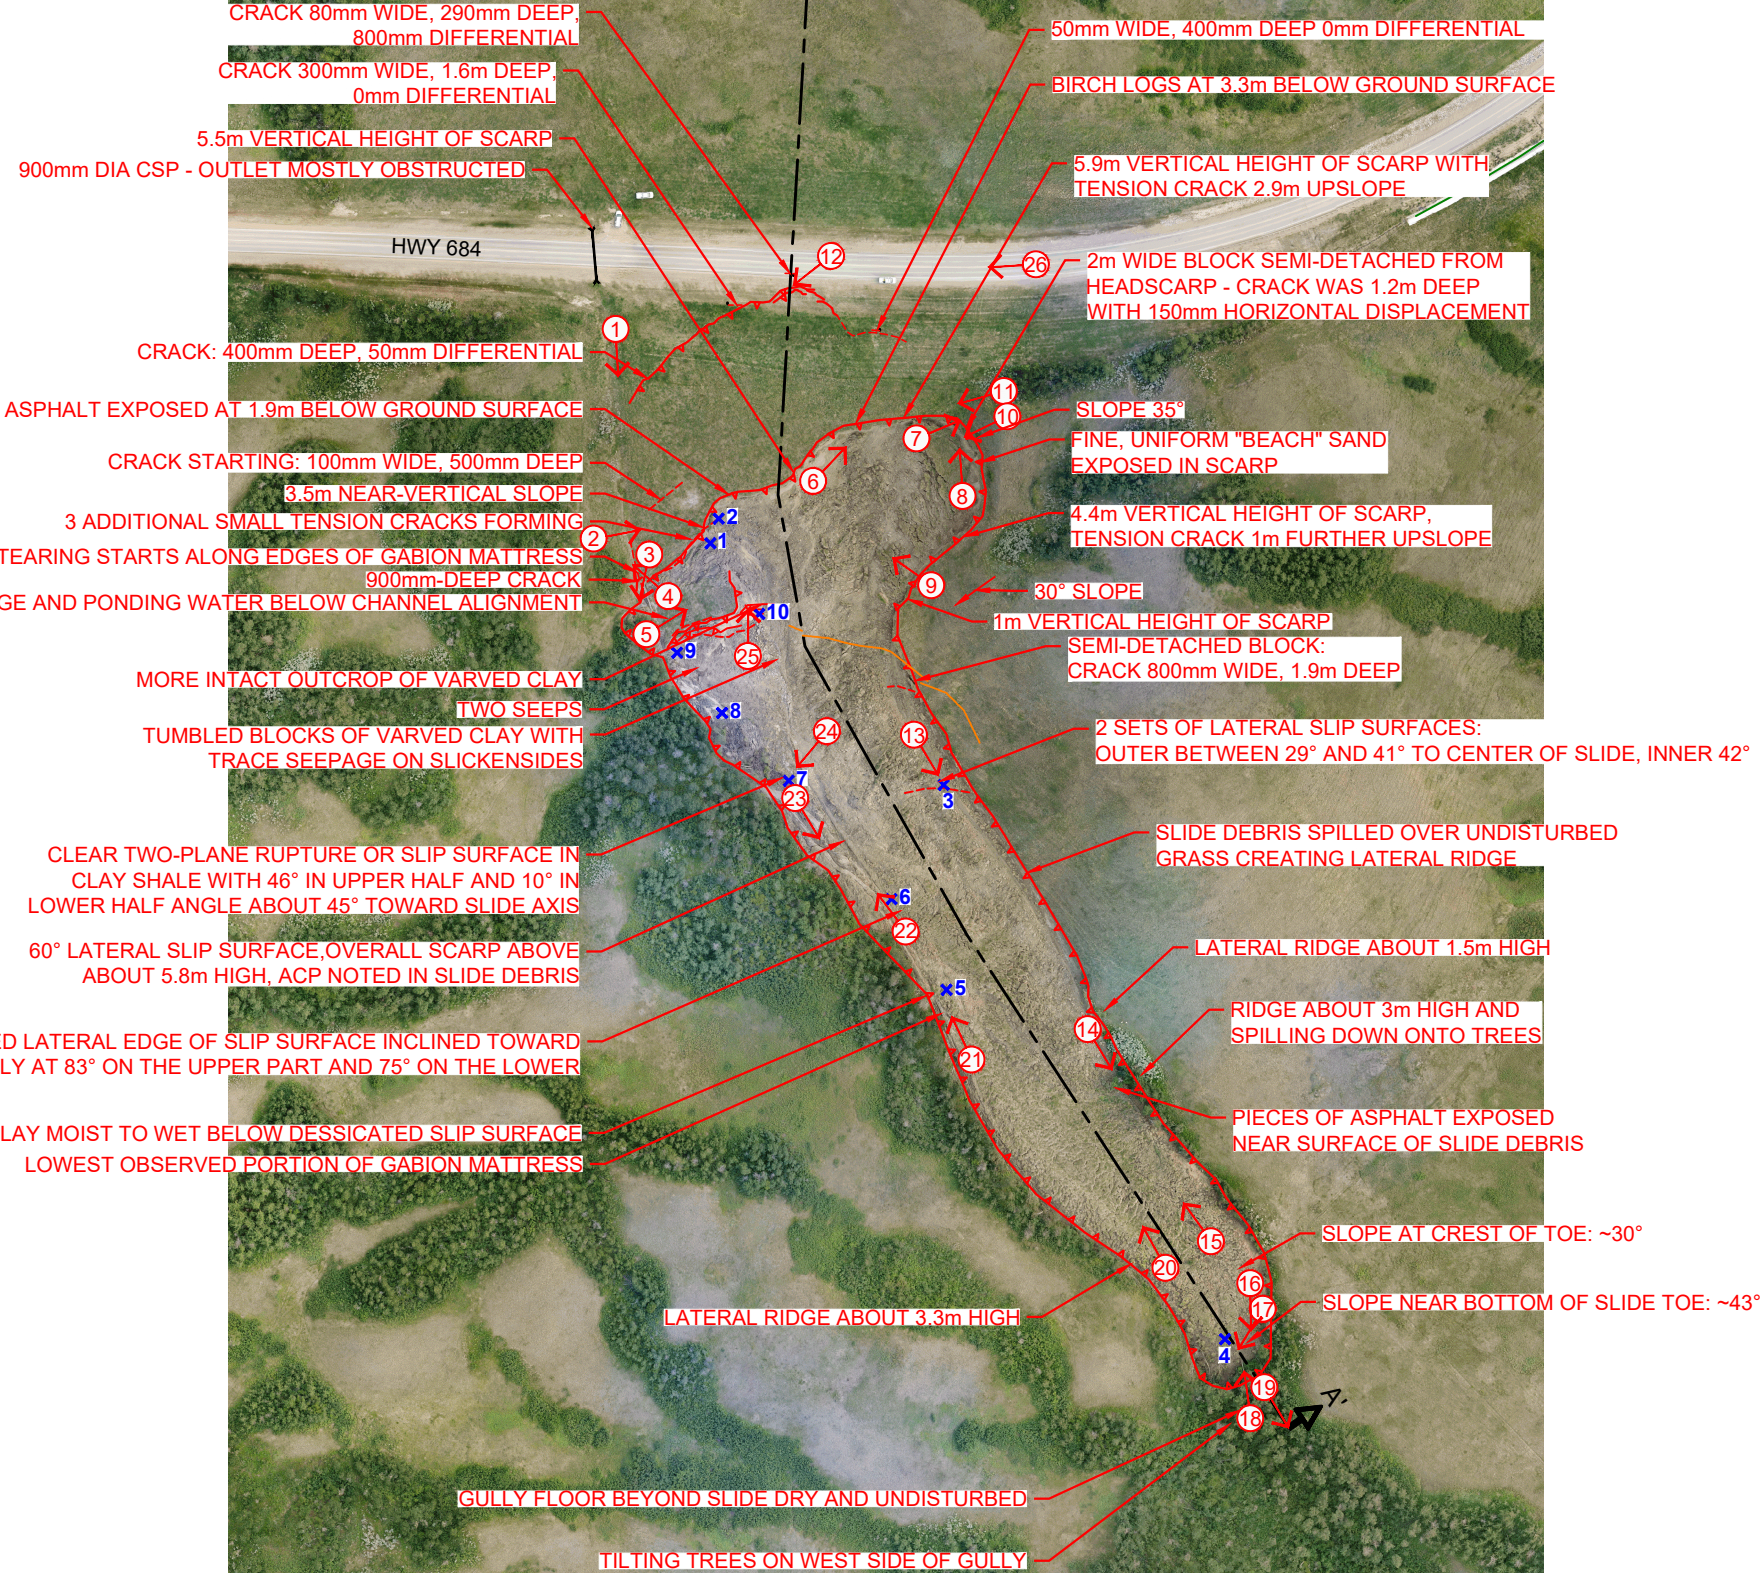
Several soil samples were collected during the site reconnaissance to understand the potential range of moisture contents present in the landslide debris. The locations of the samples are shown on Drawing 32121-PH093-2A and summarized below in Table 2.1.

- SCARP
- - - CRACK
- CRACK SEEN ON GOOGLE EARTH MAY 10, 2023, SATELLITE IMAGE
- - - POTENTIAL FILL BOUNDARY
- ① → DIRECTION AND NUMBER OF PHOTO
- x APPROXIMATE SOIL SAMPLE LOCATION
- 1 SAMPLE NUMBER

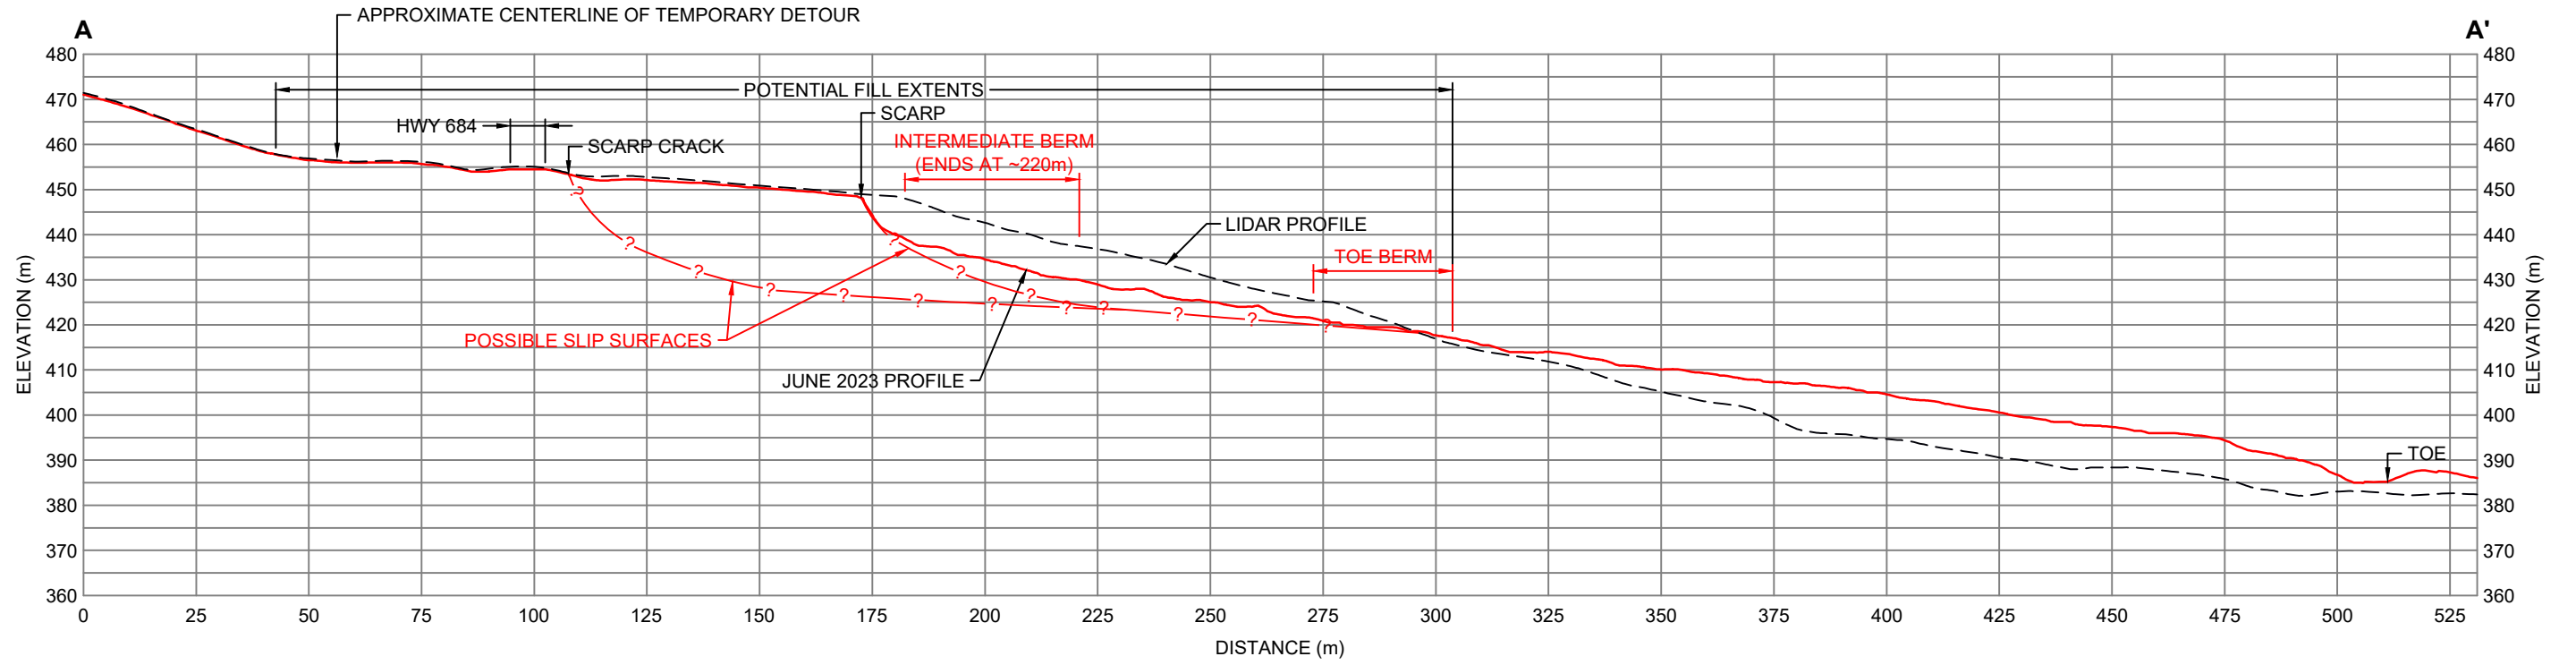
CALL-OUT SECTION A-A'

Based on comparison between the pre-disturbance LiDAR ground surface captured in 2007 and the post-disturbance UAV photogrammetry-derived elevation model, the transition between depletion and accumulation occurs coincident with the downslope end of the toe berm constructed following the 1986 slide (see Drawing 32121-PH093-3). That would suggest that the failure occurred within the fill or native, possibly disturbed, material beneath the fill. Since the failure took 37 years to occur, it is likely due to gradually straining of the relatively weak native clay soils under the load of the fill that was replaced for the repair, combined with a gradual loss of cohesion which resulted in a progressive failure. It is possible that there was also some oversteepening by erosion at the toe of the embankment. The likely source of erosion would be from the gabion mattress channel on the west side. Above-average rainfall may also have been a contributing factor in triggering erosion or raising the local groundwater table. Environment Canada's 1981 to 2010 Climate Normals for Peace River are 18 mm of rainfall for month of April and 40 mm for May. In 2023, April had only 5 mm of rainfall. But there was 72 mm in May 2023 with 50 mm of that, greater than the long-term average for the whole month, fell between May 22 and 24. However, the Google Earth imagery indicates that failure had already initiated earlier in May (assuming their dates are correct) so the heavy rainfall later in the month was not the cause although it most likely contributed to the rate and size of movement.

The elevation model derived from the UAV imagery does not exclude vegetation and was not corrected with ground control points so comparison with the 2007 LiDAR is subject to errors. Within those limitations, there appears to have been about 45,000 m³ of depletion from the fill slope and a corresponding amount of accumulation below in the gully. As discussed above, the slide appeared like a flow slide wherein a sensitive clay fails suddenly resulting in a wet mass of material flowing out and then spreading. In this case, there does not appear to have been a large amount of water involved in the slide and the appearance may simply result from the existing gully funneling the debris. There appears to be about 6 m thickness of material deposited in the gully.
