GEOHAZARD ASSESSMENT PROGRAM

PEACE RIVER / HIGH LEVEL AREA

2011 CALLOUT INSPECTION

Site Number	Location	Name	Hwy	km
PH47	West of Deadwood, AB	Deadwood Slide	690:02	Approx. 2.2
Legal Description		UTM Co-ordinates		
SW1/4 28-89-23-W5M		11V N 6289120	E 462789

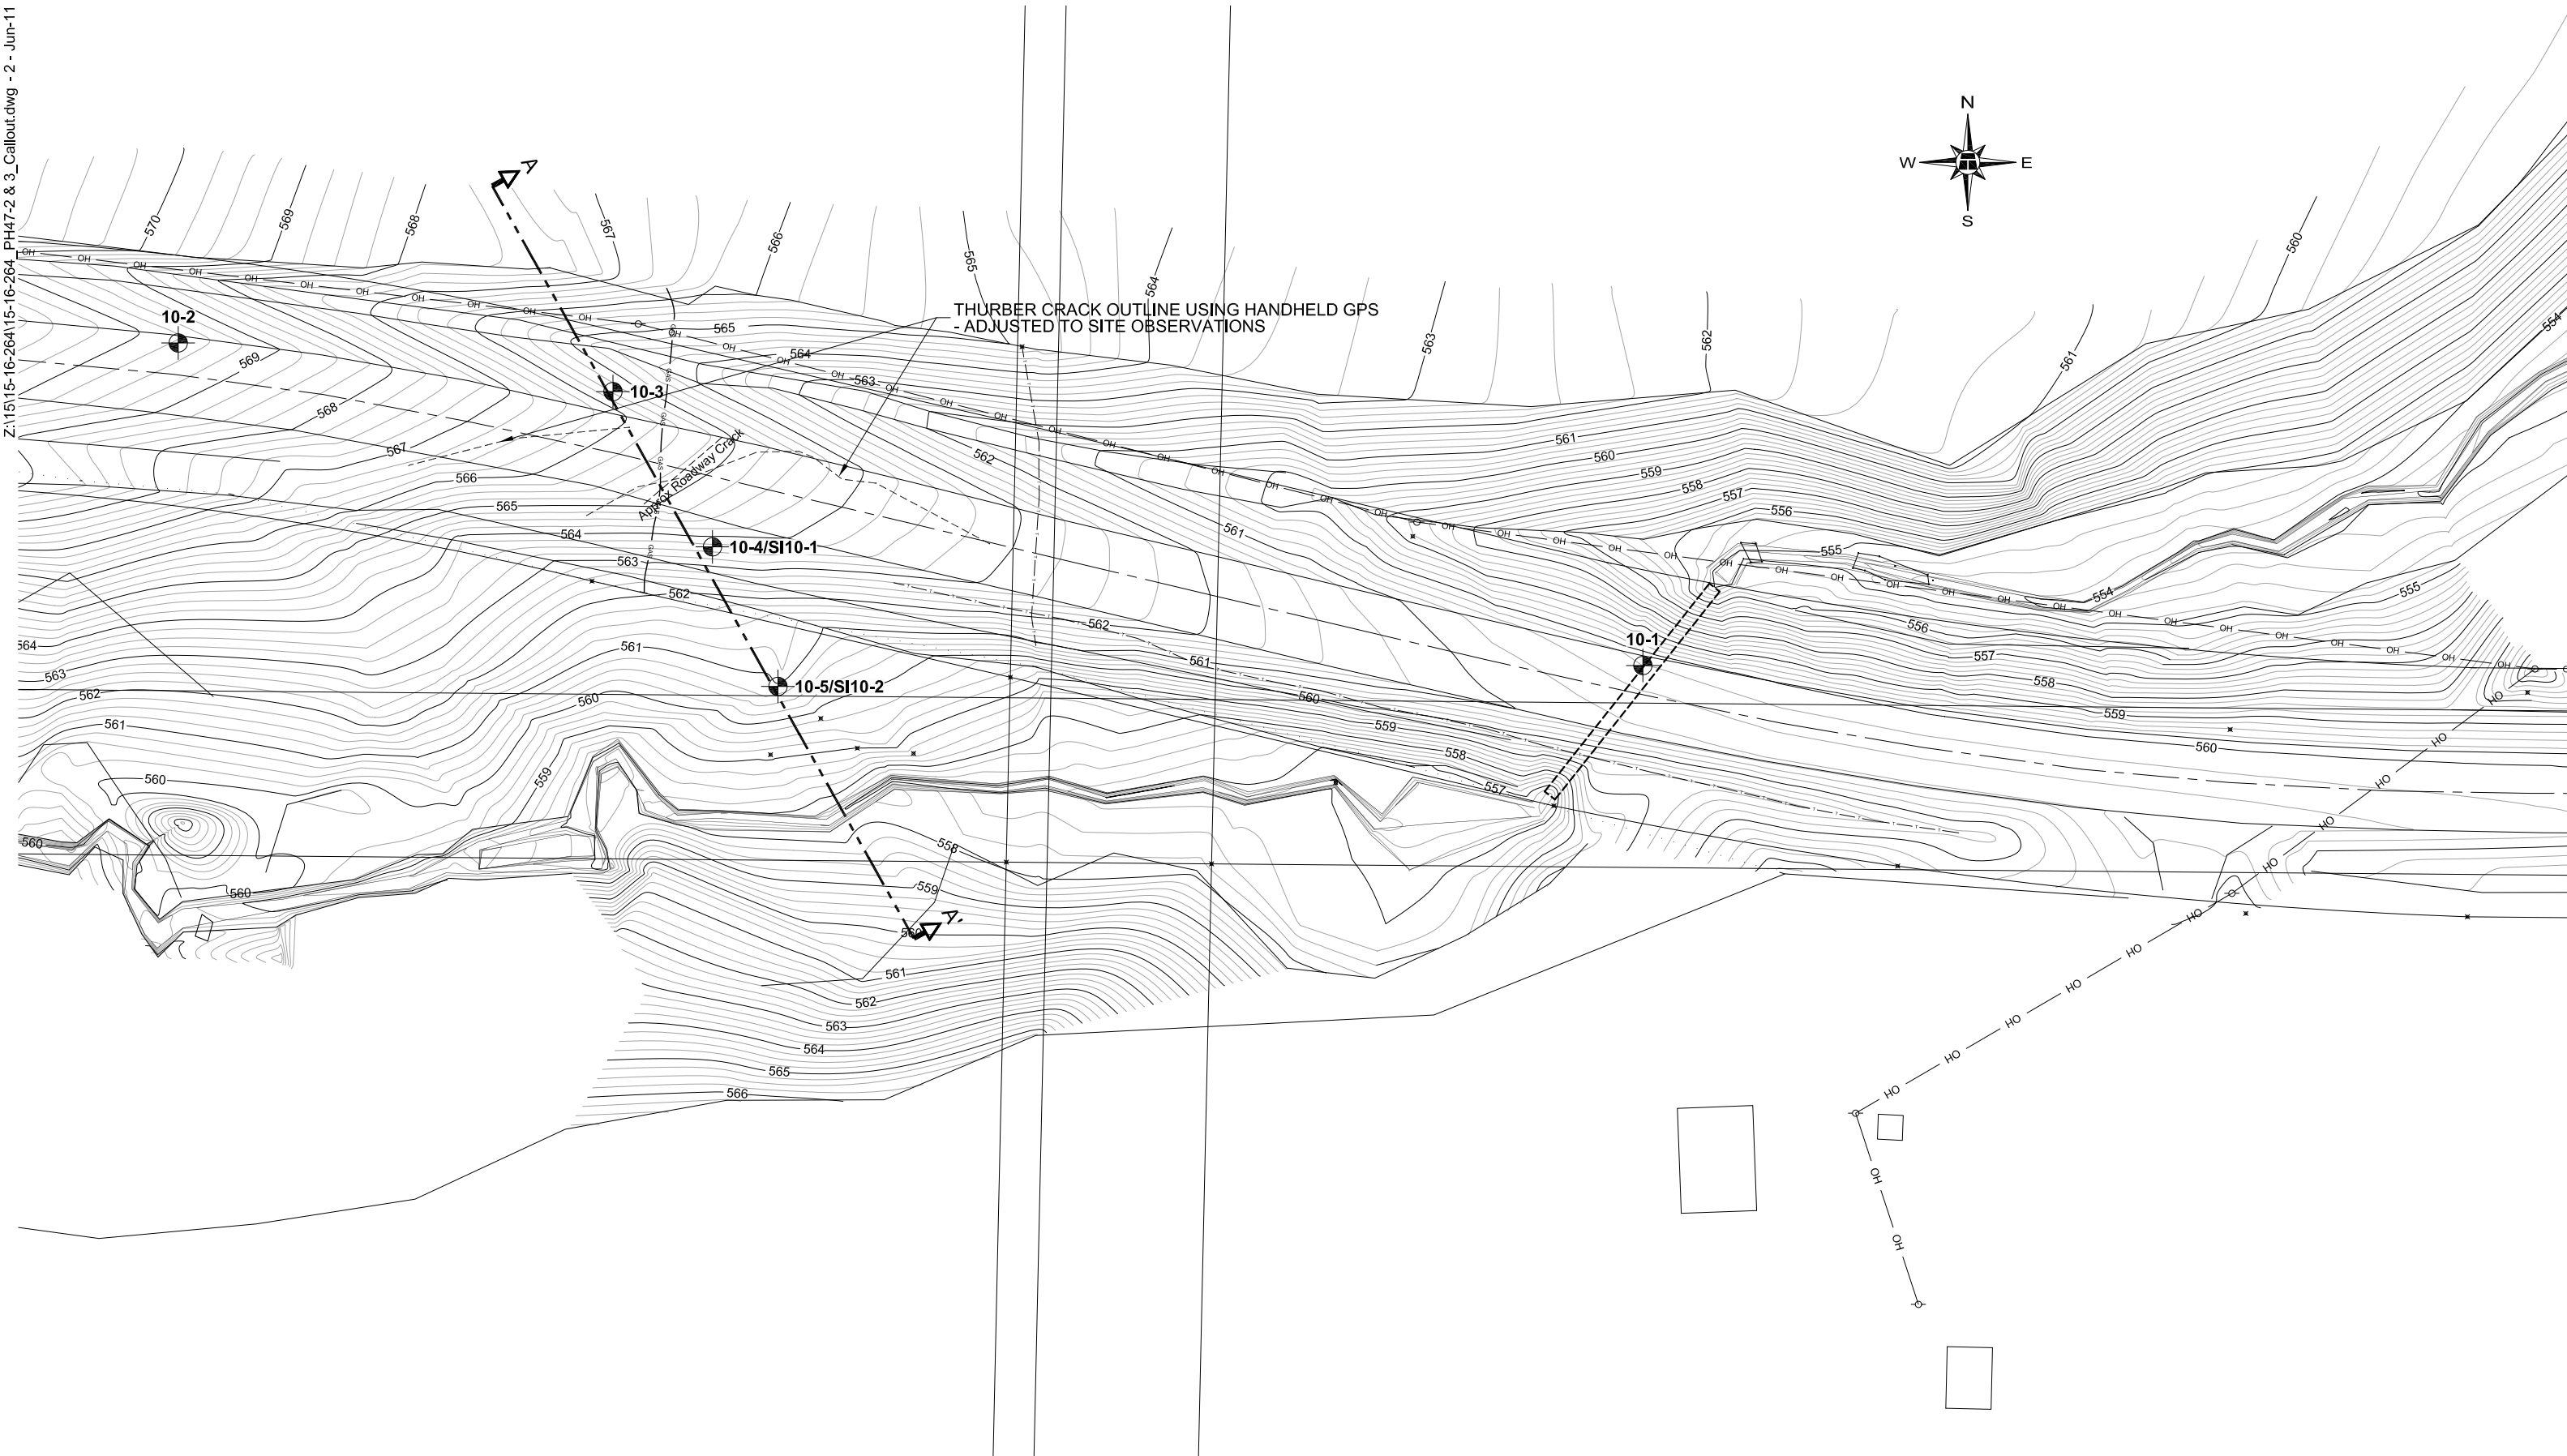
FIGURE PH47-2 CALLOUT SITE PLAN
 PH47 : HWY 672 - DEADWOOD
 PEACE REGION (PEACE RIVER / HIGH LEVEL) GEOHAZARD ASSESSMENTS
 DATE : AUGUST 2011
 THURBER PROJECT #15-16-264

- The slope failure appears to be the result of toe erosion caused by the creek located immediately south of the highway leading to over-steeping of the slope. It is expected that, if left untreated, slow creep movements will continue. Heavy rainfall in July 2011 has triggered the additional movement and it is understood from Alberta Transportation that the slide movement rate increased on July 26, 2011, following a period of heavy rain.
- The pavement cracks have opened up to about 30 mm wide and vertical drops of about 100 mm.

In the short term, the cracks, and vertical drops in the pavement structure should be milled and patched to maintain a smooth even road surface for traffic safety.

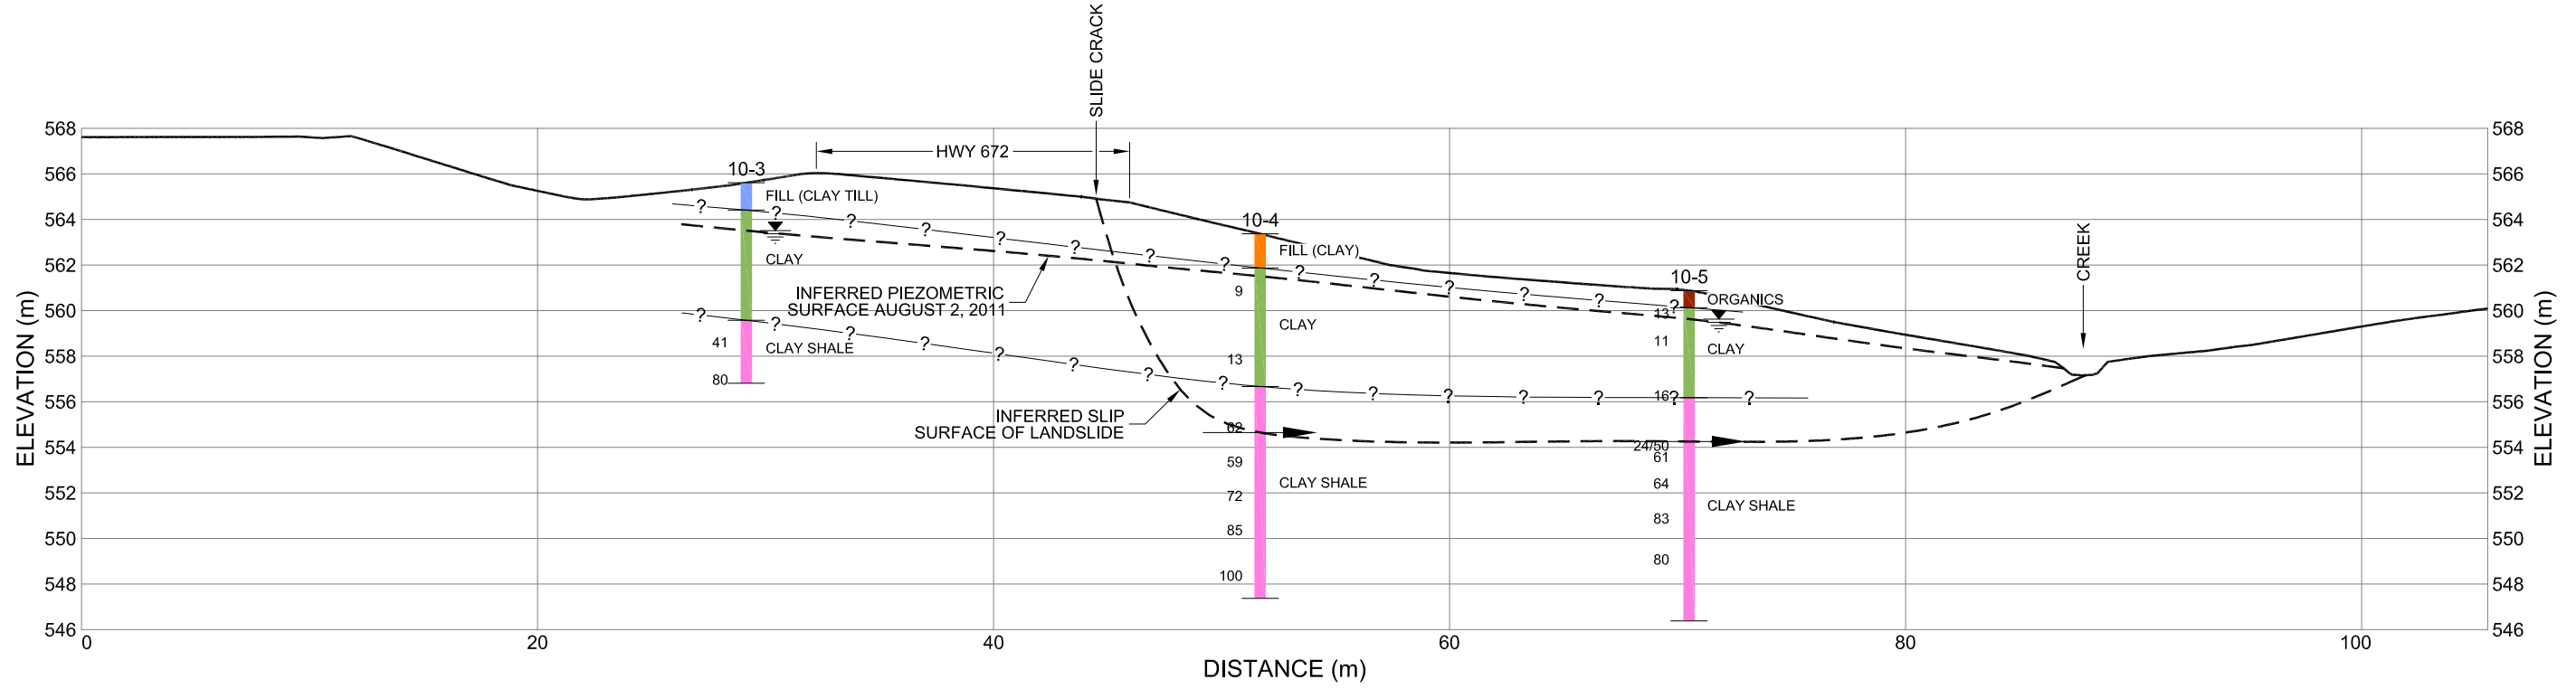
FIGURE PH47-3 CALLOUT CROSS-SECTION A-A'
 PH47 : HWY 672 - DEADWOOD
 PEACE REGION (PEACE RIVER / HIGH LEVEL) GEOHAZARD ASSESSMENTS

- As recommended during our 2010 assessment, geotechnical investigation was undertaken by J.R. Paine which involved drilling five test holes. Two slope inclinometers, three standpipe piezometers and a pneumatic piezometer were also installed as part of the investigation. The test hole logs are attached with this report. The approximate locations of the test holes and SI's are shown on Figures 47-1 and PH47-2. A stratigraphic cross-section is provided on Figure 47-3.
- The soil conditions as shown in the test hole logs indicate presence of clay fill, overlying clay/clay till followed by clay shale.
- The slip surface of the slide is based in the shale.

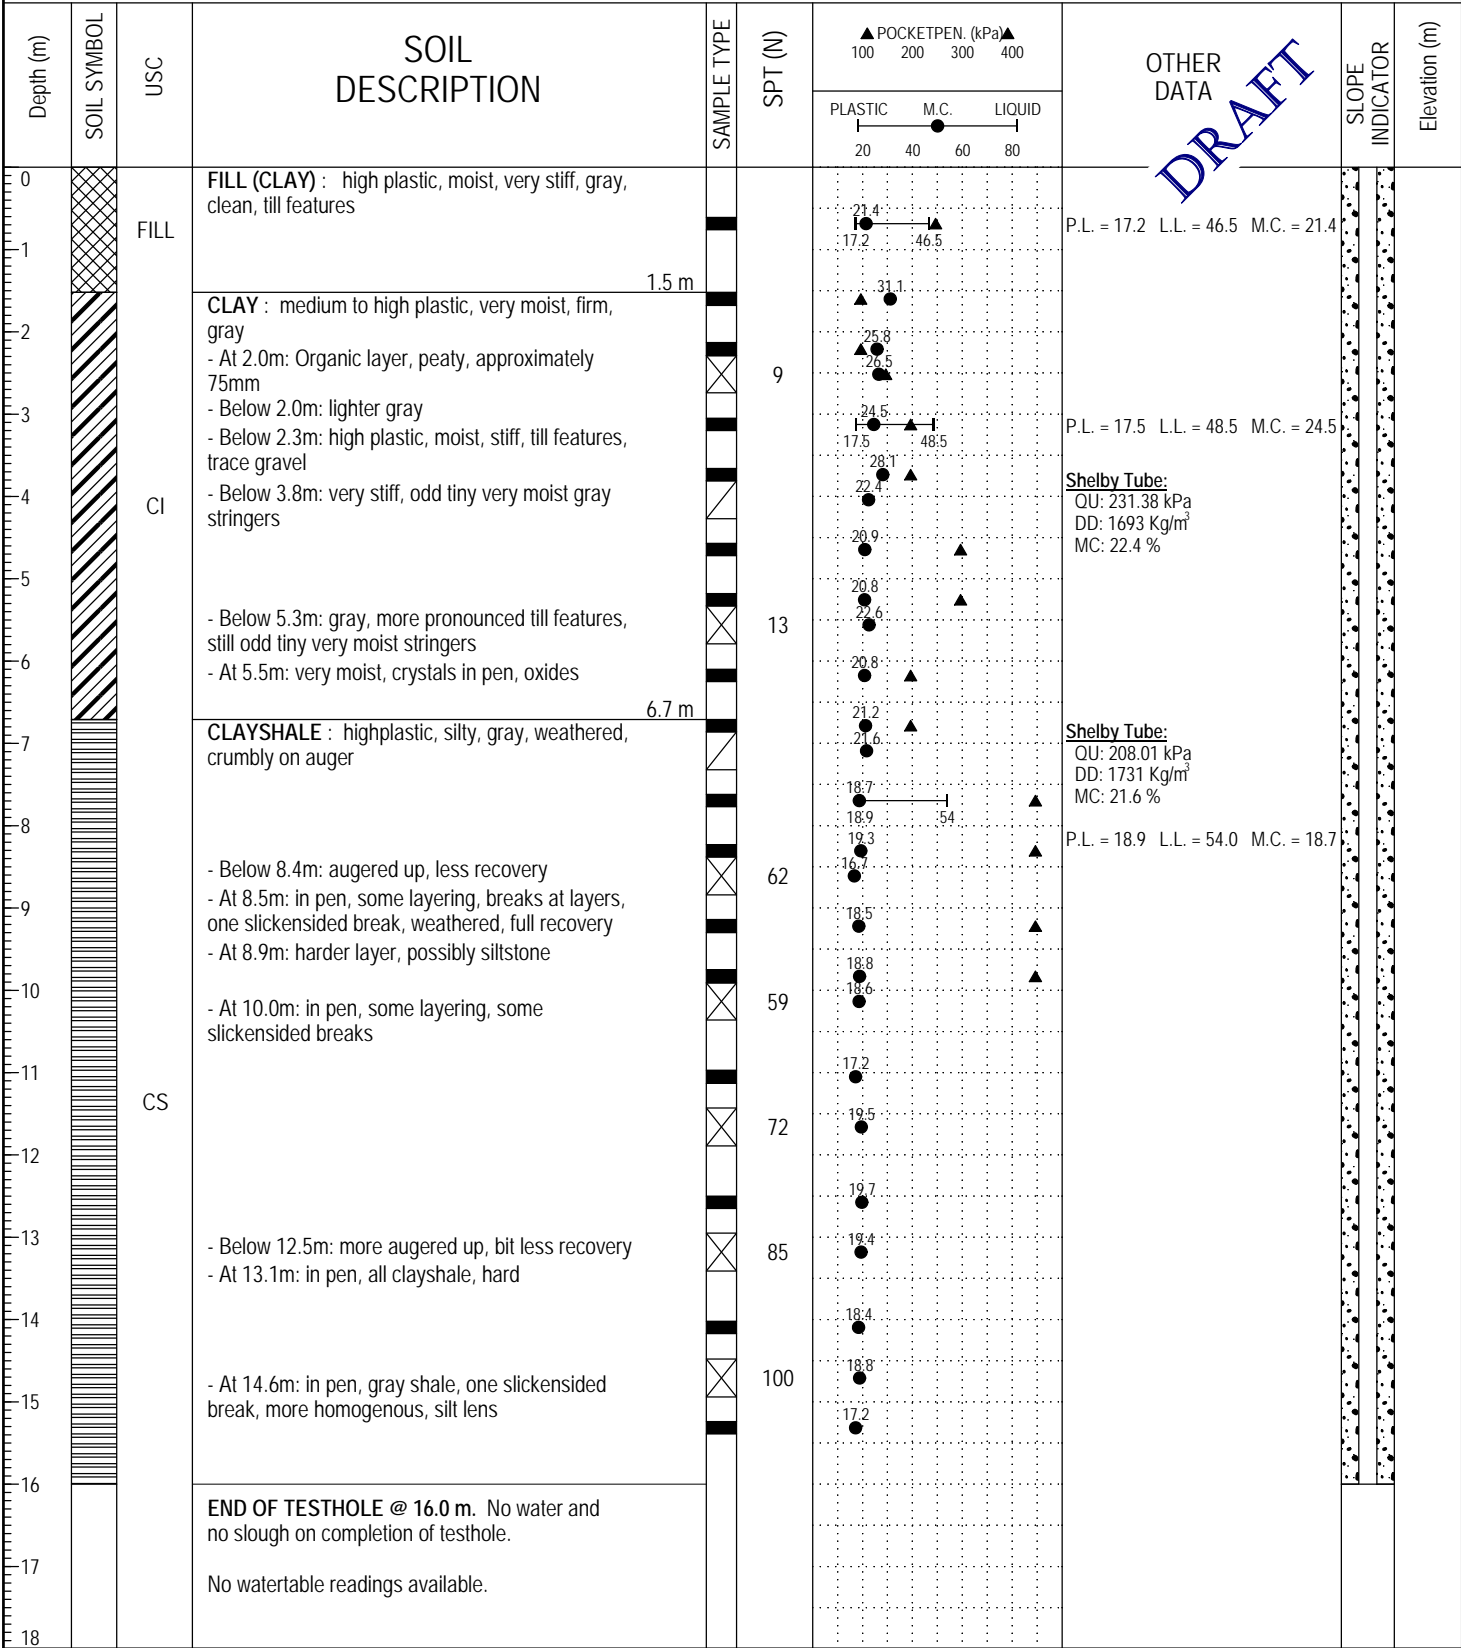
Two slope inclinometers were installed by J.R. Paine. Slope movement of about 10 mm is recorded between March and May 2011 at depths of about 9 m and 7 m in SI-10-1 and SI-10-2 respectively. The SI plots provided by J.R. Paine are attached with this report.
