**ALBERTA TRANSPORTATION
GEOHAZARD ASSESSMENT
PEACE REGION (PEACE RIVER DISTRICT)
2023 INSPECTION**

Site Number	Location	Name	Hwy	km
PH075-1	North of Peace River	Whitemud River (km 44.4)	743:02	44.4
PH075-2		Whitemud River (km 44.8)		44.8
Legal Description		UTM Co-ordinates		
NE2-88-21-W5M		11U E 486,395 486,112	N	6,273,737 6273,982

Date	PF	CF	Total
Previous Inspection:	7-July-2021	PH075-1: 11 PH075-2: 9	4 6	44 54
Current Inspection:	16-May-2023	PH075-1: 13 PH075-2: 8	4 6	52 48
Road AADT:	163		Year:	2023
Inspected By:	Max Shannon, TEC Rocky Wang, TEC Pramaya Kannel, TEC		Don Proudfoot, Thurber Ken Froese, Thurber	
Report Attachments:	<input checked="" type="checkbox"/> Photographs	<input checked="" type="checkbox"/> Plans	<input type="checkbox"/> Maintenance Items

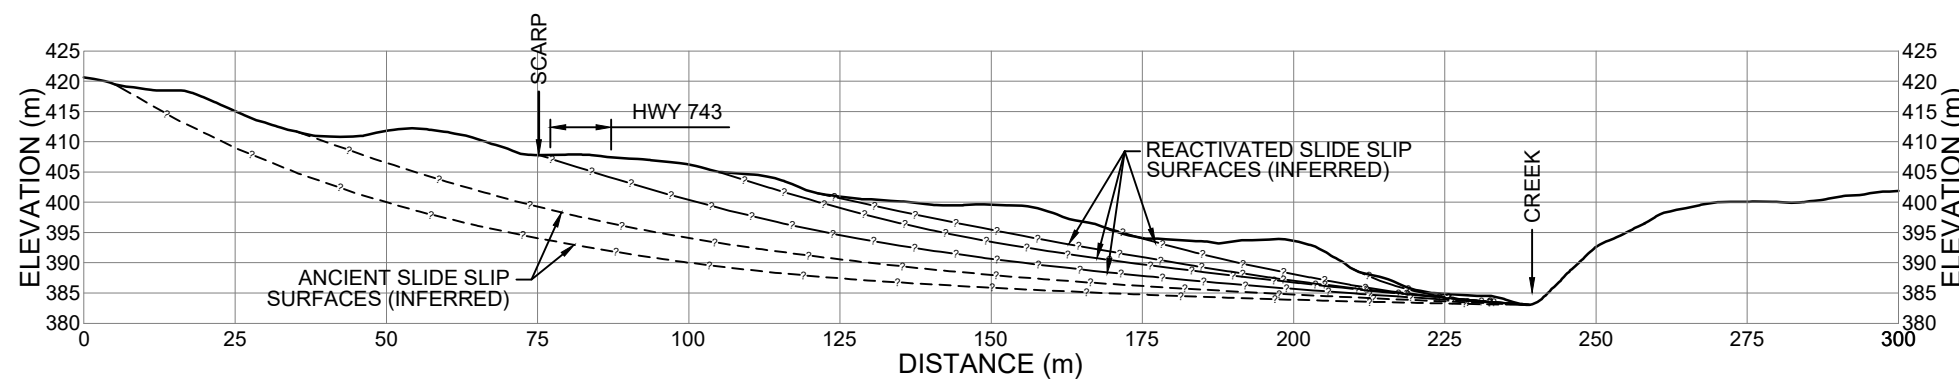
DWG No. 32121-PH075-2

PH075-2 (Drawing 32121-PH075-2)		
The slide at PH075-2 was first noticed during a callout inspection of other sites on Hwy 743 on August 4, 2020, shortly after movements closed the highway. The site is located on a sidehill
