## ALBERTA TRANSPORTATION AND ECONOMIC CORRIDORS GEOHAZARD – INSTRUMENTATION MONITORING PEACE REGION – (PEACE RIVER DISTRICT) SPRING 2024

Site Number	Location	Name	Hwy	km
PH072	HWY 744:04 C1 58.154	Sunshine Slide	744:04	Km 58.2
Legal Descriptio	n: 16-20-83-21 W5	UTM Co-ordinates		
		11U E 483111	N 62	30075

Current Monitoring:	23-May-2024	Previous Monitoring	16-Jun-2023
Instruments Read By:	.T and Mr. Nixson Mationg, of Thurber

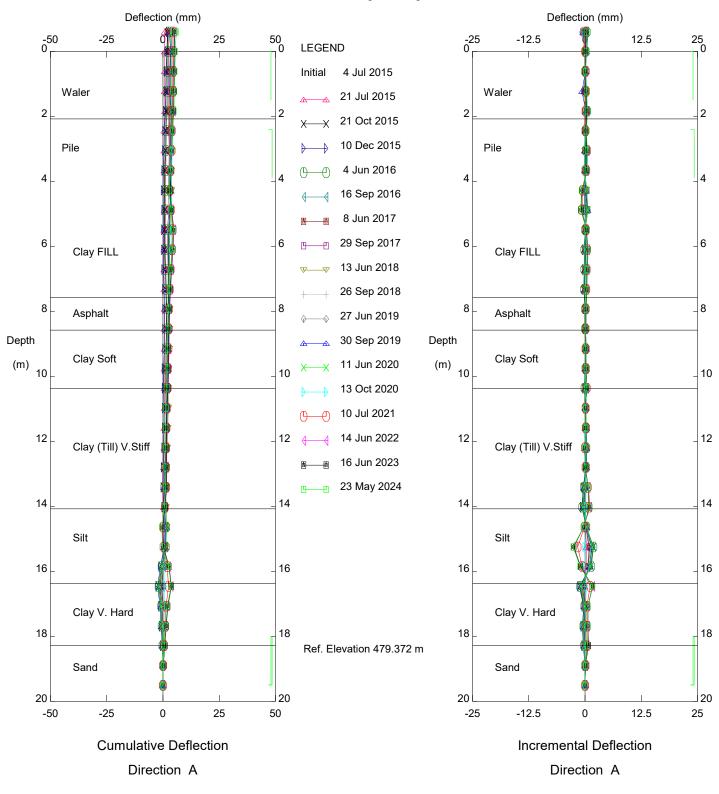
PH072 Sunshine (Post Construction), Inclinometer Pile 34

Discussion
Zones of New Movement:	None
	Pile 34 showed a rate of movement of 0.6 mm/yr over the length of the pile and a rate of movement of 1.6 mm/yr over the combined length of the pile and waler since the spring of 2023 readings. Pile 34 has shown a total cumulative pile head movement of 1.3 mm in the downslope direction since completion of construction and a total cumulative movement of 1.2 mm in the downslope direction over the combined length of the pile and waler.
Interpretation of Monitoring Results:	Pile 59 showed a rate of movement of 0.1 mm/yr over the length of the pile and a rate of movement of 0.6 mm/yr over the combined length of the pile and waler since the spring of 2023 readings. Pile 59 has shown a total cumulative pile head movement of 4.4 mm in the downslope direction since completion of construction with a total cumulative movement of 5.6 mm in the downslope direction over the combined length of the pile and waler.
