ALBERTA TRANSPORTATION LANDSLIDE RISK ASSESSMENT

SECTION A: GEOTECHNICAL FILE REVIEW

**SITE PH64: HWY 64:02 BF79554 SIDESLOPE INSTABILITIES (KM
52.7)**

Highway Control Section: **HWY 64:02**

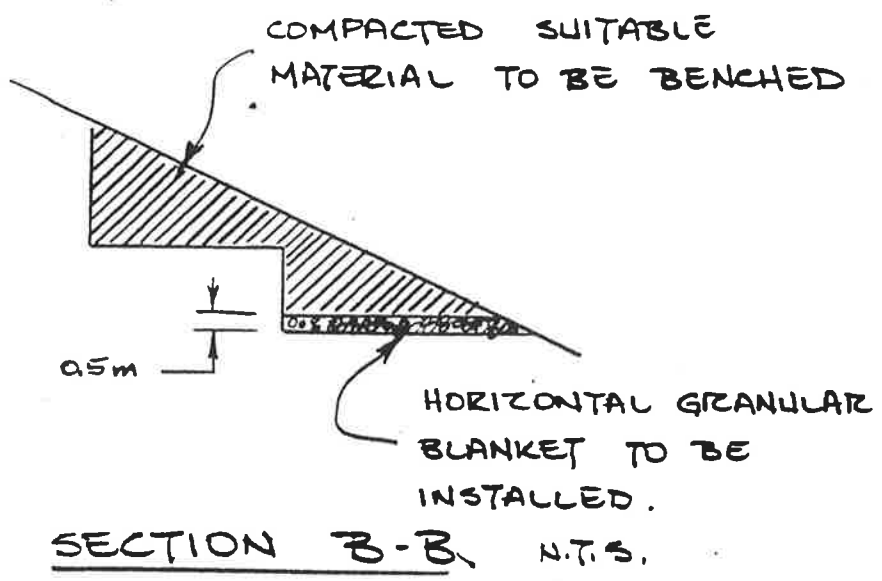
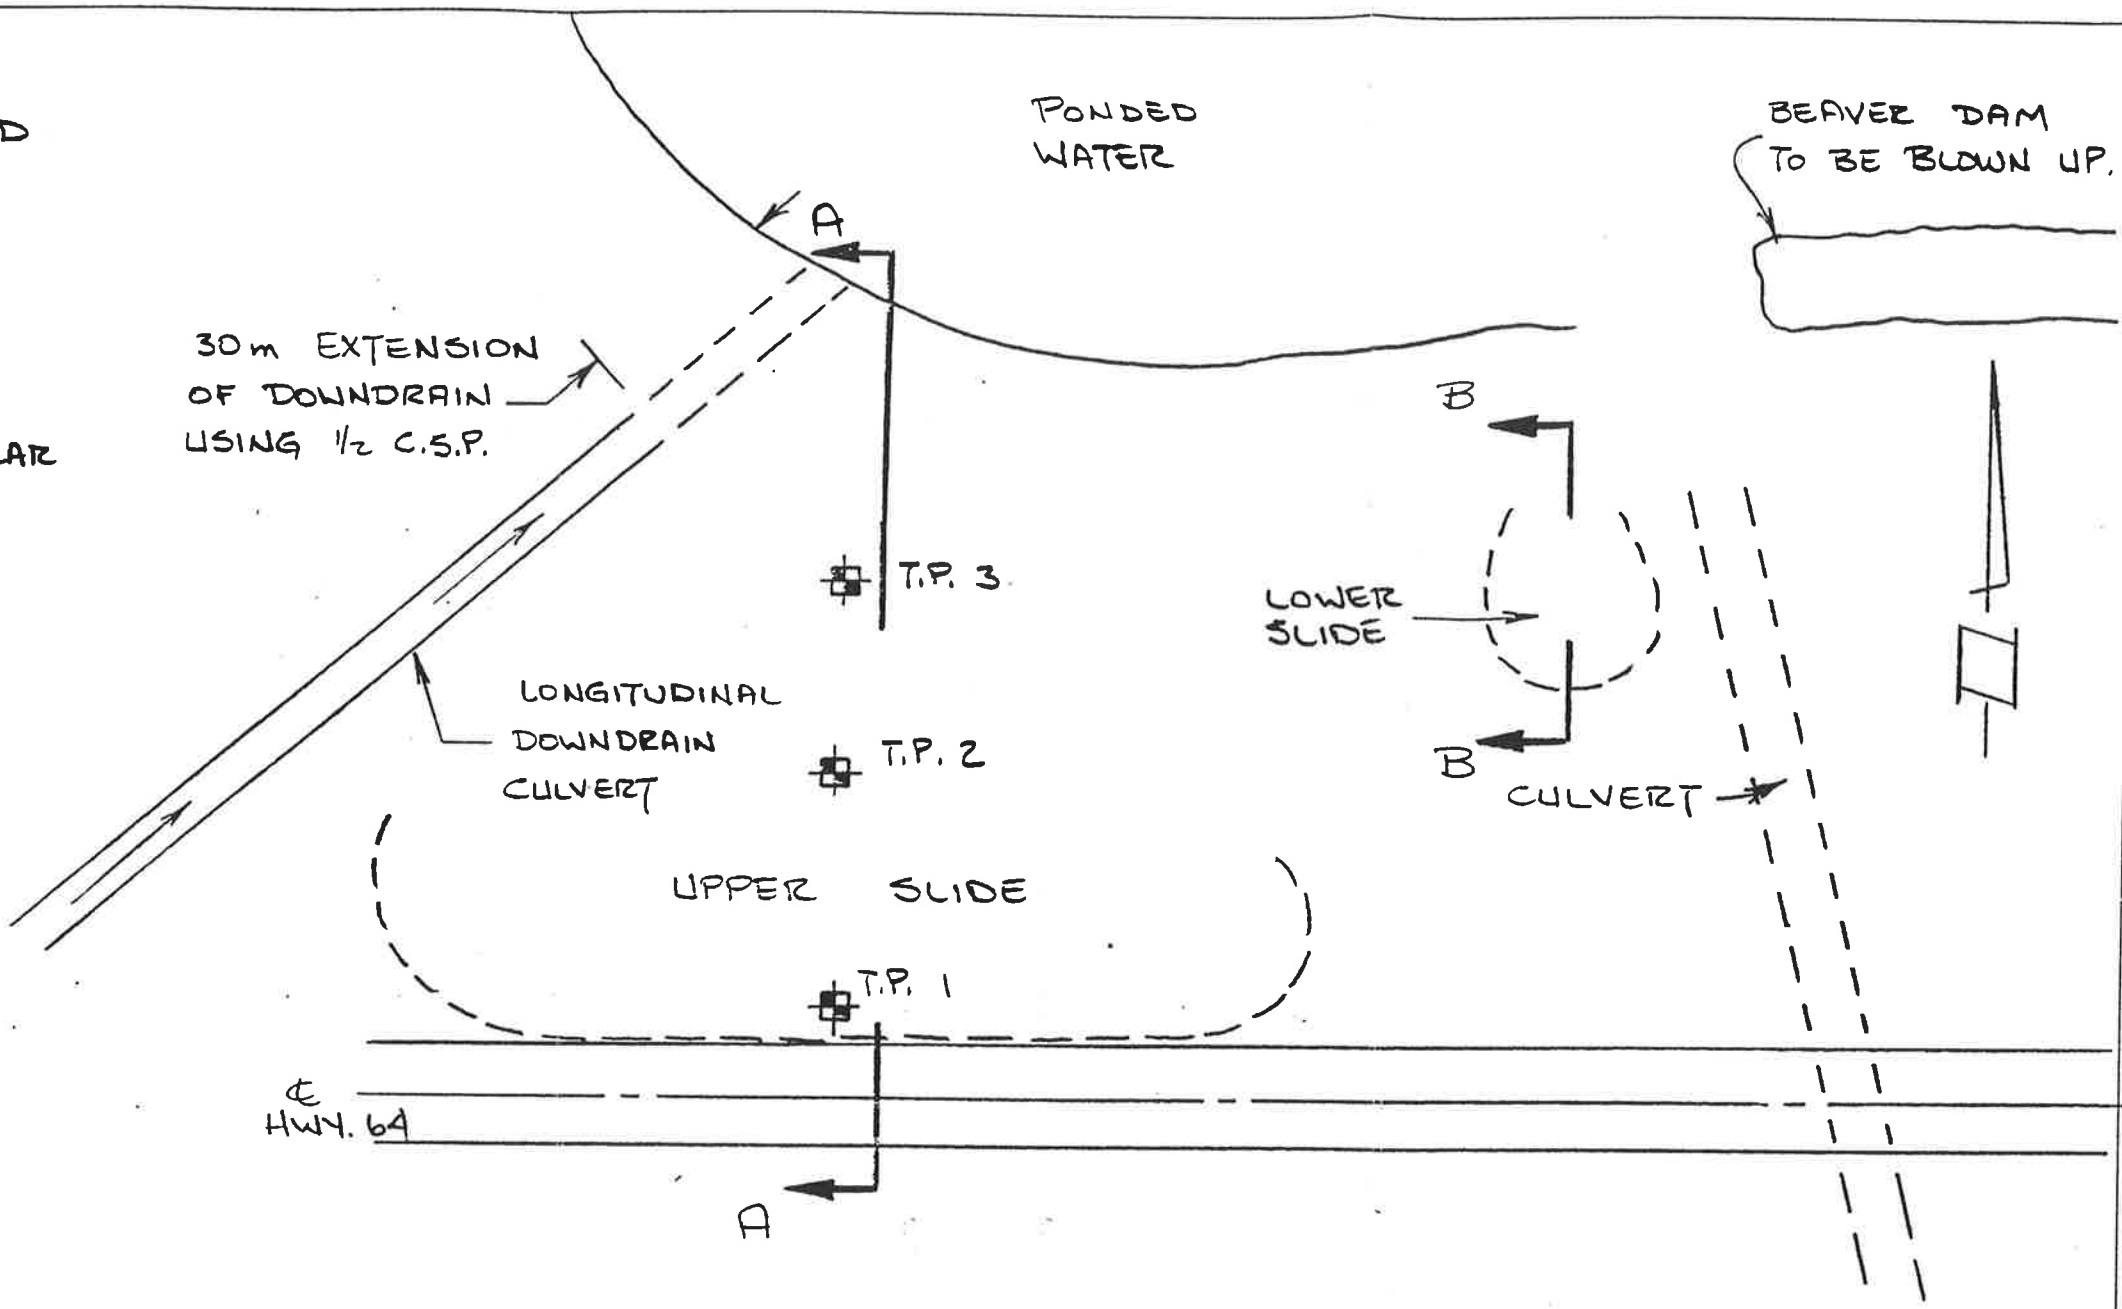
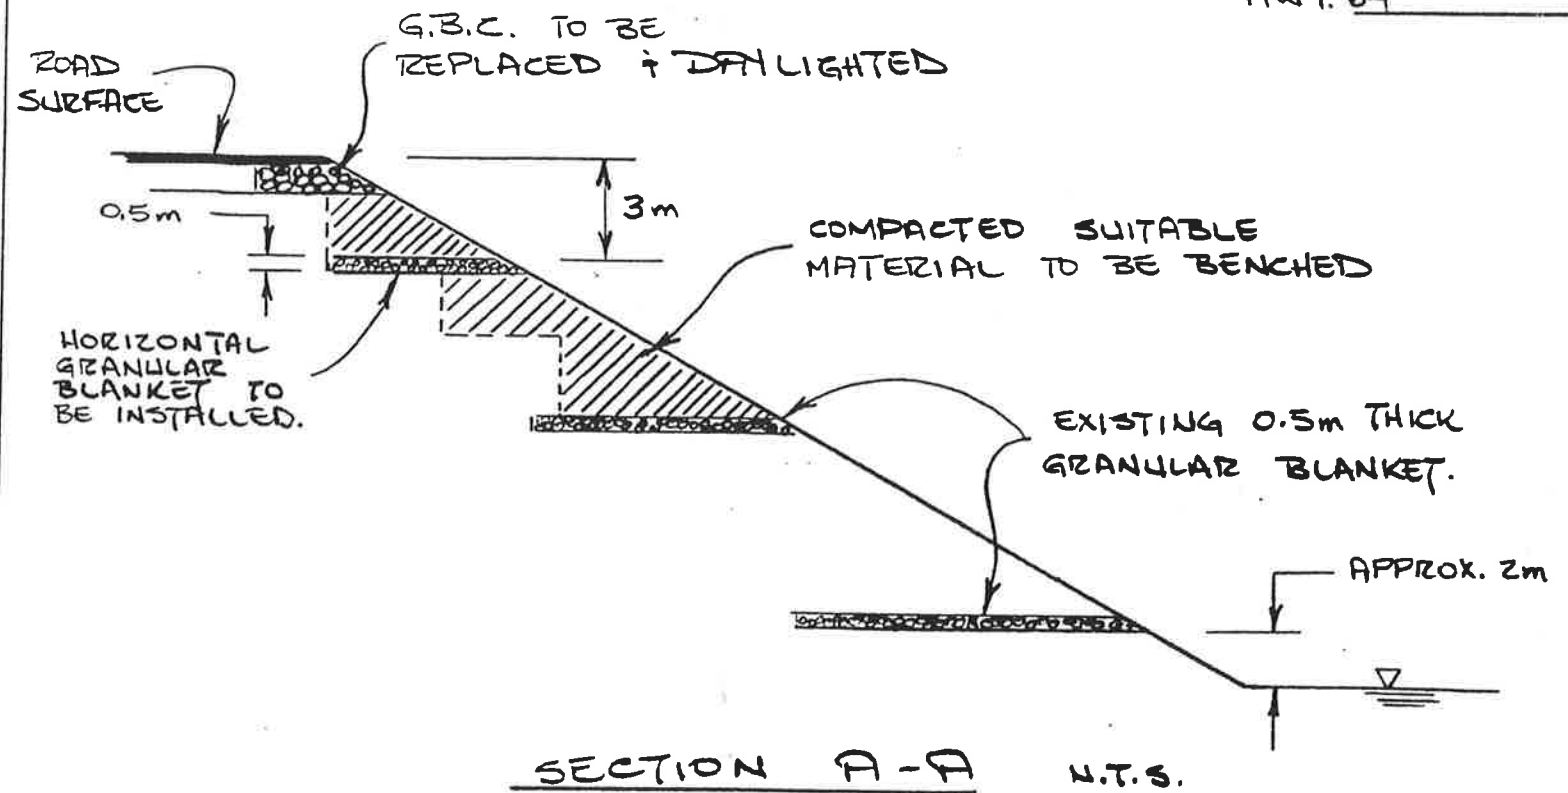
For the upper slide, the above investigation tends to indicate shallow slab slide failure limited to less than 1 m depth and that breakage along the escarpment face of the previous slide was apparent. Such inference was based on the shallow sloughed material encountered in testpitting. The bottom half and the toe of the slope appeared in good condition.

For the lower slide, sloughing failure was evident.

Two horizontal granular layers, apparently installed during last repair operation, of approximately 0.5 m thick were located at approximately midslope and at toe of slope.
