**SOUTHERN REGION GEOHAZARD ASSESSMENT  
ANNUAL ASSESSMENT REPORT  
2007**

**Alberta Infrastructure and Transportation**  
Calgary, Alberta

**AMEC Earth & Environmental,**  
**a division of AMEC Americas Limited**  
Calgary, Alberta

### 4.1 S1 – JUMPINGPOUND CREEK

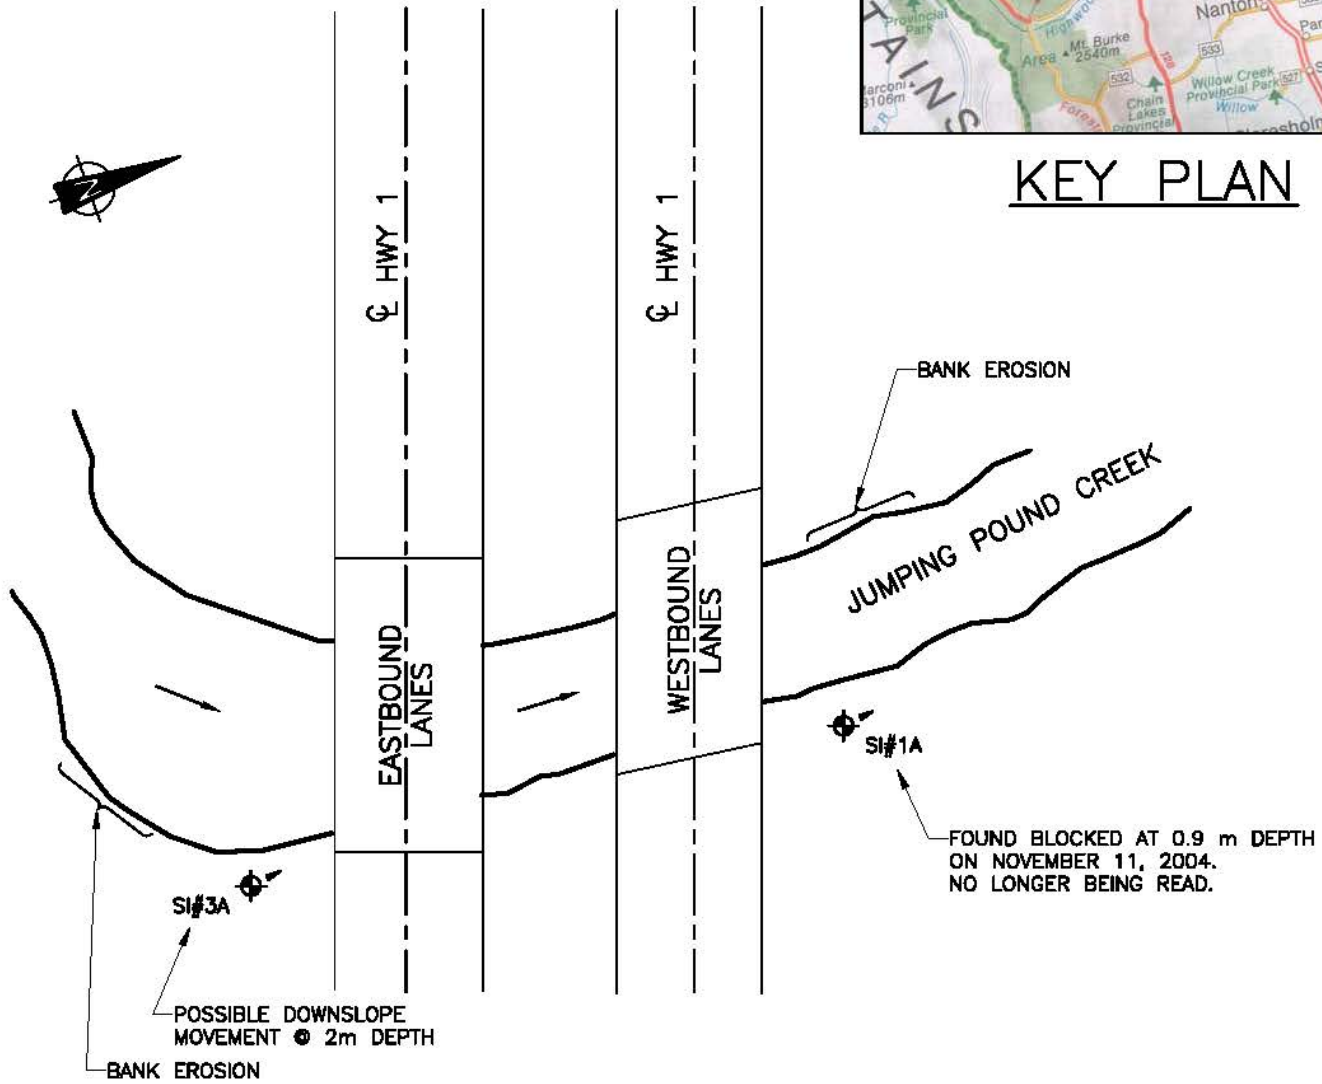
Slope instability along the crest of the east creek valley slope, downstream of the westbound lane bridge. This instability has been noted since the first annual inspection in 2000, however it does not appear to have worsened significantly since that time nor retrogressed towards the highway. Compare with the view of the same area from the 2005 inspection, as shown in Photo S1-6.

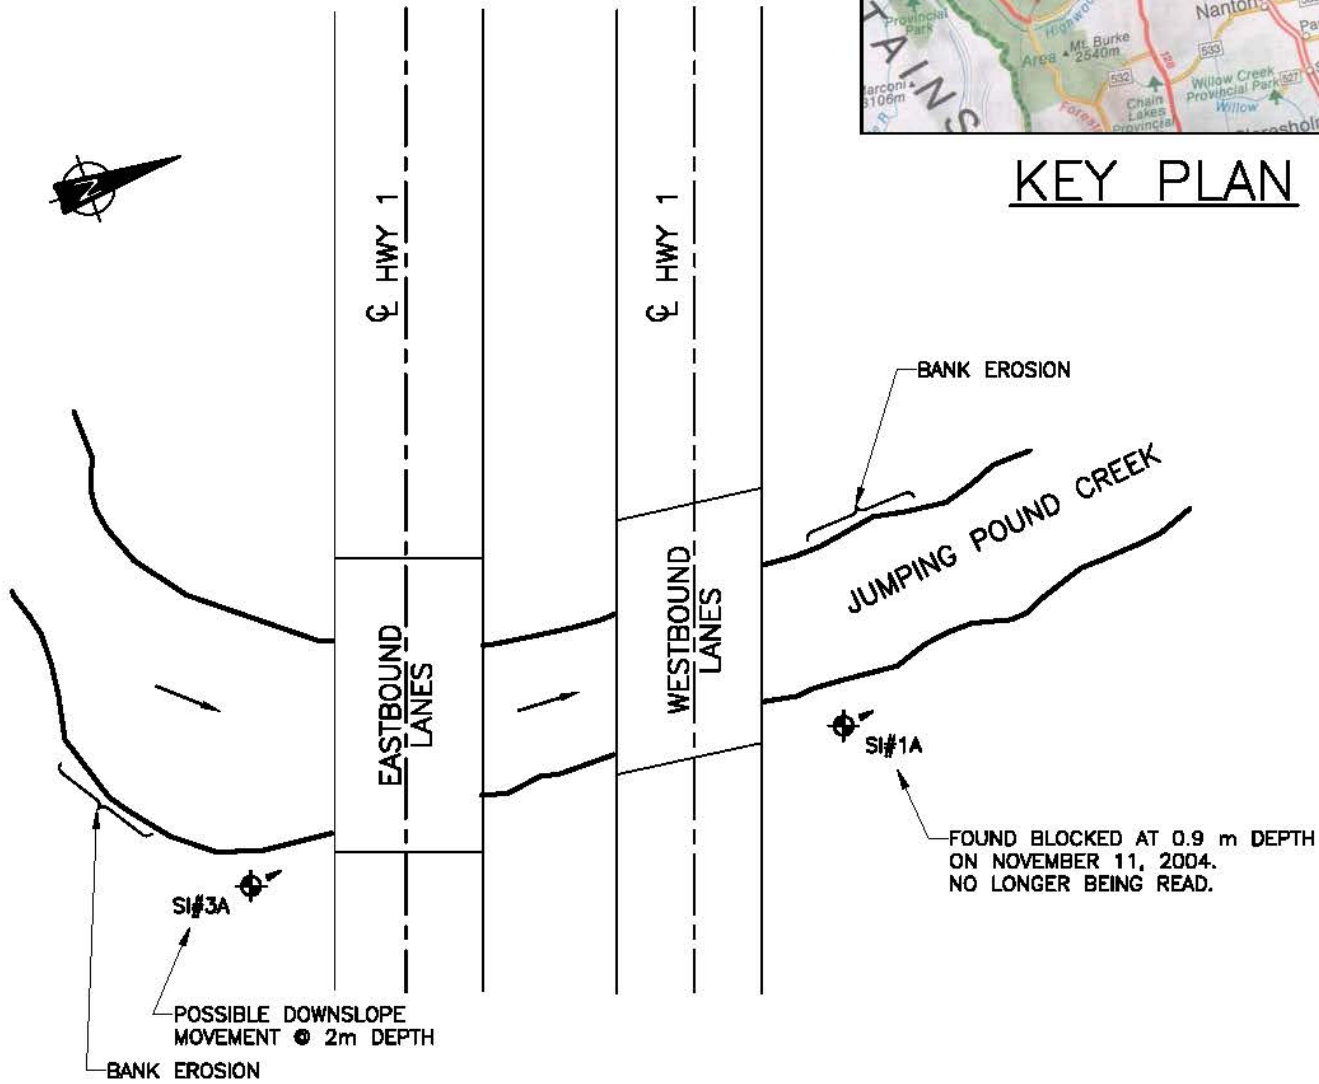
Slope instability along the crest of the east creek valley slope, downstream of the westbound lane bridge. This instability has been noted since the first annual inspection in 2000, however it does not appear to have worsened significantly since that time nor retrogressed towards the highway. Compare with the view of the same area from the 2005 inspection, as shown in Photo S1-6.
