SITE NUMBER AND NAME: S047 Coleman Bin Wall		HIGHWAY & KM: 3:02, 13.283	PREVIOUS INSPECTION DATE: June 1, 2017	INSPECTION DATE: May 2, 2018
LEGAL DESCRIPTION: 09-07-008-04 W5M 12-08-008-04 W5M	NAD 83 COORDINATES: UTM Northing Easting 11 5500995 679014		RISK ASSESMENT: PF: 1 CF: 6 TOTAL: 6	
AVERAGE ANNUAL DAILY TRAFFIC (AADT): On Hwy 3. 7,830 (west), 8,810 (east), (Ref No. 70060)			CONTRACTOR MAINTENANCE AREA (CMA): 26

PROJECT
SOUTHERN REGION GEOHAZARD RISK MANAGEMENT PROGRAM

TITLE
Site Plan
S047 - Coleman Bin Wall
Hwy 3:02, km 13.283

FIG No.
2

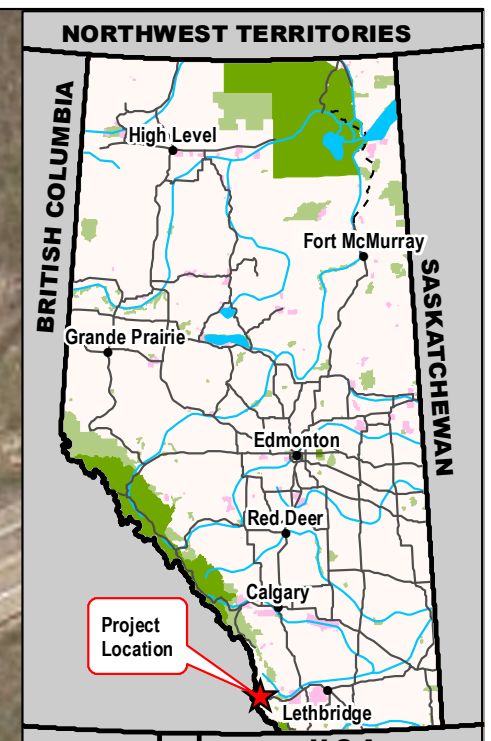
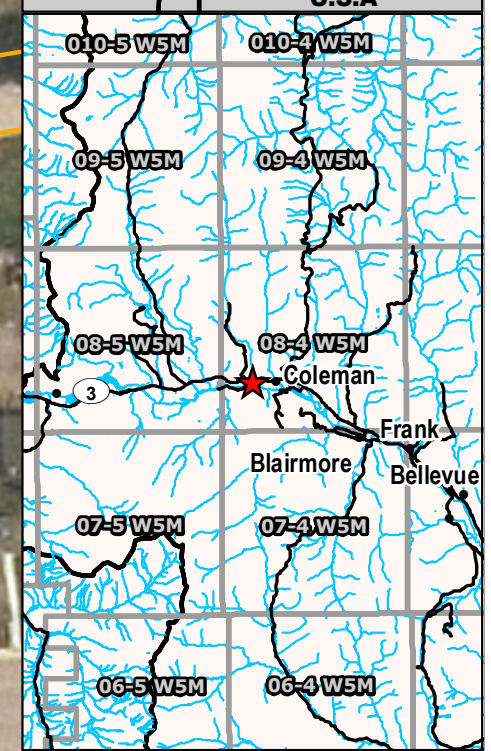
Conditions in this figure do not reflect repair work conducted prior to site inspection

Corroded sections repaired with concrete retaining wall. 11 of the 22 sections were repaired (half the wall).
