October 28, 2011

**Re: Southern Region Geohazard Assessment Program
S25 - Highway 3, Km 29.45, Near Monarch, AB
2011 Annual Inspection Report**

This letter documents the 2011 annual site inspection of Site S25 – Monarch, on Highway 22:14, near Monarch, AB.

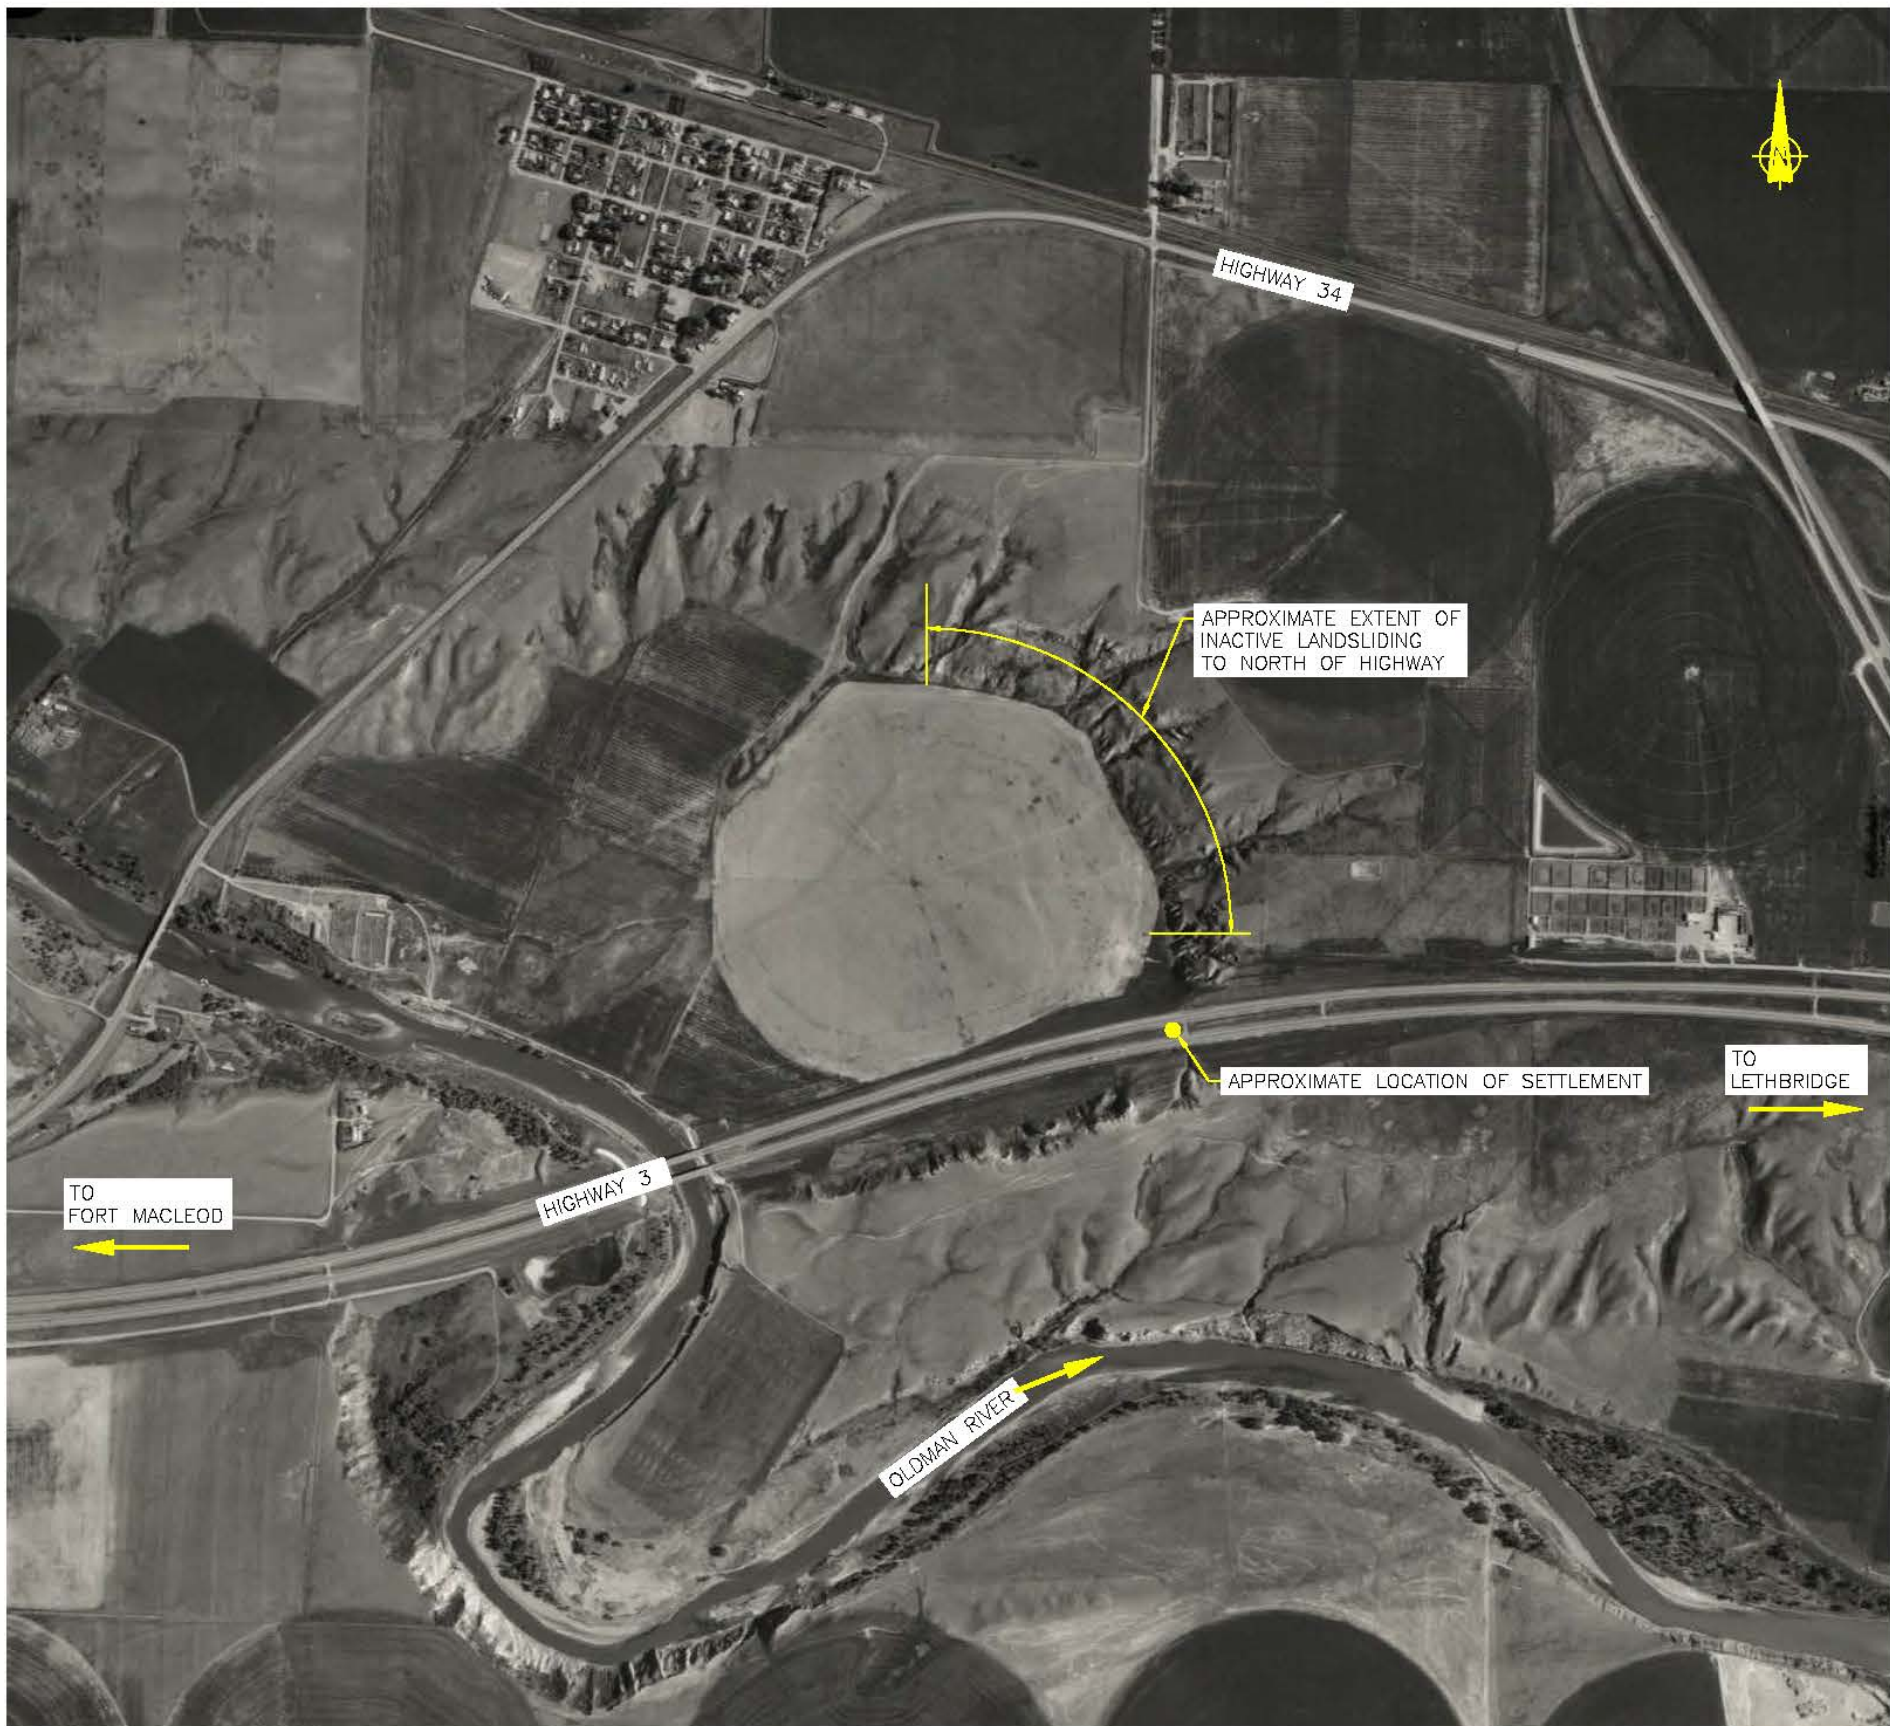
- An overlay had been placed at the previously noted settlement areas in the east and westbound lanes, likely in 2010. Refer to Figure S25-2 and Photo S25-1. Cracking had formed through the recent overlay following a similar pattern as was observed in 2007.
- The cracking was relatively minor and did not follow a definitive pattern that would be associated with landslide movement. There was settlement in the area near the cracking, but the settlement encompassed a broad area, and was not localized at the crack locations. The settlement was subtle and was noted by observing suspension compression of vehicles as they travelled through the site area. Refer to Photos S25-2 and S25-3.
