Highway 940 – Km 14 Ditch Erosion Site

The site inspection was performed on September 27, 2008 by Mr. Andrew Bidwell, P.Eng. of AMEC.

PROJECT:		HWY 940 GEOHAZARDS REVIEW							
TITLE:		Km 14 DITCH EROSION SITE							
DATE:	JANUARY 2009	JOB No.:	CG25262	CAD FILE:	25262Z06.dwg	FIGURE No.:		REV.	A

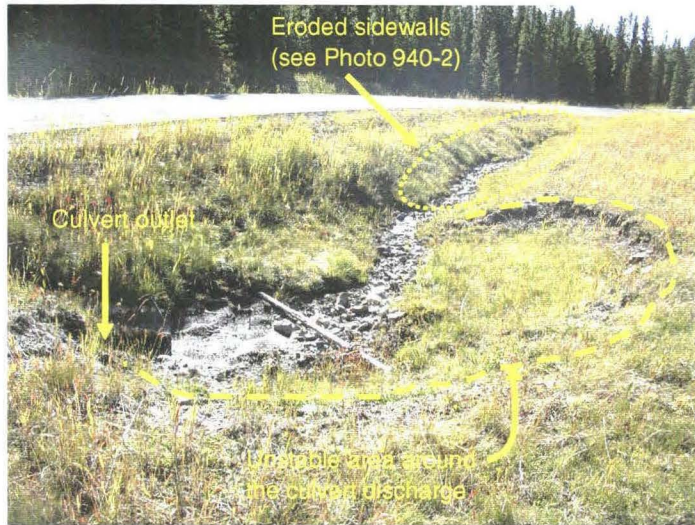
- The ditch erosion widens and deepens to approximately 2 m maximum depth starting around 40 m south from the outlet of the north culvert. Photo 940-2 shows this segment of the ditch. Fine grained, clayey soils are exposed in the ditch base and sidewalls in this area. There are numerous slump failures along the ditch sidewalls in this area. At the time of the inspection, the west edge of the road had not been directly undermined by the slumping in the ditch sidewalls.

It is recommended that AT consider Option 1. Soil nailing (Option 2) may not be an effective repair method for this site due to the relatively shallow nature of the slumping. Furthermore, soil nailing would not mitigate the potential for further downcutting of the ditch base and at this site is likely cost-ineffective relative to Option 1.

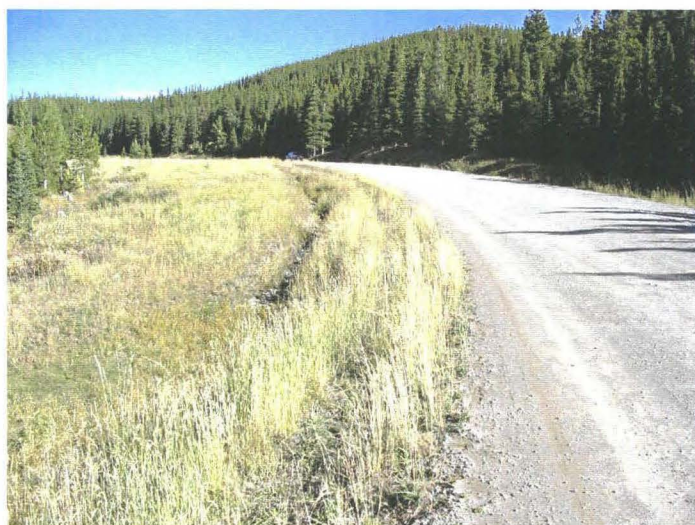
- The attached site sketch shows the layout of the site and the relative locations of the site features described below.
- There is significant erosion and downcutting along an approximately 110 m segment of the west road ditch. The northern limit of the erosion is around the outlet of a 500 mm diameter culvert, as shown in Photos 940-1 and 940-2. The erosion extends southwards (downstream) along the ditch. The southern limit of the erosion is around the inlet of another culvert to the south that carries the west ditch drainage back over to the east ditch, as shown on the attached site sketch.
